**Basic Recreational Use Attainability Analysis of
Armand Bayou Above Tidal
Segment 1113A**

Contract No. 582-8-80188

Prepared by:
University of Houston-Clear Lake

November 13, 2009

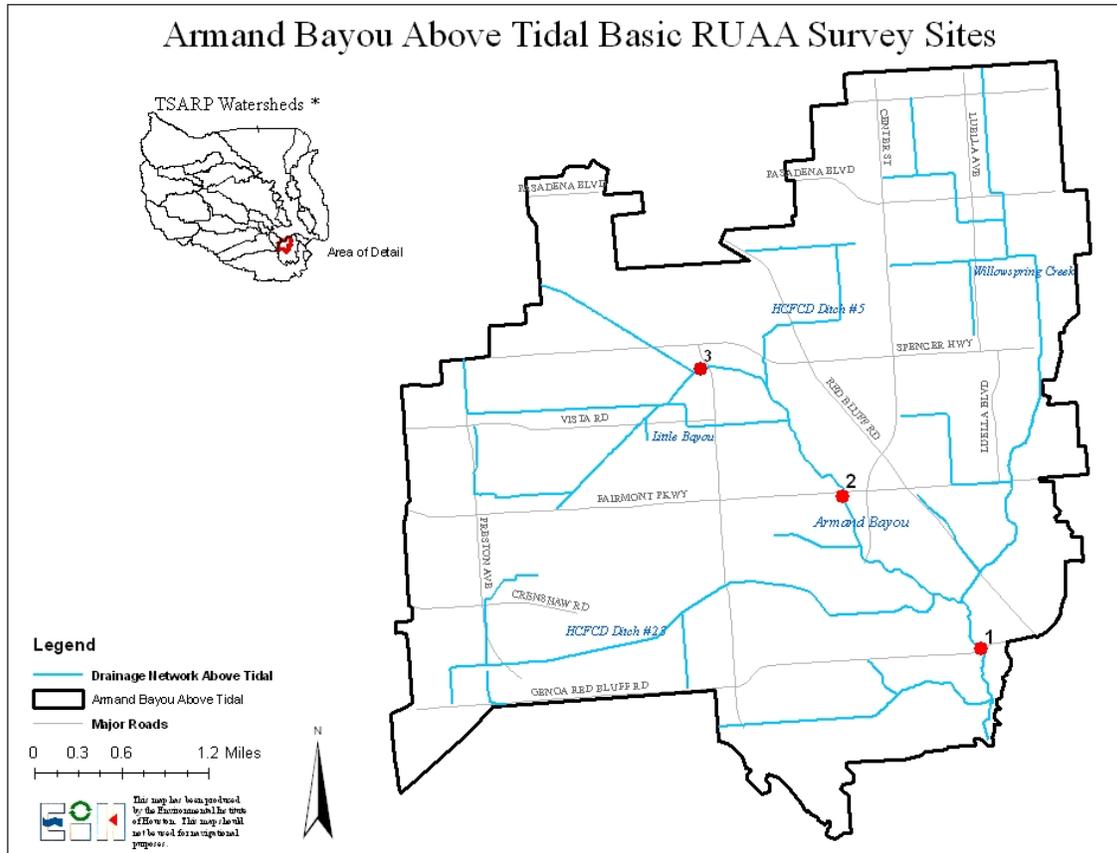
Figure 1. Basic RUAA survey sites selected based on river mile, accessibility, and recreational features. Aerial photos of the sites are included in the photographic record (Appendix 3).

In general, the target density of survey sites should be approximately three (3) sites per every five (5) miles of stream (Texas Commission on Environmental Quality (TCEQ) 2009b). During our study survey sites were established in areas where the water body is accessible to the public and has the highest potential for recreational use (road crossings, public lands/parks located near the water body, and populated areas). A total of three (3) survey sites were established (Table 1 & Figure 1-4).

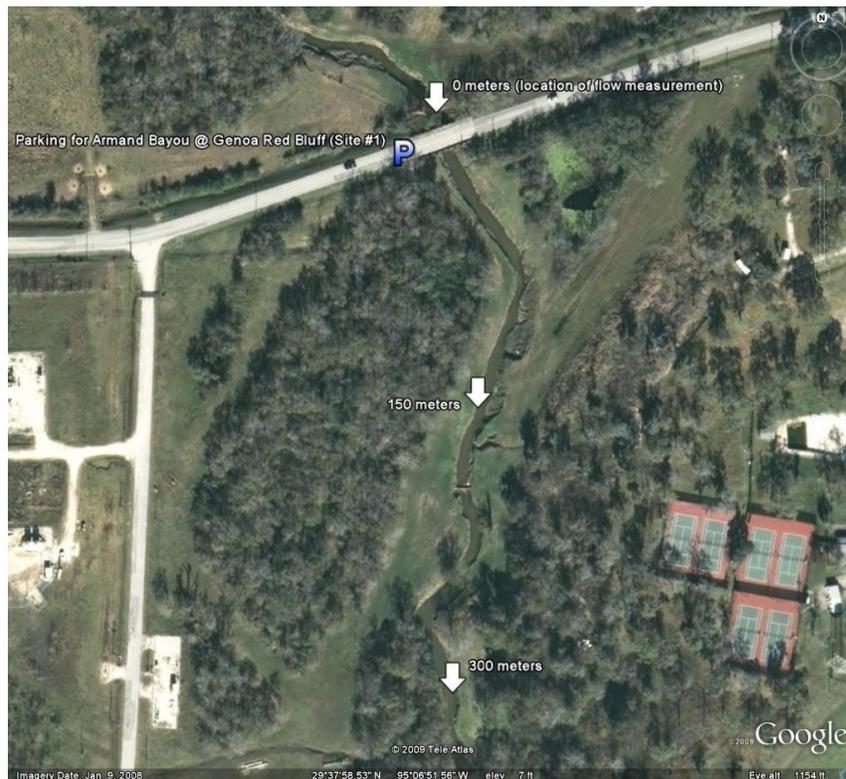
Figure 2. Aerial view of Site # 1 (Genoa-Red Bluff @ Armand Bayou)

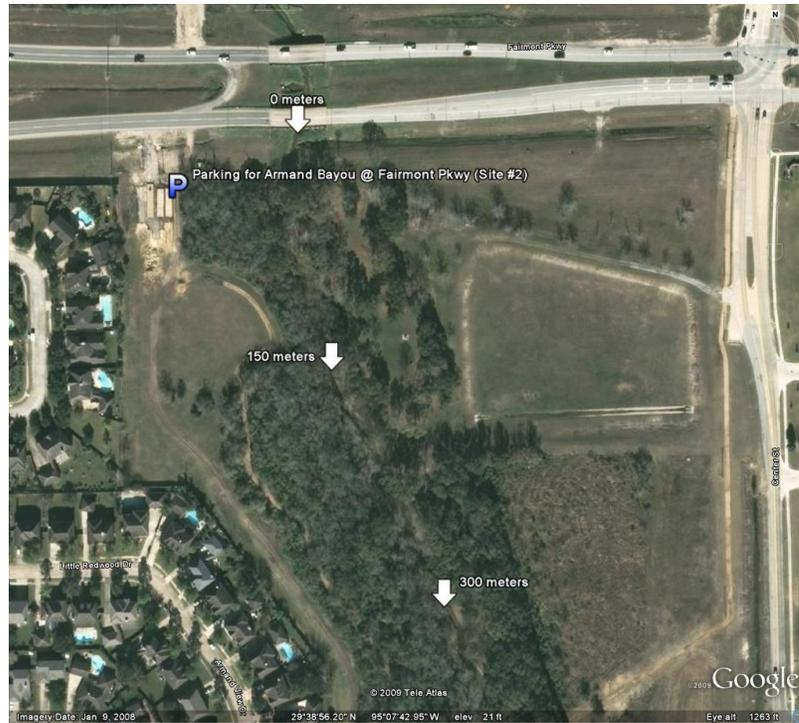
Figure 3. Aerial view of site 2 (Fairmont Parkway @ Armand Bayou).

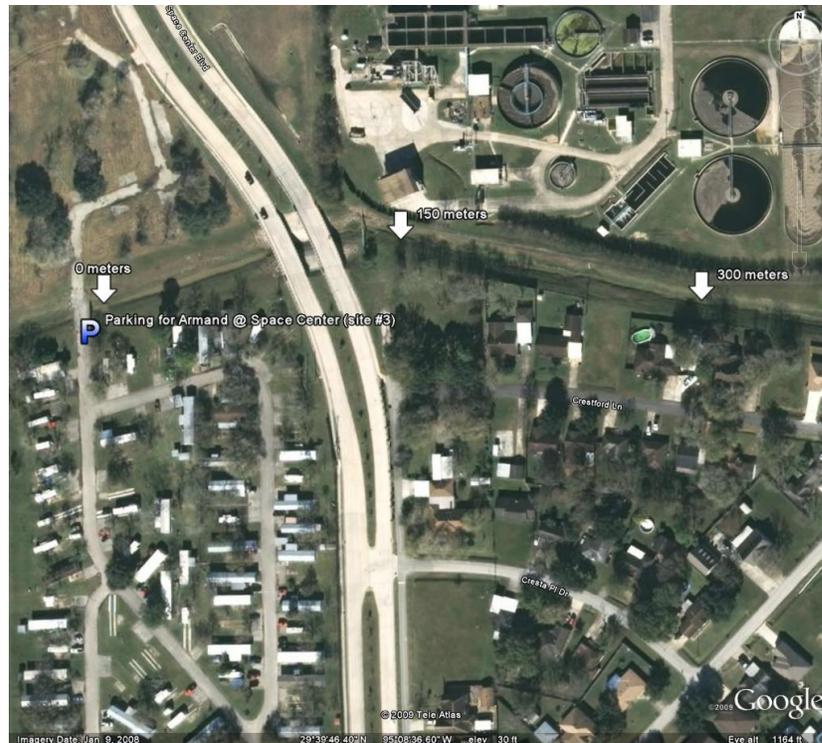
Figure 4. Aerial view of site 3 (Space Center Blvd @ Armand Bayou)

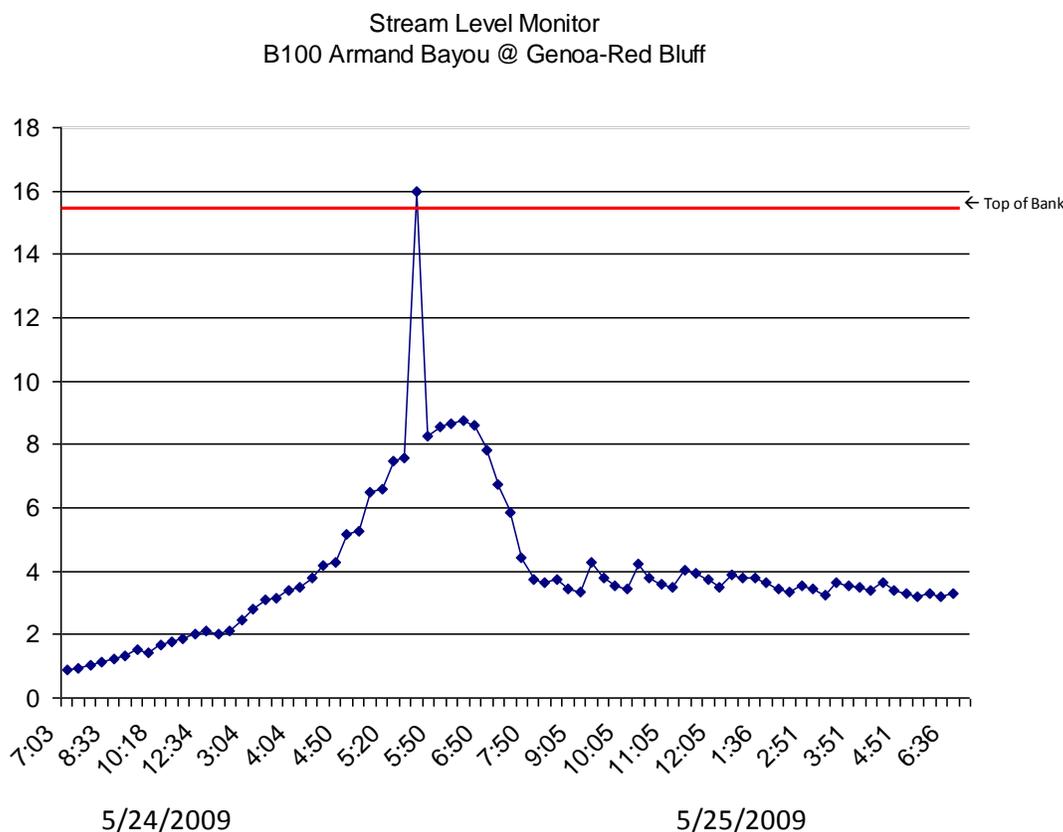
All three sites were visited on all occasions and all required data were recorded. Completed scanned datasheets are included as Appendix 2. The flow on the first day of sampling (5/25/09) was significantly higher than the observed flow on the later two sampling events (7/4/09 and 7/25/09). This was due to the fact that a significant rainfall occurred on the day (5/24/09) previous to the first survey (Figure 5). Thus the average flow (cfs) that is being presented in this report is believed to be higher than the average base flow for Armand Bayou above tidal watershed (segment 1113A). However, flow conditions in the bayou on 5/25/09 did not resemble flood conditions; the stream was nominally wadeable, water in the stream was not turbid and conditions were deemed appropriate for assessment. The average air temperature and water temperatures were well within the requirements for sampling conditions as outlined in the RUAA procedures manual. Average stream depth and stream width are also reported in Table 2.

Figure 5. Stream Level Monitor data from the Harris County Office of Homeland Security & Emergency Management (OHSEM) website for the 24hours prior to Field Surveys conducted on 5/24/2009.

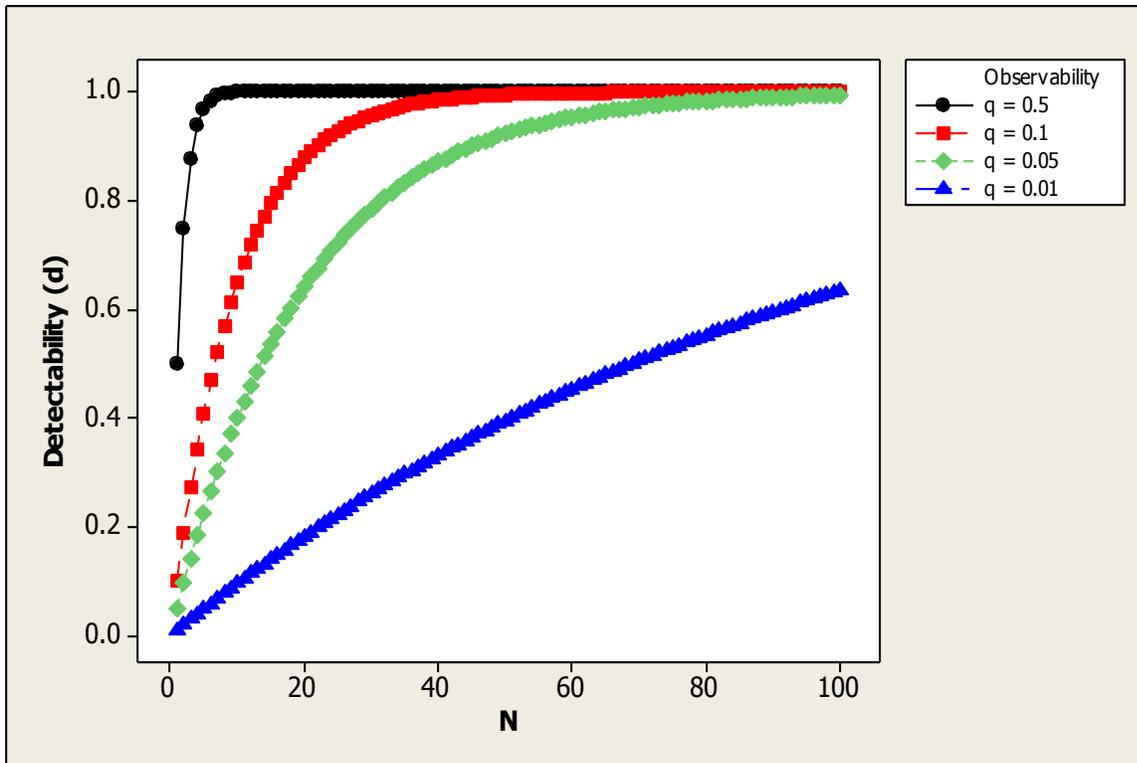
Consequently detectability is very sensitive to both abundance and observability of individuals (Figure 6). A related issue is the desired detection limit, that is, what magnitude of primary contact use are we interested in detecting. This is directly related to the size (number of individuals) participating in the activity, the number of sampling events that are conducted and the desired power or ability to detect a real difference (primary contact use versus non-use) when it is in fact true (Figure 7)(Hintze 1996). Other sources of error are similar to those encountered by fisheries creel surveys and can include not detecting all potential access or activity sites and subsequent under reporting of activity (Pollock et al. 1994). This represents site and time selection sources of error that is not directly related to the previous discussion on statistical issues.

Figure 6. Detectability (d) of an observed activity versus number of individuals' present (N) conducting activity for selected values of observability (q).

Due to these factors it is important that future recreational use attainability analyses carefully qualify results that may yield apparent “non-primary use” due to lack of observed activity, since these observations may only be statistical artifacts caused by low observability and numbers, or low sample size (number of survey events both spatially and temporally). These problems underscore the need for complementary onsite questionnaires and background reviews to insure that streams with low recreational use levels are not incorrectly classified as having no recreational use. Finally, although the RUAA methods attempt to measure and characterize stream conditions that may affect recreational use, non-linear responses to varying environmental conditions such as streamflow can affect perceived recreational quality in an unpredictable manner and this will often differ between streams (Brown et al. 1991). These

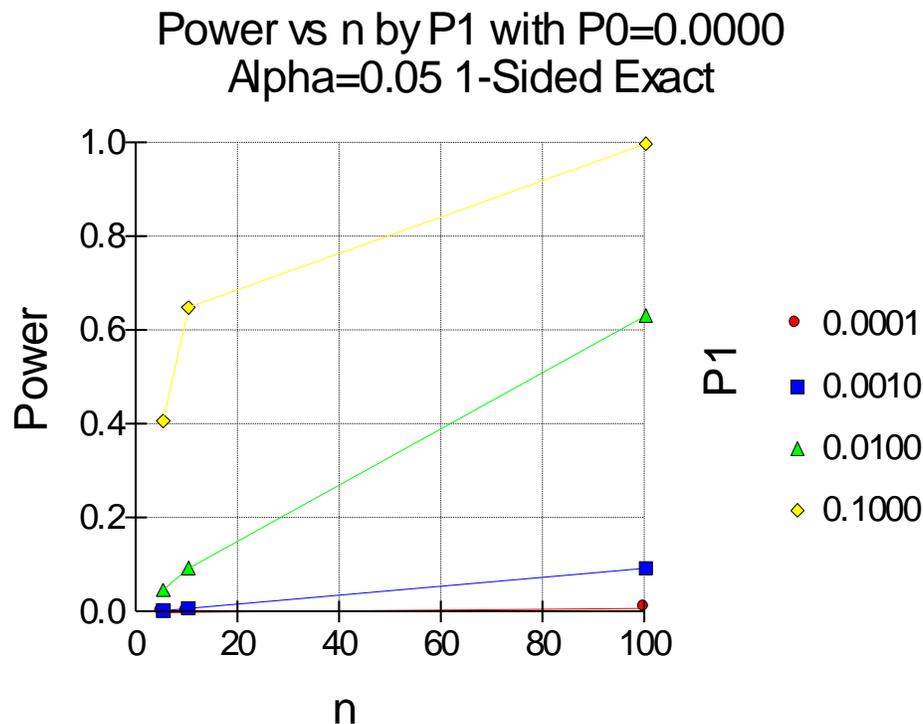
Figure 7. Statistical power (ability to detect real difference, when null hypothesis is false) varies with sample size (n) and magnitude of desired difference we wish to detect. Assuming no one (P0) uses the stream versus some proportion (P1).
