**Central and Southeast Texas Recreational Use-Attainability Analyses Project
Shepherd Creek (Segment 1209J) Basic RUA**

Results Report

Contract No. 582-9-90440
EIH Technical Report #10-011

Prepared by:
George Guillen & Jenny Wrast
University of Houston-Clear Lake

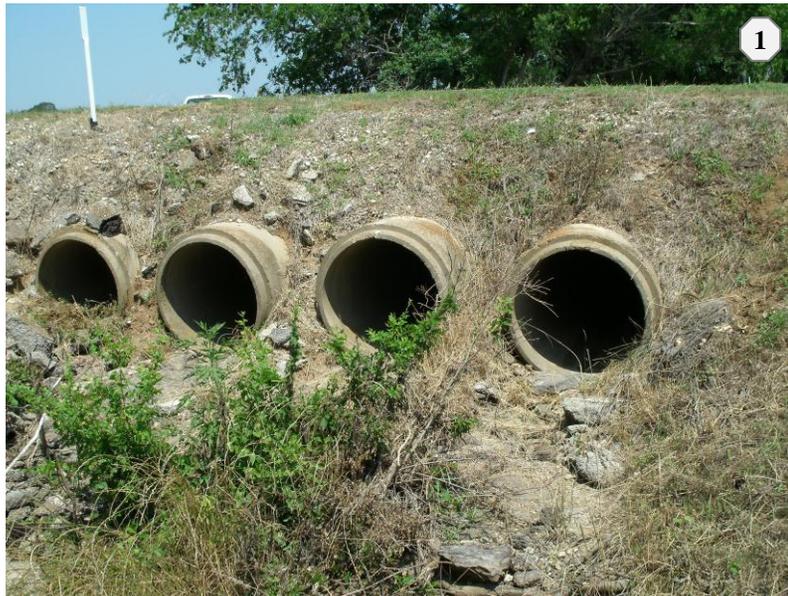
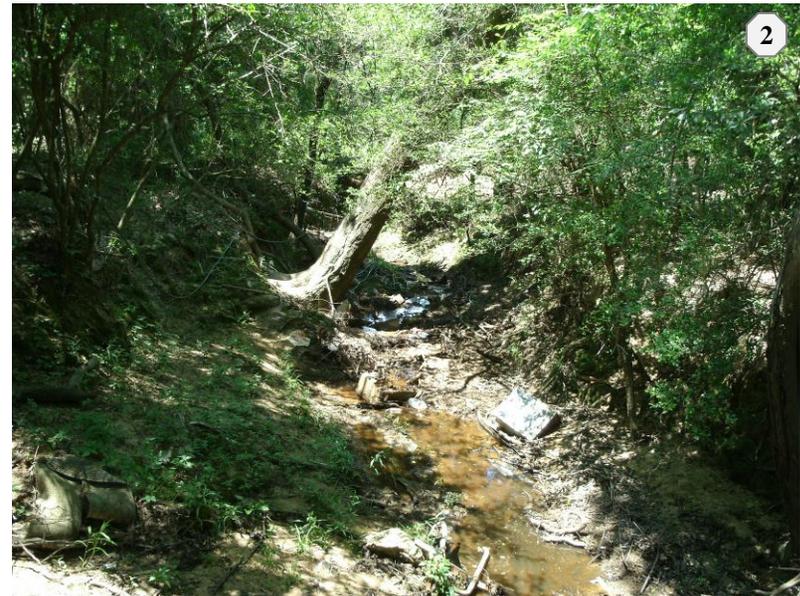
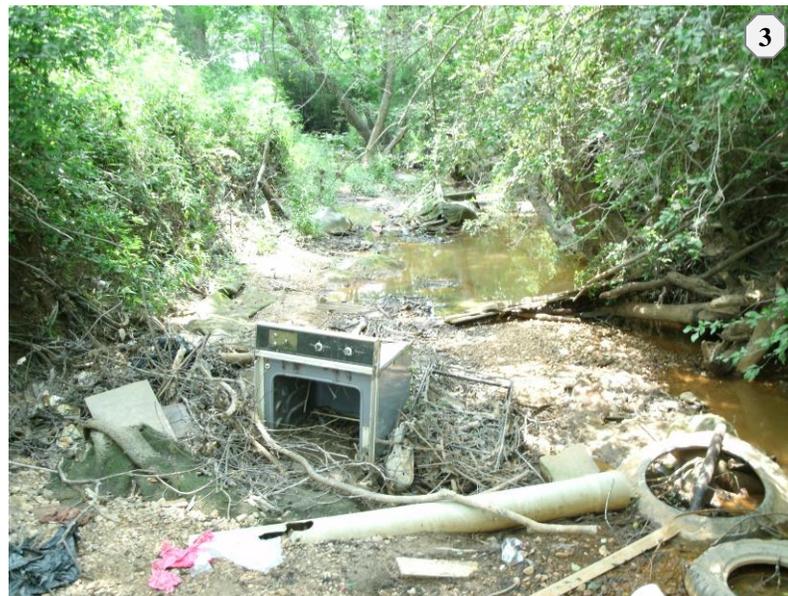
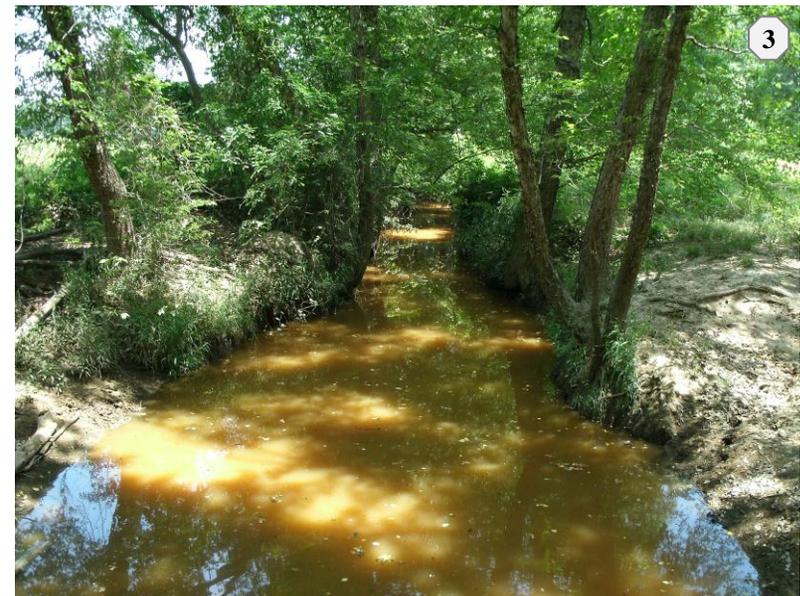
Figure 2. Pictures of field survey sites 1, 2, and 3 (as labeled) of Shepherd Creek, Segment 1209J, that depict the various physical characteristics and conditions observed along the creek

Every effort was made to obtain supplementary recreational use information about the entire length of the segment, including areas other than the selected sites in this Basic RUAA. Topographic maps and aerial imagery were used to provide the needed geographic information about potential recreational opportunities, potential access points, and potential access obstacles along the Shepherd Creek. Review of these resources resulted in reconnaissance site selection. The subsequent reconnaissance site visits confirmed the limited public access along the Shepherd Creek. Fences, gates, and no trespassing signage are common public access limitations on the segment and resulted in less than three (3) sites for every five (5) miles of stream. Figure 2 is a photographic representation of the various conditions found along Shepherd Creek.
