Central and Southeast Texas Recreational Use Attainability Analyses Project:

San Bernard River Above Tidal (Segment 1302) Comprehensive RUAA Gum Tree Branch (1302A) Basic RUAA West Bernard Creek (1302B) Basic RUAA

Results Report

Contract No. 582-9-90440 EIH Technical Report # 11-002

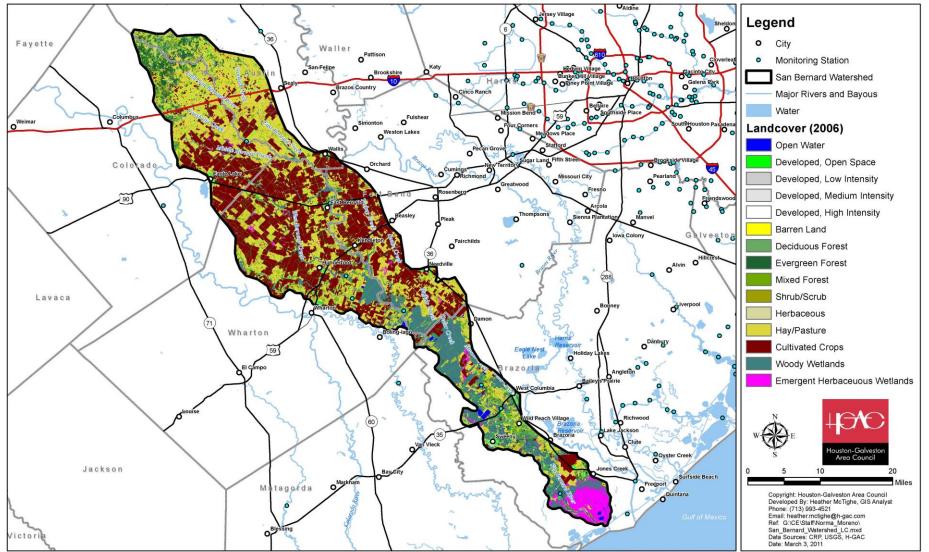
Figure 1. Land use and land cover in the San Bernard River Watershed from the Watershed Protection Plan by the Houston-Galveston Area Council found at: <u>http://www.h-gac.com/community/water/watershed_protection/sanbernard/default.aspx</u> (accessed: 7/14/2011).

The main land use within the watershed is crop production and cattle grazing. Currently, no major metropolitan areas are located in the watershed. Land uses within the watershed are primarily rural and agricultural, with small scattered areas of urbanization (East & Hogan, 2003 & HGAC, 2011) (Figure 1).

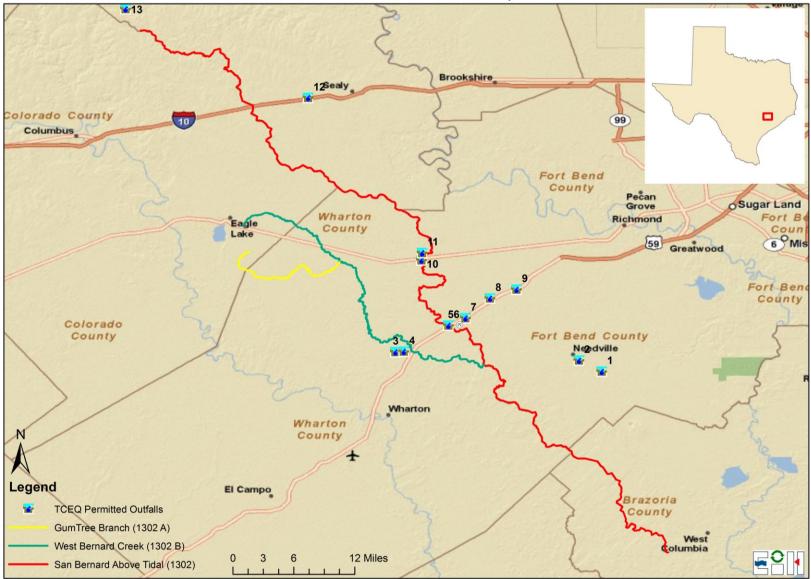
Figure 2. Permitted outfalls in the San Bernard River Above Tidal Watershed for Recreational Use Attainability Analysis Survey. Outfall number corresponds to Table 1.

Table 1. Permitted outfalls in the San Bernard River Above Tidal Watershed. Outfall number corresponds to Figure 2.

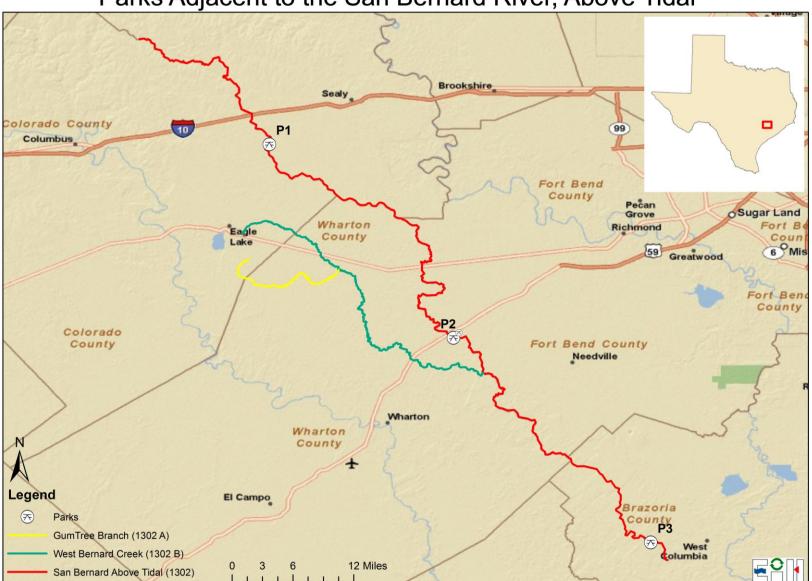
Figure 7. Map of the parks that are directly adjacent to the San Bernard River Above Tidal. Park Number corresponds to Table 2.

Table 2. Parks located directly adjacent to the San Bernard River Above Tidal. Park number corresponds to Figure 7.

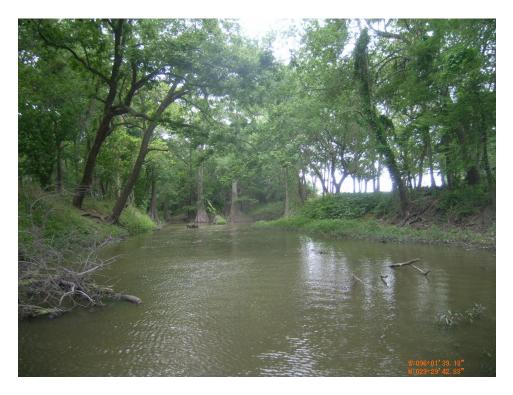
Figure 8. Picture of field survey site 10, showing the general representation of the physical conditions seen on the San Bernard River Above Tidal (Segment 1302)

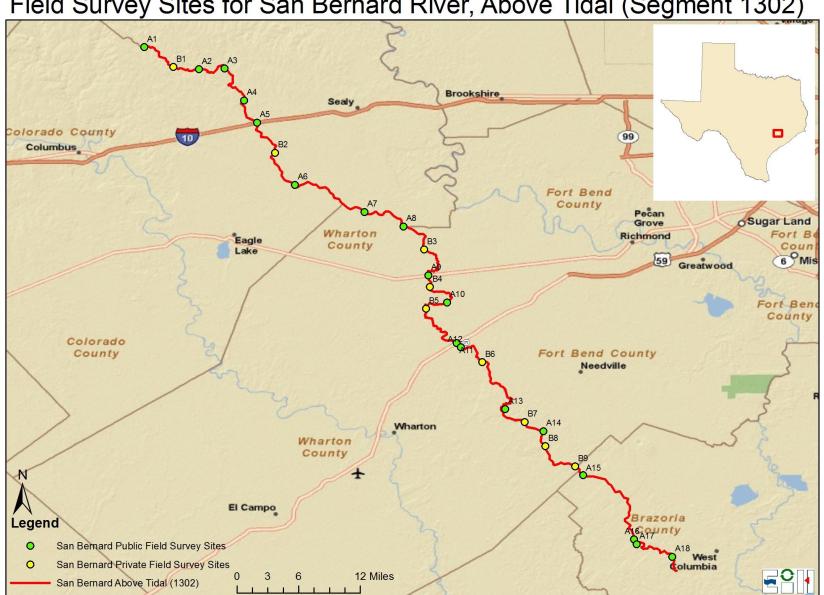
Figure 9. Comprehensive RUAA survey sites on the San Bernard River Above Tidal (Segment 1302) selections based on river mile/assessment units, accessibility, and recreational features (see Table 3).

Table 3. Field survey sites for the Comprehensive RUAA Survey on the San Bernard River Above Tidal (Segment 1302) (see Figure 9).

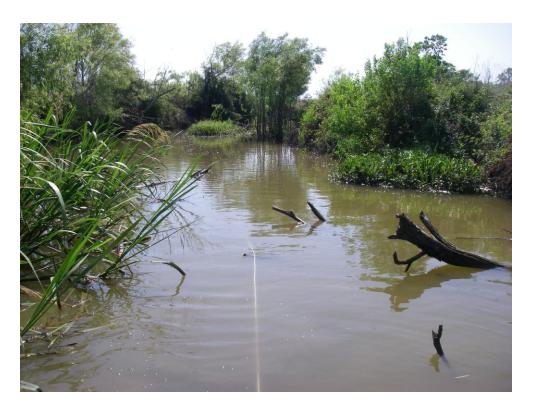
Figure 10. Picture of field survey site 2, showing the general representation of the physical conditions seen on Gum Tree Branch (1302A)

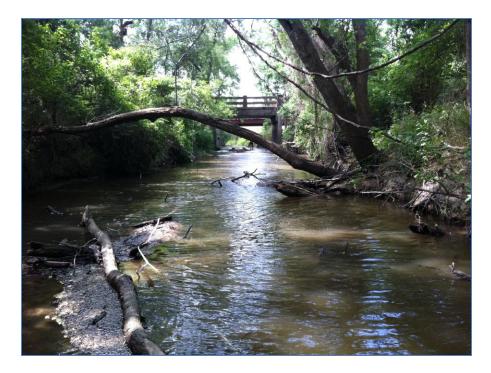
Figure 12. Picture of field survey site 8, showing the general representation of the physical conditions seen on West Bernard Creek (1302B)

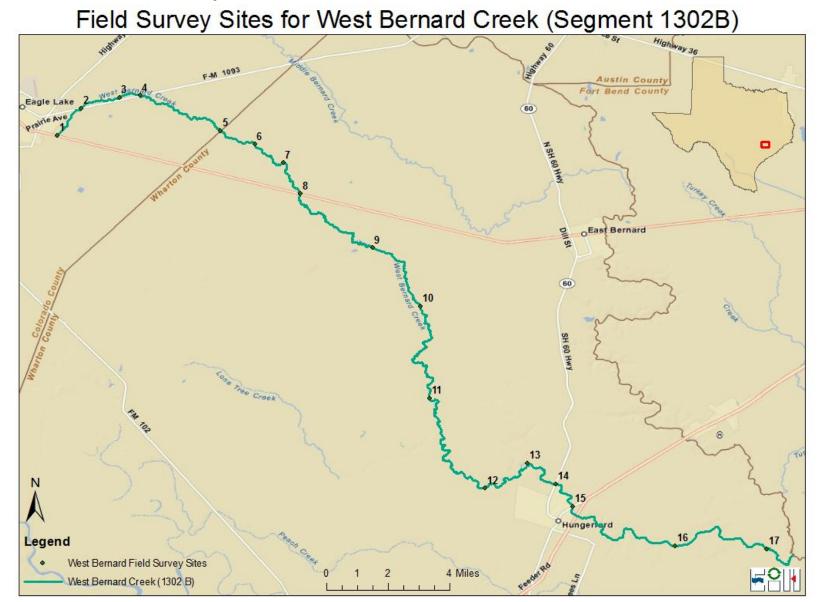
Figure 13. Basic RUAA survey sites on West Bernard Creek (1302B) selections based on river mile/assessment units, accessibility, and recreational features (see Table 5).

Table 5. Field survey sites for the Basic RUAA Survey on West Bernard Creek (1302B) (see Figure 13).

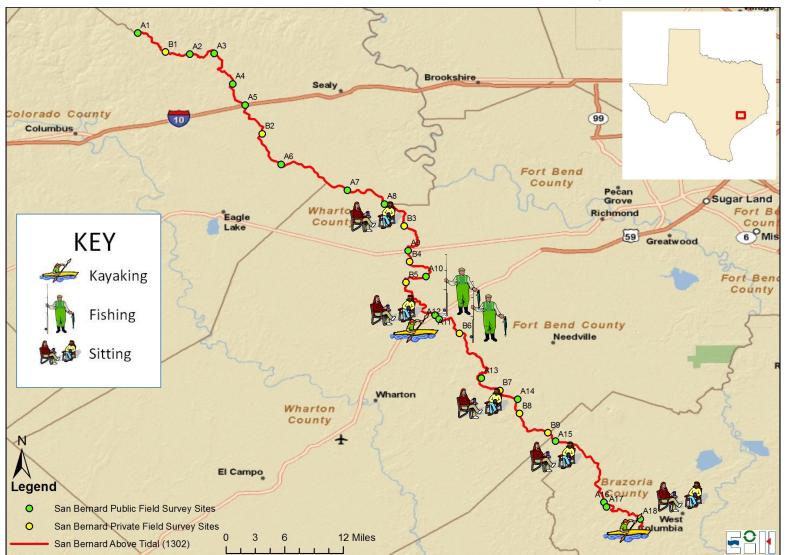
Figure 14. Comprehensive RUAA survey sites on the San Bernard River Above Tidal (Segment 1302) selections based on river mile/assessment units, accessibility, and recreational features. Constructed from field observations. Locations are approximate. See Appendix 8-A for an interactive Google Earth map depicting exact locations of uses, impediments, and evidence.
