Harris County Texas Comprehensive Turbidity Study Results Report

Prepared in cooperation with the Harris County Flood Control District

EIH Technical Report # 12-001

2/28/2012
University of Houston-Clear Lake
Environmental Institute of Houston

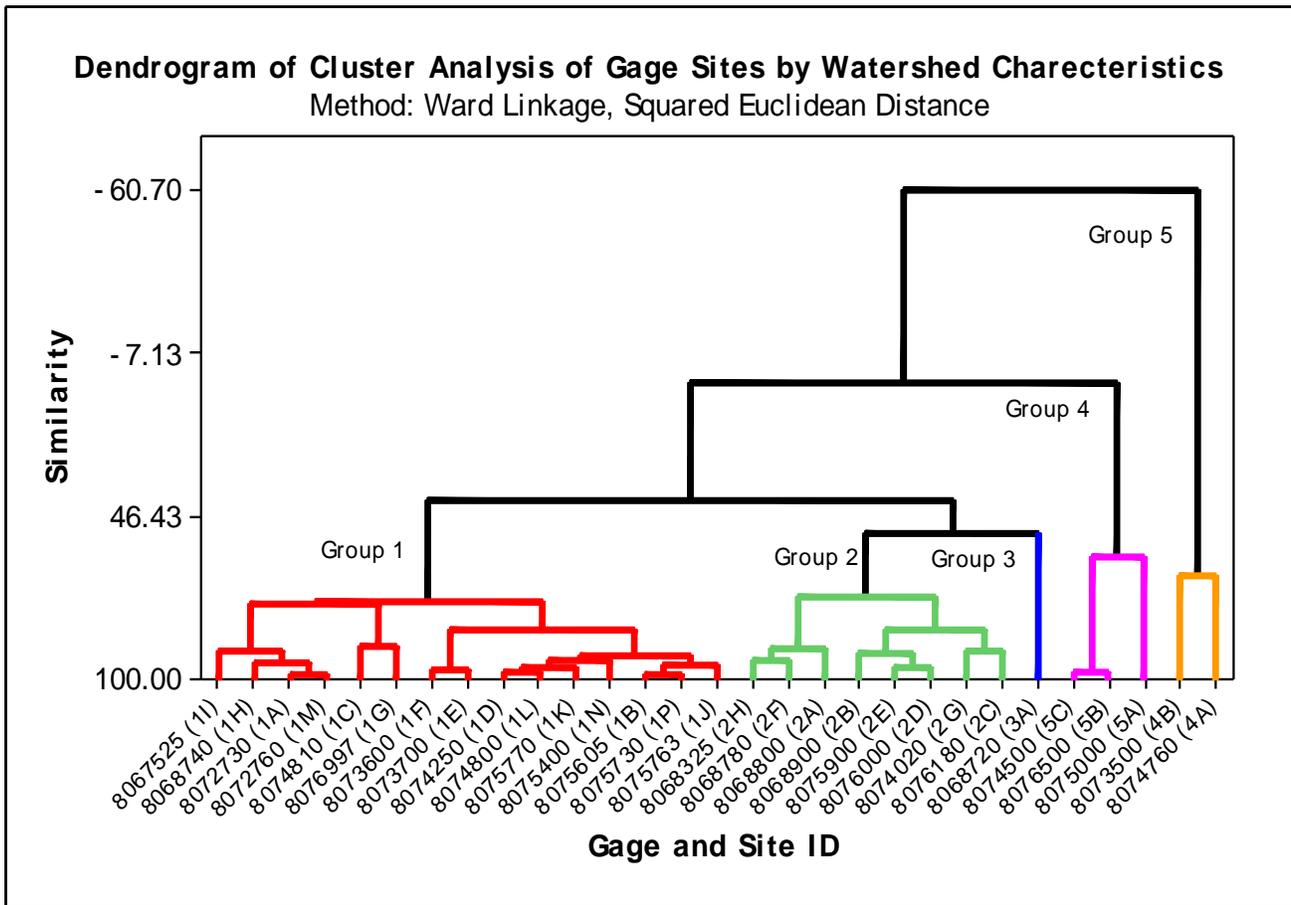
Figure 1. The statistical clustering of sites based upon land use and cover, and soil type.

We employed the Clustan[®] statistical software package to conduct a cluster analysis of sites to determine the most reasonable number of groupings of sites based on their similarity (Wishart 2006). The cluster analysis algorithm utilized Wards method, squared Euclidean distance, and un-weighted, standardized variables. The “Best Cut” method was subsequently used to identify a reasonable number of groups based on similarity of groups. Based on the results of this analysis, five unique watersheds, or site types, were differentiated. The analysis was re-run using the Minitab[®] statistical package to generate presentation quality graphics (Figure 1). The algorithm in Minitab[®] also utilized Wards method, squared Euclidean distance, and un-weighted, standardized variables. The major characteristic of each site and watershed area group is listed in Table 2. Data used to conduct the cluster analysis is provided in electronic format in Appendix 1.

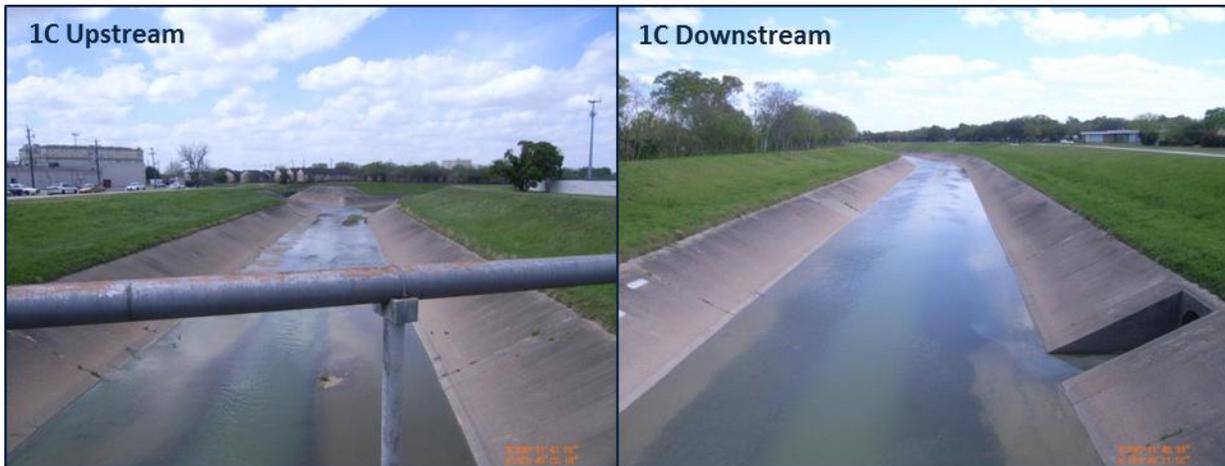
Figure 4. Photographs of PM site 1C, USGS gage 8074810, Brays Bayou at Gessner Dr, Houston, Texas.

Site 1C, Brays Bayou at Gessner, was a concrete-lined, trapezoidal channel located next to USGS gage 8074810 and HCFWS rain gage 180 (Figure 4). Accumulated sediment particles were found along various portions of the streambank. Maximum water depth was less than 3 ft. deep. The stream was approximately 25 ft. wide. The surrounding area was suburban residential, with two golf courses located nearby and along the banks.

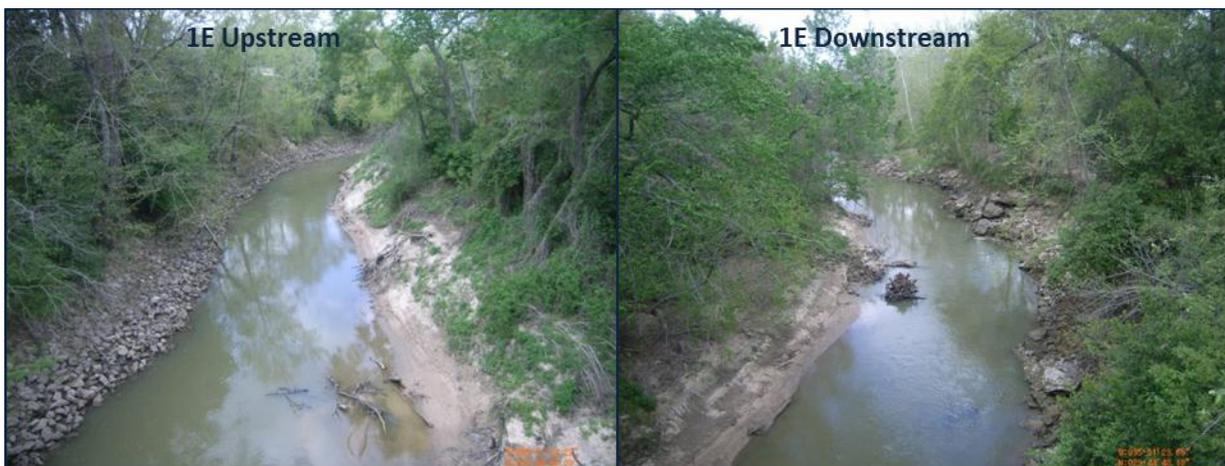
Figure 5. Photographs of PM site 1E, USGS gage 8073700, Buffalo Bayou at Piney Point, Texas.

In contrast, Site 1E, Buffalo Bayou at Piney Point (USGS gage 8073700; HCFWS gage 2260) exhibited a more natural channel form with soft bottom sediments including fine sands. It had an approximate maximum depth of 3.6ft and minimum width of 28ft (Figure 5). Although the riparian zone was forested, there was still a high concentration of adjacent residential land.

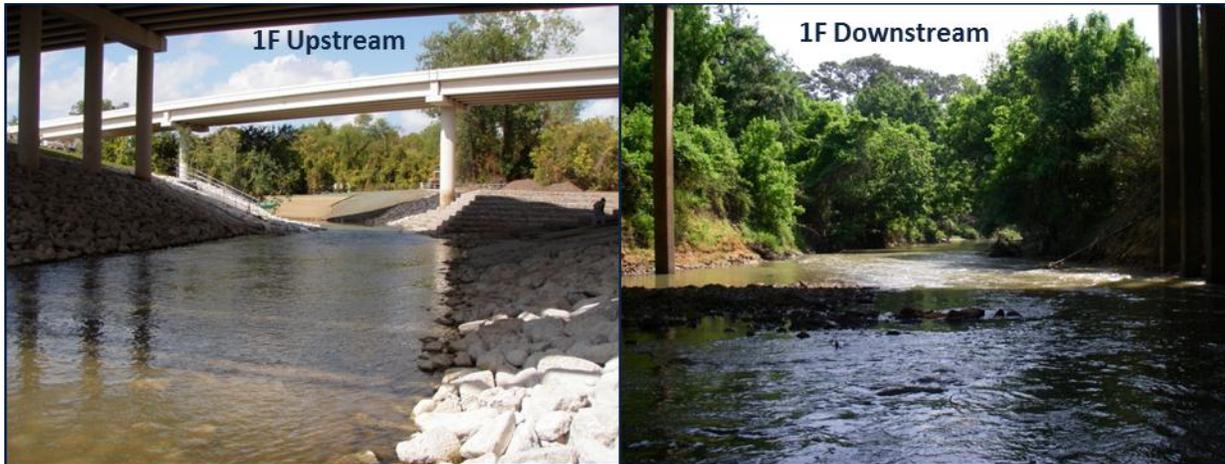
Figure 6. Photographs of PM site 1F, USGS gage 8073600, Buffalo Bayou at W. Belt Dr. at Houston, Texas.

The area surrounding site 1F, Buffalo Bayou at West Belt Drive (USGS gage 8073600 and HCFWS gage 2270), was very similar to that at 1E. However, the immediate area possessed a combination of concrete-lined banks and new, large cobble/rip-rap (Figure 6). The width and depth of this site was 40ft. and 3.9ft. respectively.

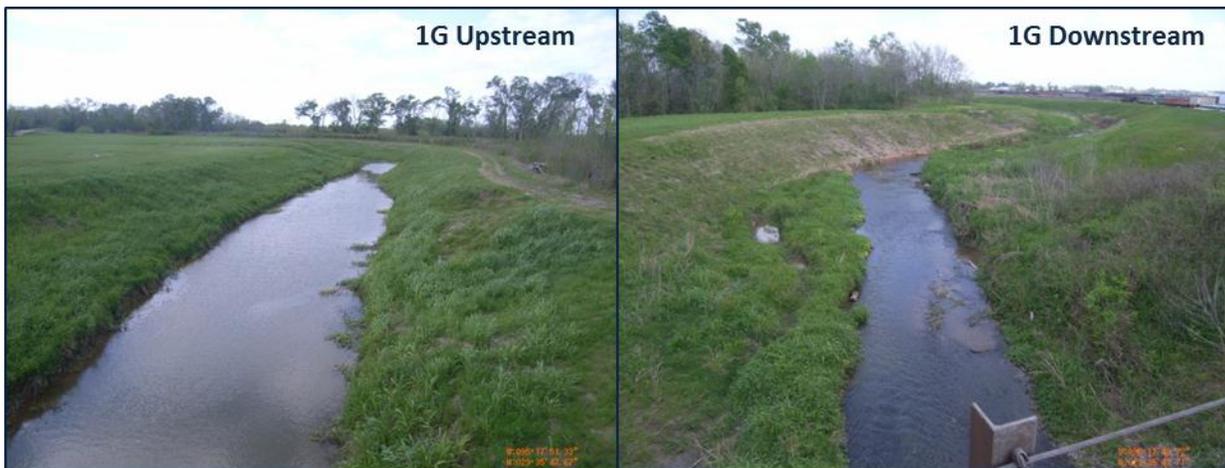
Figure 7. Photographs of AS site 1G, USGS gage 8076997, Clear Creek at Mykawa St., near Pearland, Texas.

Site 1G was an AS site located on Clear Creek next to USGS gage 8076997. Located very near to the South Sam Houston Tollway, it had a cleared and mowed riparian zone with light industrial and undeveloped, though maintained, lands surrounding. Moderately sloped banks line this relatively narrow and shallow channelized creek, with approximate maximum depth and minimum width of 3.7ft and 7.5ft (Figure 7). The substrate was sandy clay and quite firm throughout most of the site with some softer, boggy spots, especially around bends where the water slowed or eddied.

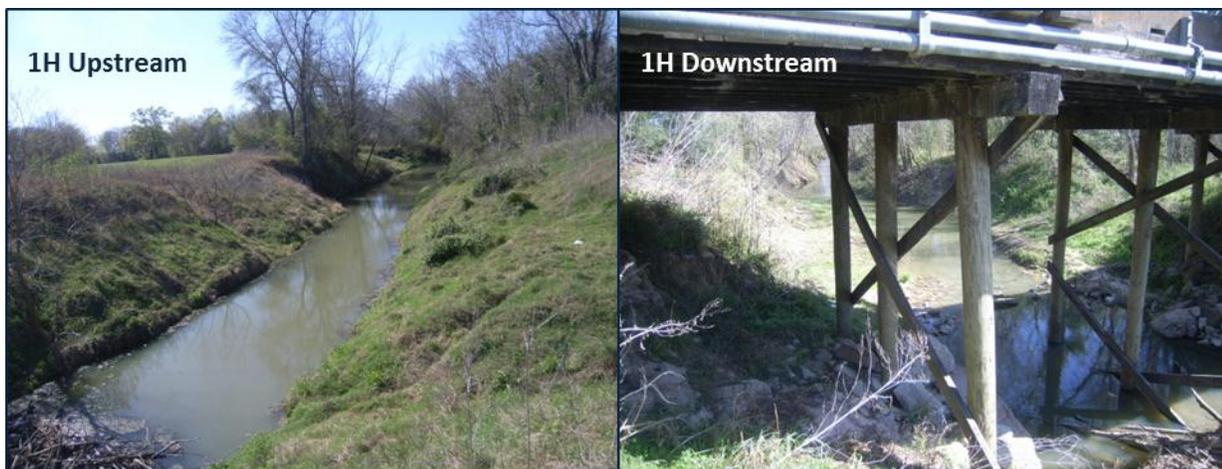
Figure 8. Photographs of PM site 1H, USGS gage 8068740, Cypress Creek at House-Hahl Rd, near Cypress, Texas.

Exhibiting similar widths and depths as 1G, site 1H was located in a much more rural section of Harris County on Cypress Creek (Figure 8). It had tree-lined, moderately steep banks, with a powerline corridor crossing upstream and a large golf course adjacent downstream. Although it is so rural and relatively near to the headwaters, this site showed definite evidence of channelization.

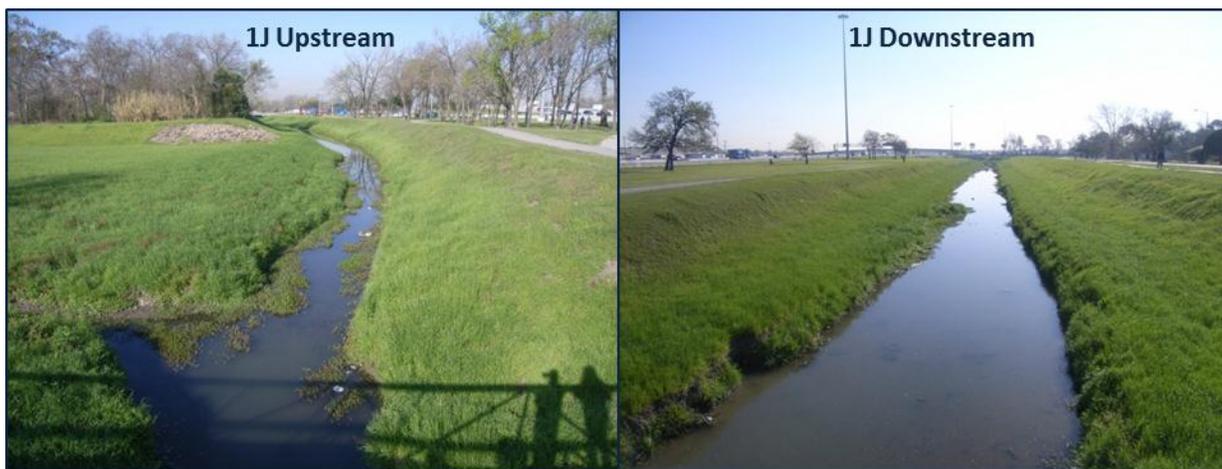
Figure 9. Photographs of PM site 1J, USGS gage 8075763, Hunting Bayou at Hoffman St., Houston, Texas.

Sites 1J and 1K (Figure 9 and Figure 10) were both located on Hunting Bayou, approximately 4 river miles apart and adjacent to Loop 610. They were co-located with USGS gages 8068470 and 8075763 and HCFWS gages 840 and 830, respectively. Both sites were channelized and highly urbanized outside of the immediate vicinity. The maximum stream width at these sites was relatively small (< 25ft), and the maximum water depths were less than 2 feet. These sampling locations and the rest of the Type 1 sites all had grassy, mowed/maintained riparian zones.

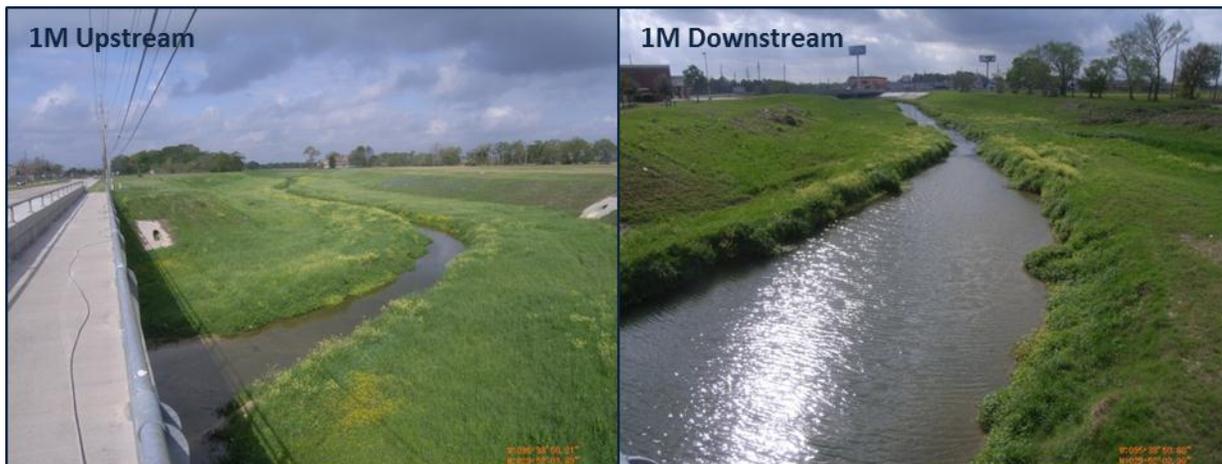
Figure 11. Photographs of PM site 1M, USGS gage 8072760, Langham Creek at W. Little York Rd near Addicks, Texas.

Site 1M was located on Langham Creek in a suburban residential area, next to USGS gage 8072760 and HCFWS gage 2120. Again, the stream was quite narrow and shallow. This site had markedly clearer water than every other site and a sandy bottom (Figure 11).

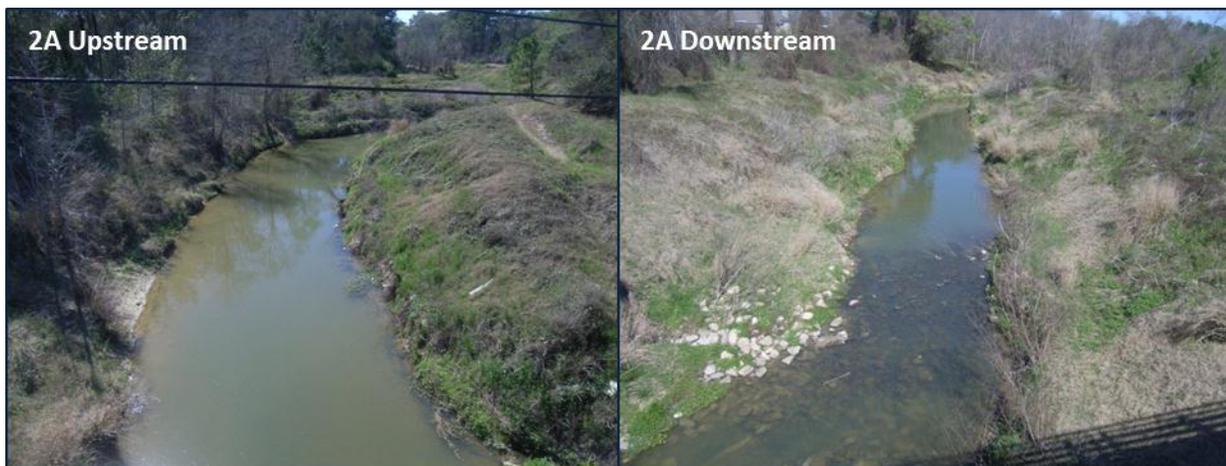
Figure 13. Photographs of PM site 2A, USGS gage 8068800, Cypress Creek at Grant Rd., near Cypress, Texas.

Sites 2A, 2B, and 2D were located at Cypress Creek at Grant Rd., near Cypress, Cypress Creek at Stuebner-Airline near Westfield, and Greens Bayou in Houston, respectively. Site 2B was an AS site. All of these waterbodies were moderately-sized streams ranging from 15 to 30 ft wide (Figure 13 to Figure 15). Bottom sediments were clay and silt. The stream banks are vegetated with grass, appeared mowed with and the adjacent land being covered with small shrubs and trees. Land use was largely rural to suburban.

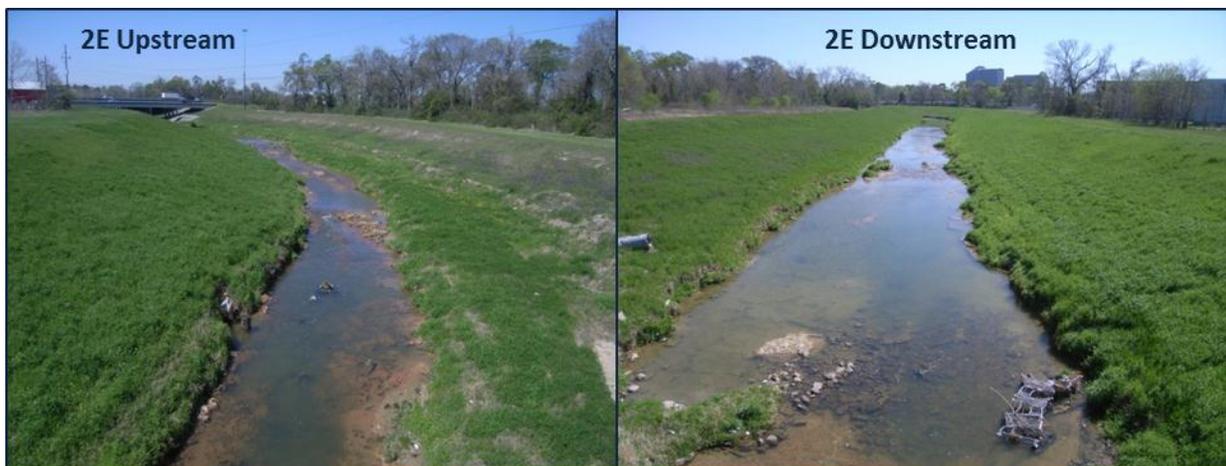
Figure 16. Photographs of PM site 2E, USGS gage 8075900, Greens Bayou near US Hwy 75, near Houston, Texas.

Sites 2E and 2G were approximately 2 ft. deep and ranged in size between 9 to 35 ft wide respectively (Figure 16 and Figure 17). Both were located in suburban areas. The stream banks were covered with mowed grass. Both streams lacked natural meanders and appeared to be channelized for flood water conveyance.

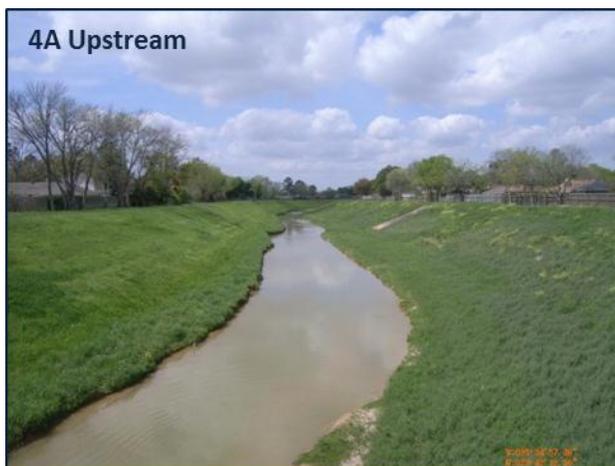
Figure 19. Photographs of AS site 4A, USGS gage 8074760, Brays Bayou at Alief, Texas.

Sites 4A and 4B were located at Brays Bayou near Beltway 8 at USGS gage 8074760, and Buffalo near Addicks at USGS gage 8073500 respectively (Figure 19 and Figure 20). Site 4A was designated as an AS site. Both sites were located near residential areas. The stream channel lacked significant meanders. Site 4A had mowed grassy banks with adjacent housing. Site 4B was located near Addicks Reservoir and had heavily vegetated banks with woody debris. The stream width and depth was 1 ft. and 22 ft. respectively at site 4A, and 2 ft. and 45 ft. respectively at site 4B.

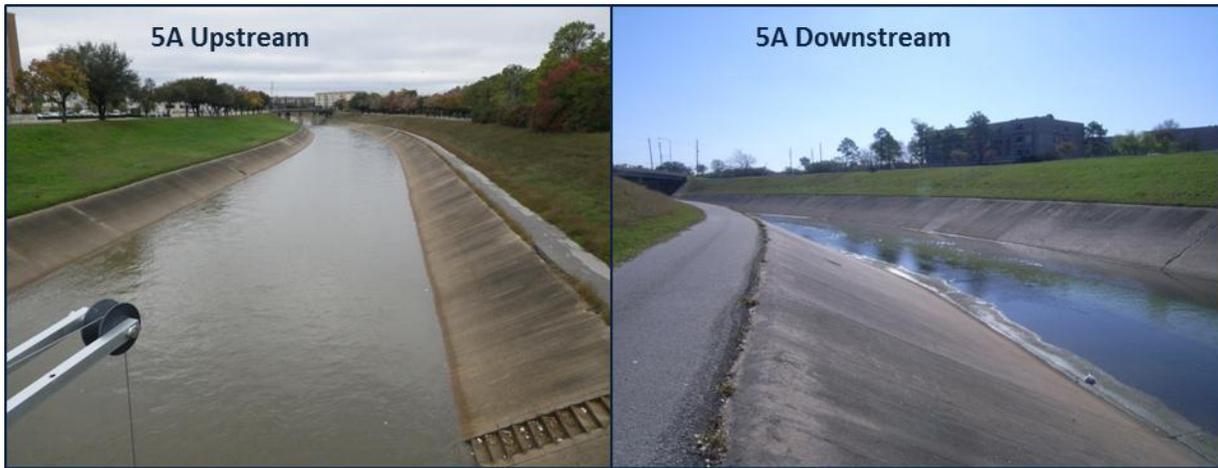
Figure 21. Photographs of PM site 5A, USGS gage 8075000, Brays Bayou at Houston, Texas.

The last group of sites consisted of several urban bayous including sites 5A, 5B and 5C (Figure 21 and Figure 23). Site 5A was located at USGS gage 8075000 on Brays Bayou near the intersection of South Main and S. Braeswood. This portion of Brays Bayou was a trapezoidal concrete lined bayou surrounded by extensive urban and suburban development. The channel dimensions during the initial site visit was 2.5 ft. deep by 38 ft. wide. Site 5B was an AS site located adjacent to USGS gage 8076500 at Halls Bayou. The substrate type was concrete lined under the bridge, but earthen up and down stream. There was a public park located on the left bank upstream of the bridge. Site 5C was located at USGS gage 8074500 at Whiteoak Bayou surrounded by residential and urban development. This site was concrete lined and had relatively high velocities at base-flow conditions.

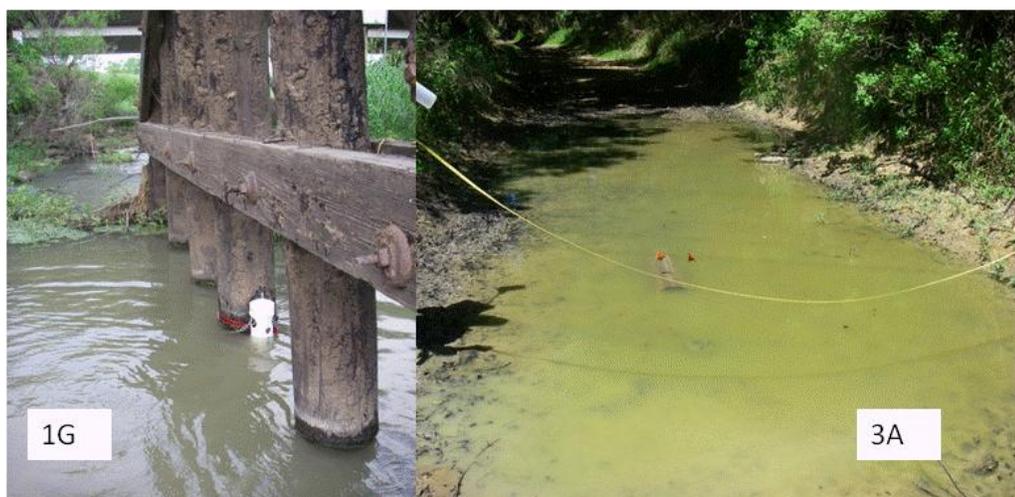
Figure 24. PVC and lock box data sonde deployment methods, sites 1G (left) and 3A (right).

Sampling occurred periodically during several 30-day periods, with a minimum of 2 wet weather, or “rain-influenced”, events for each site. This ensured coverage over a variety of conditions and seasons, including spring (April and May), summer (June to August), fall (September and October) and winter (November and December) 2011. At AS sites, a YSI 6920V2 automated datasonde, equipped with a model number 6136 nephelometer probe, was used to monitor water quality and turbidity during the deployment period. Two attachment methods were used for sonde placement: a horizontal lock box anchored into the substrate at the middle of the stream or a PVC tube strapped to the downstream side of a bridge piling (Figure 24). The method used was dependent upon the site conditions; sites 1G and 2B used PVC, while sites 3A, 4A, and 5B used lock boxes. Sondes and lock boxes were provided by the HCFCD.

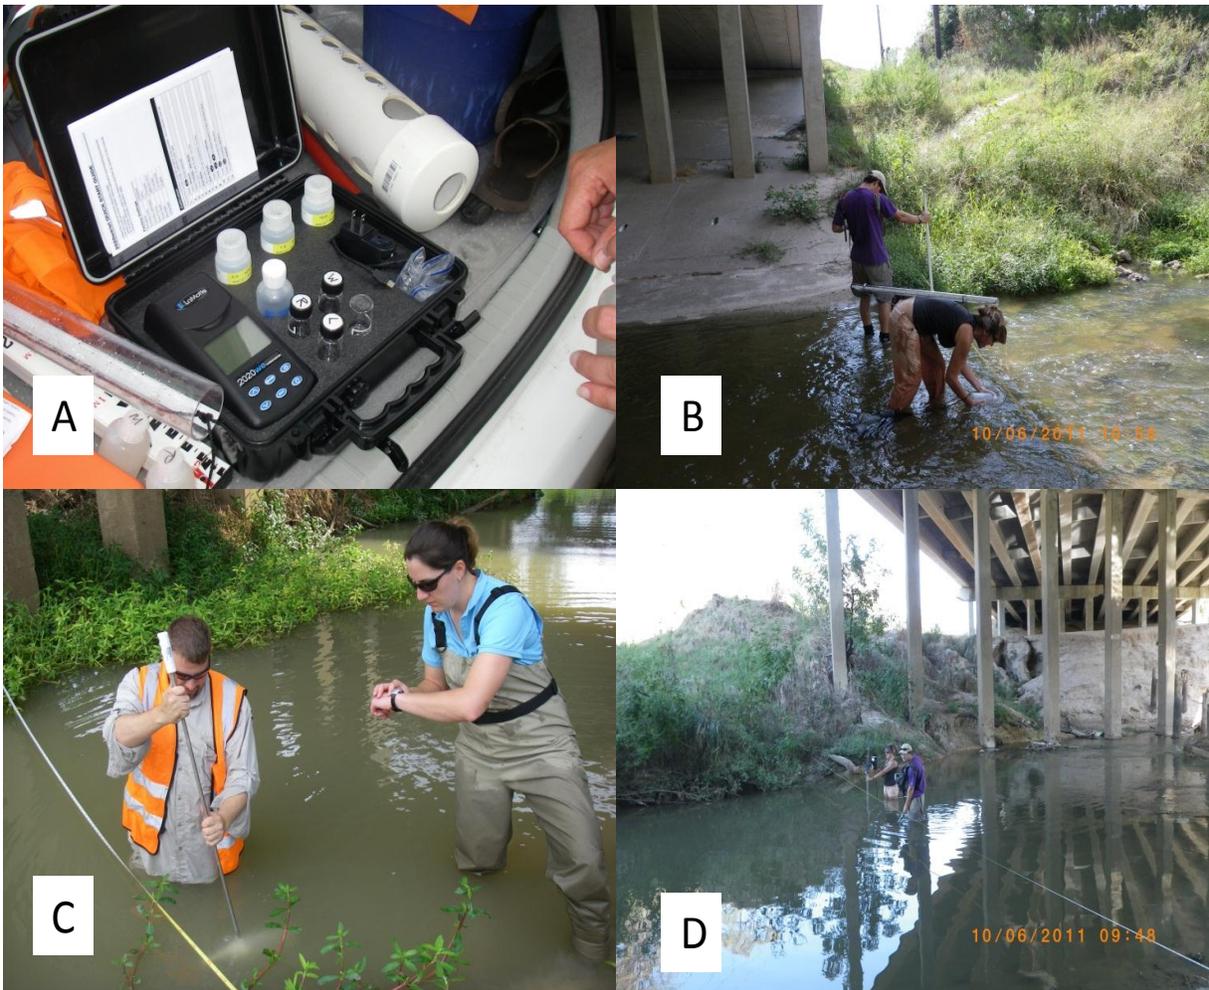
Figure 25. (a) Portable turbidity meter for field NTU readings; (b) field personnel taking depth and grab samples; (c) field personnel taking SSC samples; (d) field personnel taking flow measurements and sonde readings

Various water quality parameters and observations were collected at every site to evaluate the turbidity and suspended sediment content (Figure 25). Parameters collected at every site were NTU, SD, TSS, and SSC. To determine sampling locations, stream width was divided into 3 equal increments (left, middle, right), and samples were collected at the midpoint of each section. SD, NTU, and TSS were collected as near-surface grab samples (top 0.3m of water, excluding any surface film). Depth and flow-integrated SSC samples were collected using a sampler specific to sampling conditions (described below). Samples for TSS and SSC were preserved in a cooler on wet ice throughout the day and

processed within 7 days of collection. NTU readings were performed in the field within 15min of collection with a LaMotte 2020we portable turbidity meter (Figure 25). Secchi disk transparency was also read in the field with a standard, alternating black and white disk at the bottom of a 1m tube. Field splits were taken once daily for each TSS, SSC, and NTU sample for quality control. Field split data was reviewed for reasonability and then averaged with the corresponding original sample before use in data analysis.

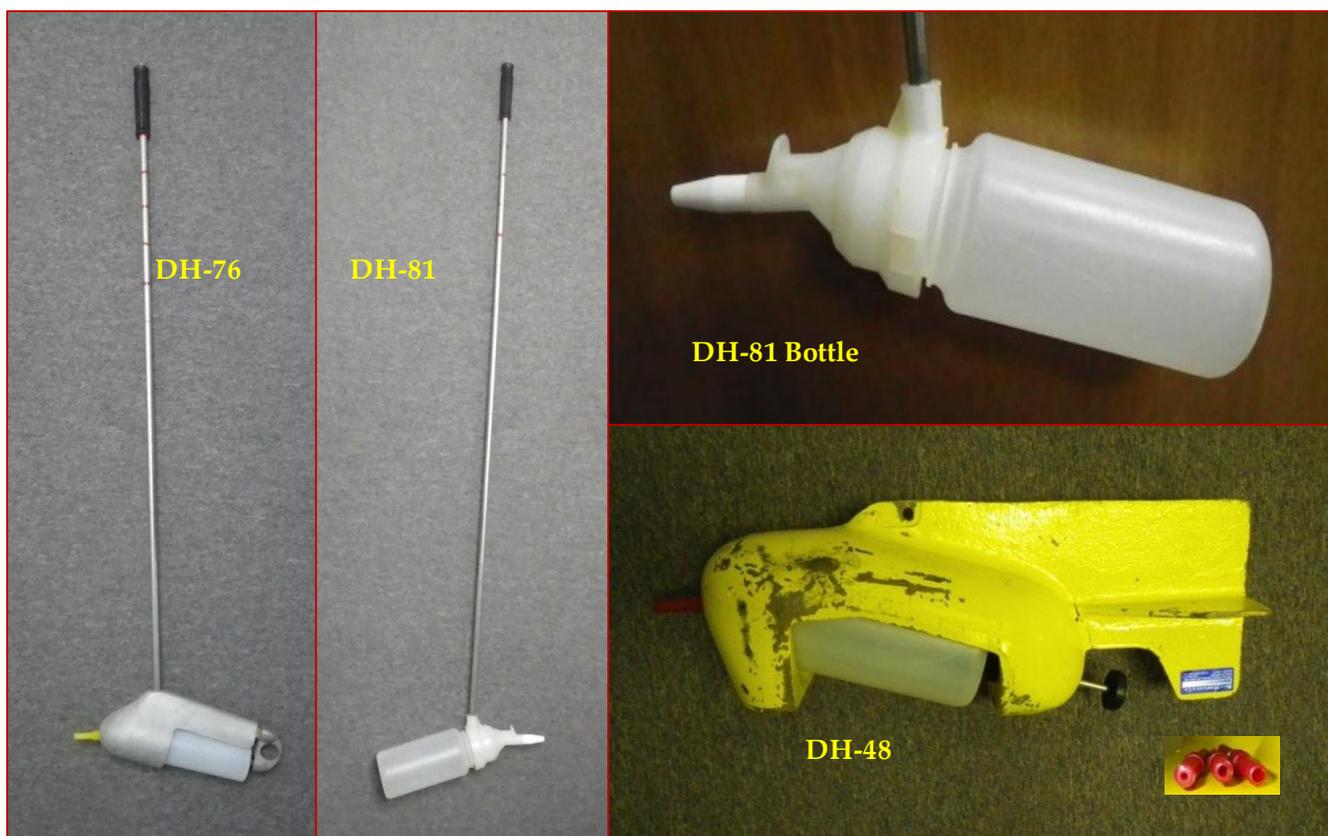
Figure 26. Suspended sediment samplers used throughout study

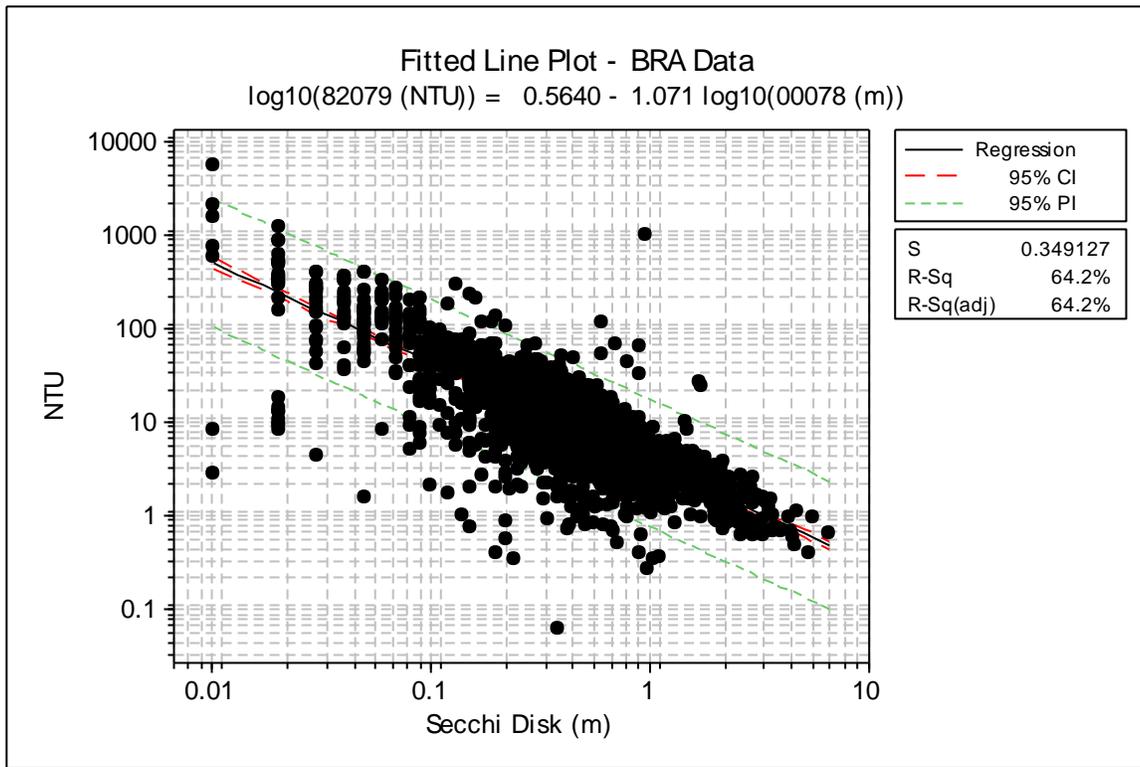
Figure 27. Analysis of turbidity data for the Brazos River Basin utilized in (Parent 2009).

We utilized the data provided by (Parent 2009) and conducted a regression analysis of the \log_{10} transformed data using the censored data set for the Brazos and Trinity Rivers. These are the closest basins to the Harris County study area. The results of our regression analysis of the Brazos and Trinity River data are depicted in Figure 27 and Figure 28. The original data used to conduct these analyses are provided in electronic format in Appendix 8. The log-transformed NTU and SD readings were highly correlated ($r = .80$ and 0.82 for the Brazos and Trinity Rivers, respectively). Both models provided fairly good fits with SD explaining 64% and 67.8% of the variability in turbidity measurements.

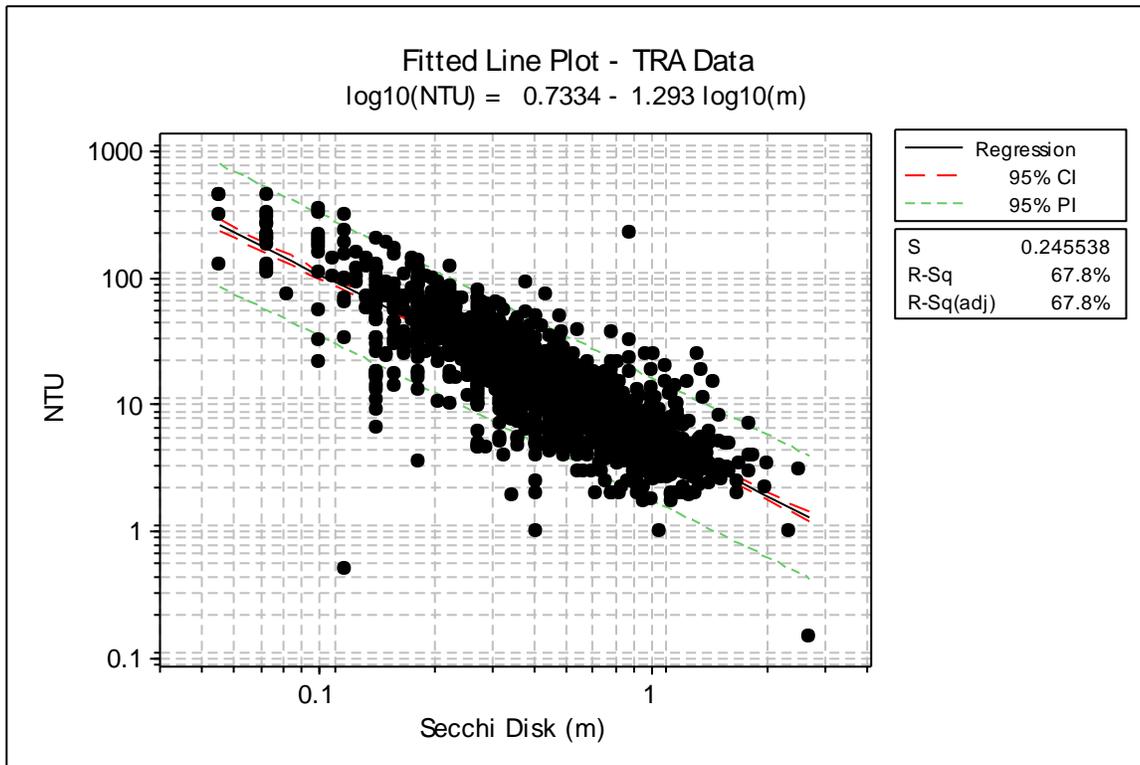
Figure 28. Analysis of turbidity data for the Trinity River Basin utilized in (Parent 2009).

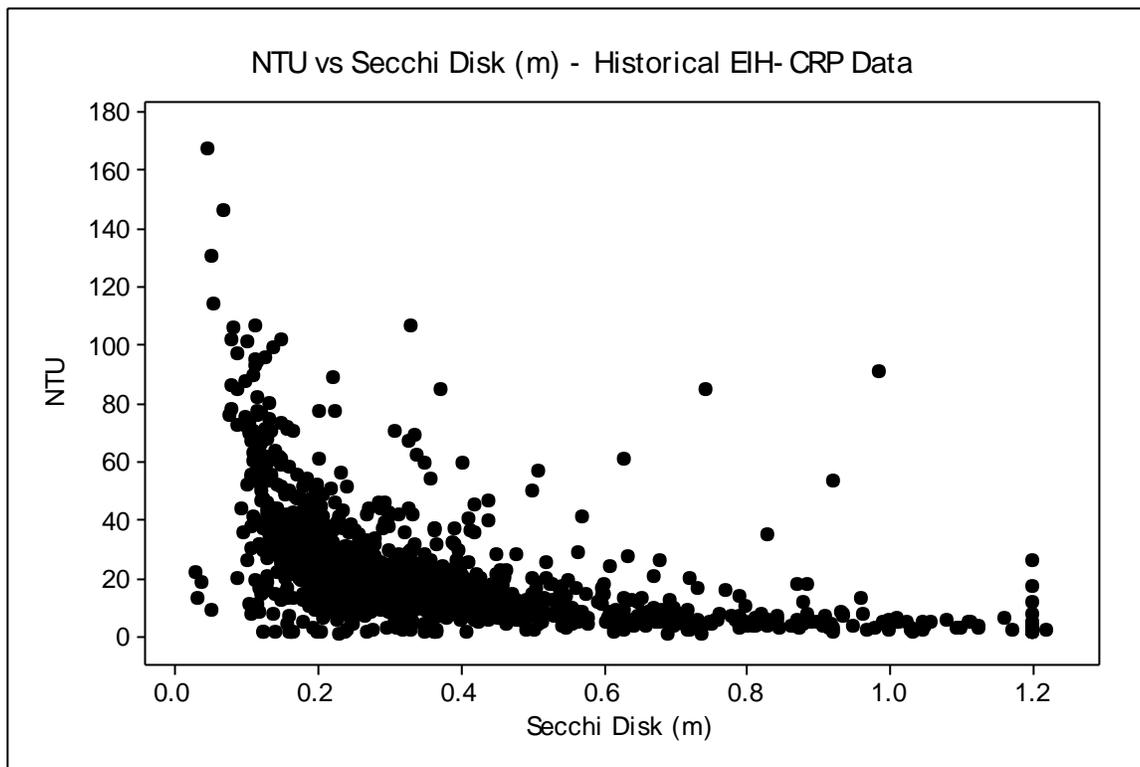
Figure 30. Paired NTU vs. SD measurements obtained by monitoring at 69 sites in Harris, Brazoria and Galveston counties from 12-1-2005 to 7-18-2011. N = 1,445

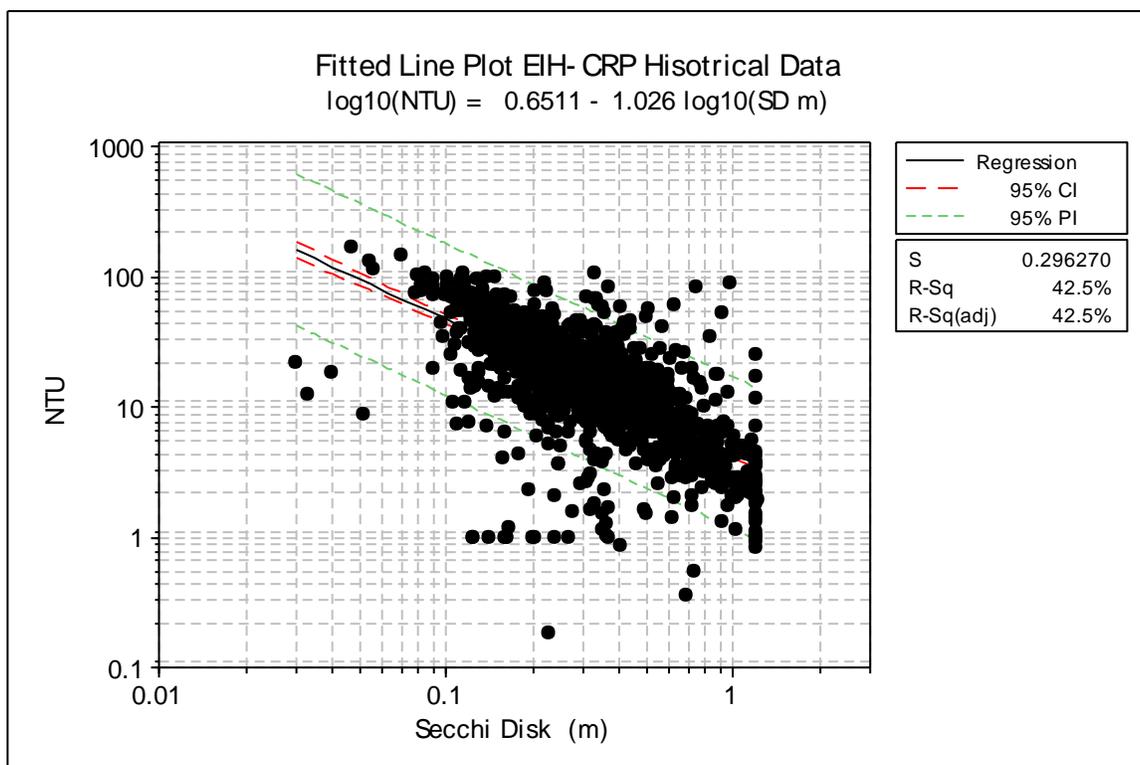
Figure 31. Results of regression on log-transformed, paired NTU vs. SD measurements obtained by monitoring at 69 sites in Harris, Brazoria and Galveston counties from 12-1-2005 to 7-18-2011. N = 1,445

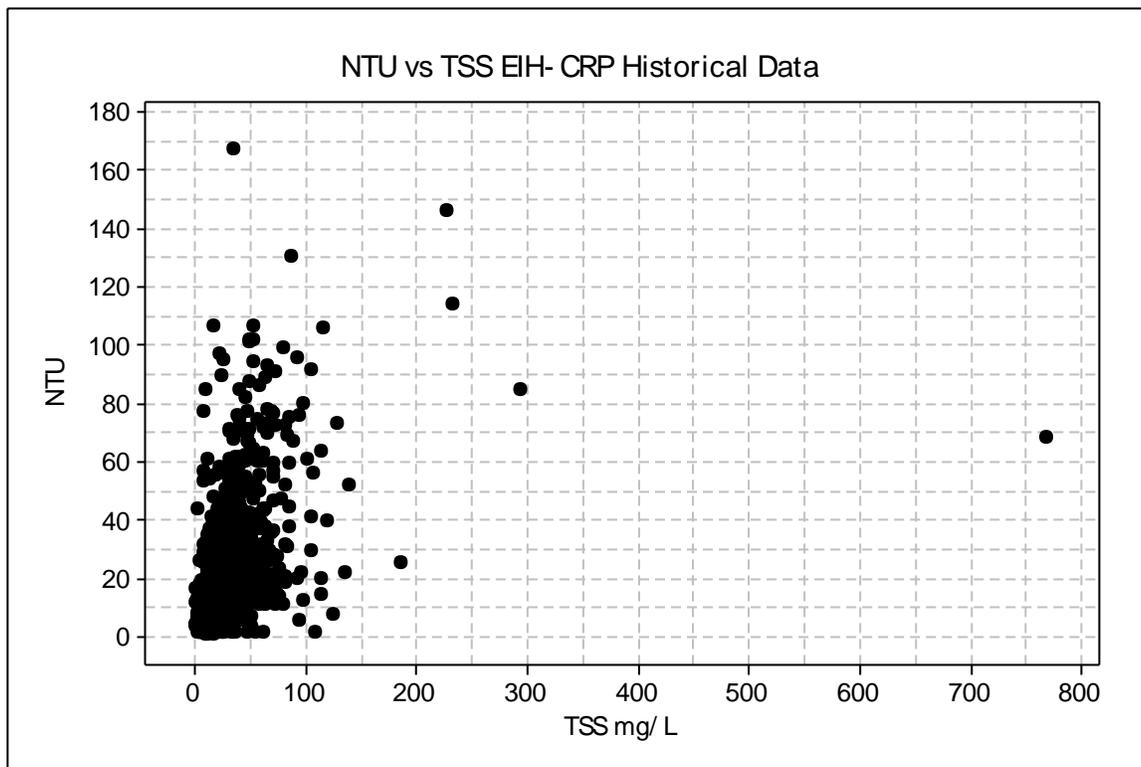
Figure 32. Paired NTU vs. TSS measurements obtained by monitoring at 69 sites in Harris, Brazoria and Galveston counties from 12-1-2005 to 7-18-2011. N = 1,445

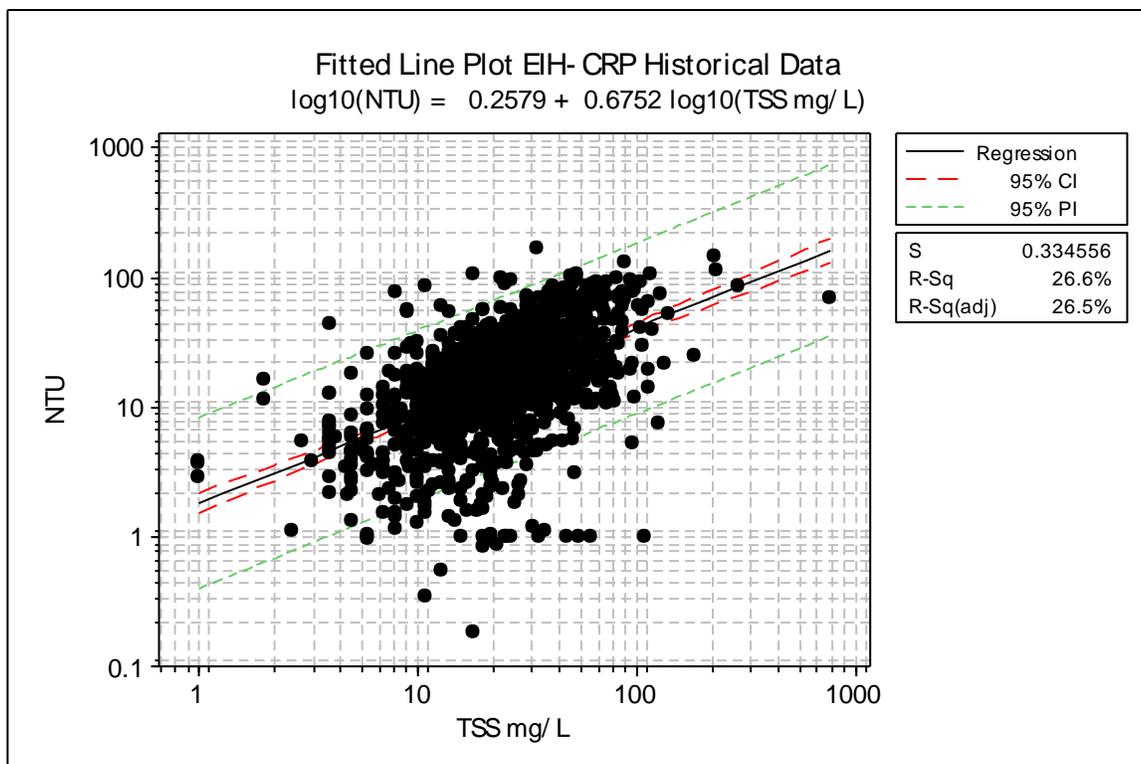
Figure 33. Results of regression on log transformed, paired NTU vs. TSS measurements obtained by monitoring at 69 sites in Harris, Brazoria and Galveston counties from 12-1-2005 to 7-18-2011. N = 1,445

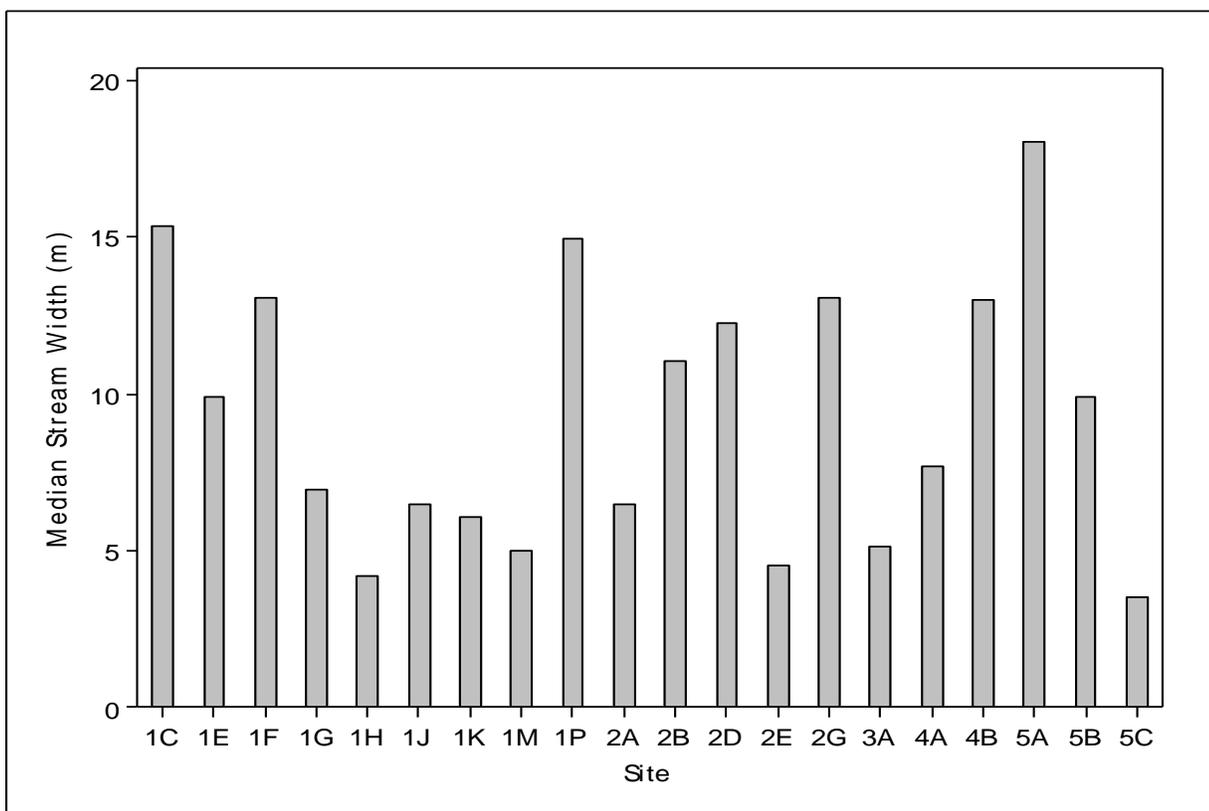
Figure 35. Median stream width during study period at each survey site. Note: Site 3A was often intermittent, so median stream width was equivalent to median pool width.

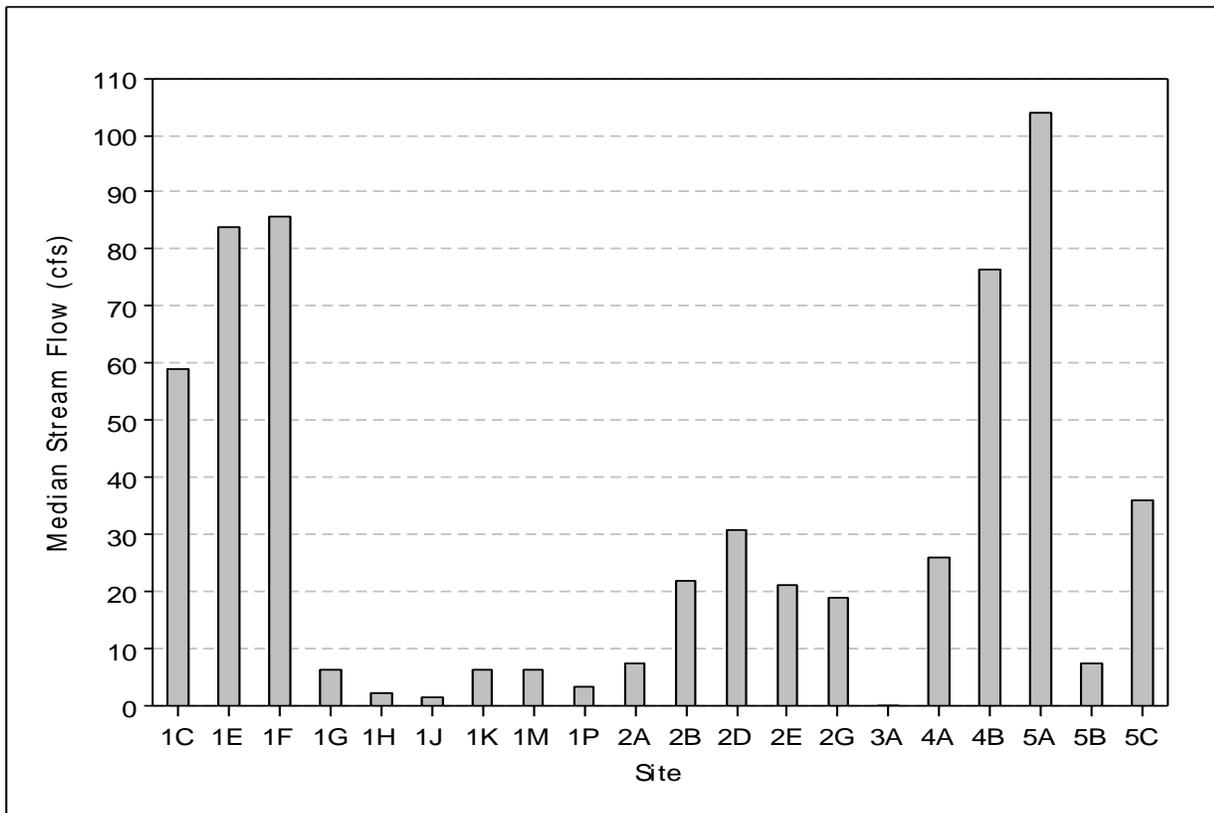
Figure 36. Median streamflow observed during the study period at each site. Streamflow based on values observed during active monitoring.

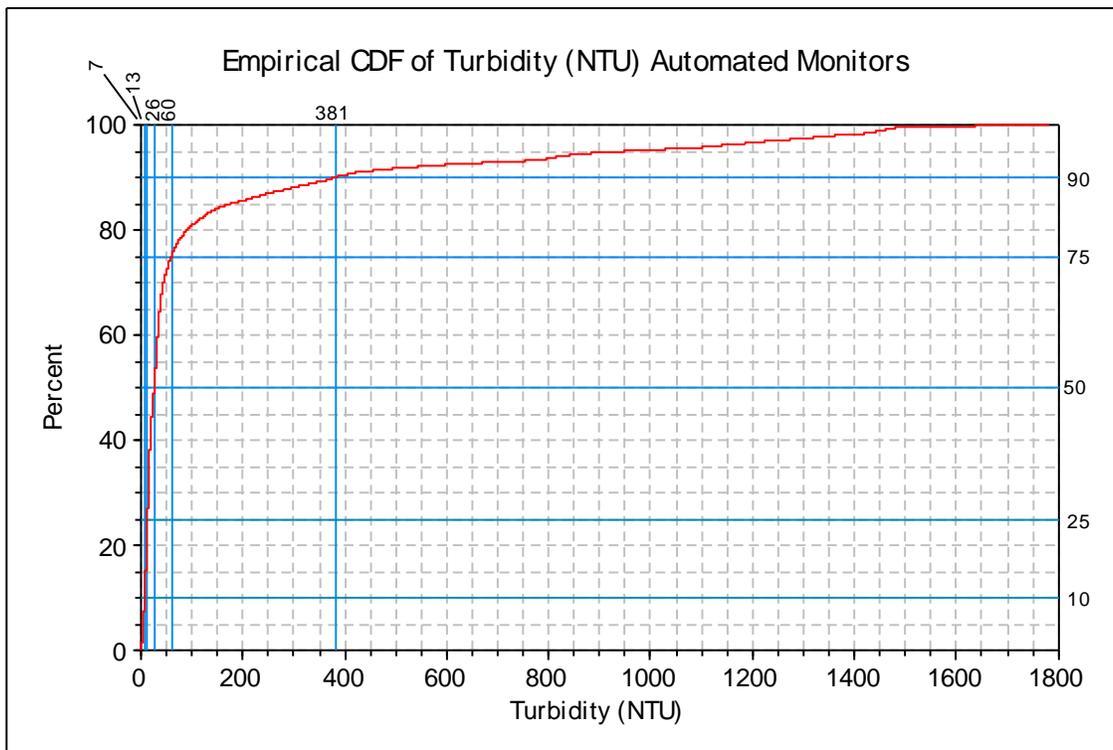
Figure 40. Cumulative distribution of turbidity NTU observed during this study from all datasondes (N = 28,783, out of 31,339 original NTU readings, excluding values < 0). Values marked by the vertical blue line denote the 10th, 25th, median, 75th and 90th percentile.

Automated monitoring datasondes deployed at 5 sites collected a total of 31,339 NTU measurements. However, 2,556 NTU values were negative; suggesting that the turbidity probe may have been exposed to air due to turbulent flows or low water levels. Therefore, only 28,783 measurements (91.8%) were used in our analysis (Figure 40). The 10th, 25th, median, 75th and 95th percentile NTU values were 7, 13, 26, 60 and 381 respectively, and ranged between 0 and 1,778. Median NTU values were higher at site 3A. This site often experienced extremely low or zero flows. During these periods water was only found in stagnant pools. The presence of stagnant water and easily disturbed, silty sediment during low flow may have caused unrepresentative or skewed turbidity readings due to disturbance and/or suspended algae. Highly discolored water caused by dissolved organic material was also frequently observed at site 3A. Each AS site, however, had some extremely high values denoted as outliers on the boxplot (Figure 41). Due to the narrow distribution of values, (9.8, 12.6, 16.0 NTU corresponding to the 25th, median, and 75th percentiles respectively), the majority of remaining values associated with site 5B appeared to be outlier values. Sites 2B and 5B had the highest and lowest overall average NTU values (Figure 42). The site 5B datasonde was deployed on the bottom of the stream bed. We did observe periods where the instrument had been surrounded by a highly concentrated suspension of fine silt. At site 5B, streamflow was also often very low.

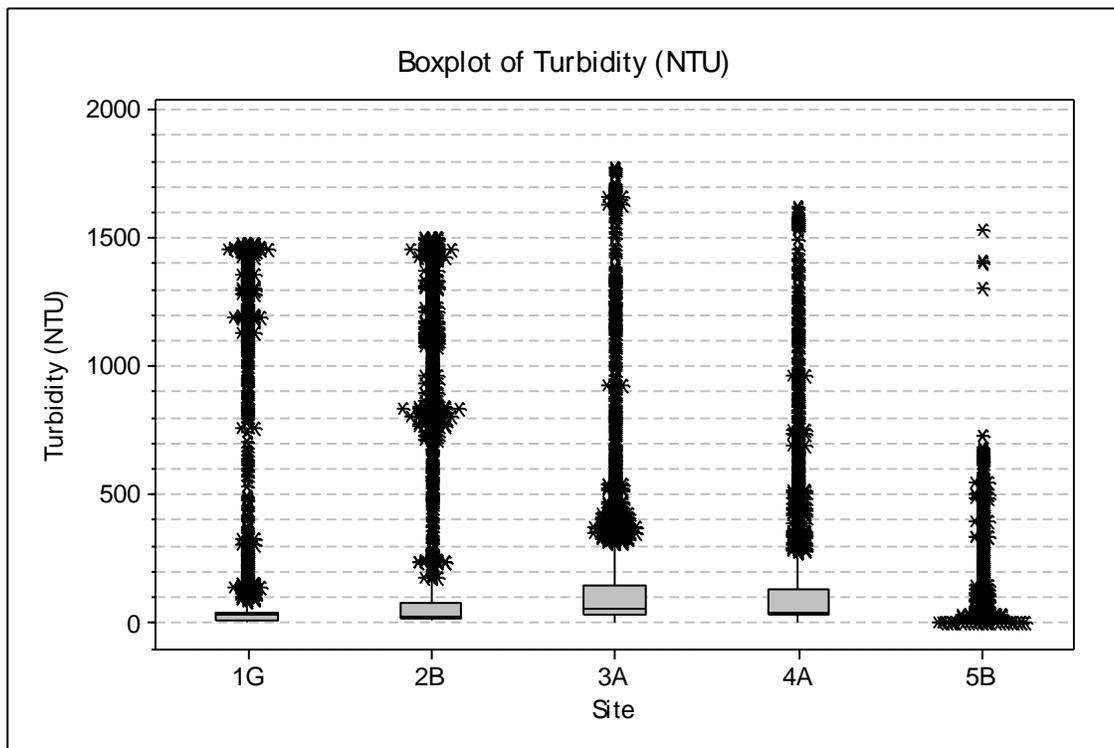
Figure 41. Boxplot of turbidity NTU values recorded by automated datasonde samplers.
