Harris County Texas Comprehensive Turbidity Study Results Report

Prepared in cooperation with the Harris County Flood Control District

EIH Technical Report # 12-001

2/28/2012
University of Houston-Clear Lake
Environmental Institute of Houston

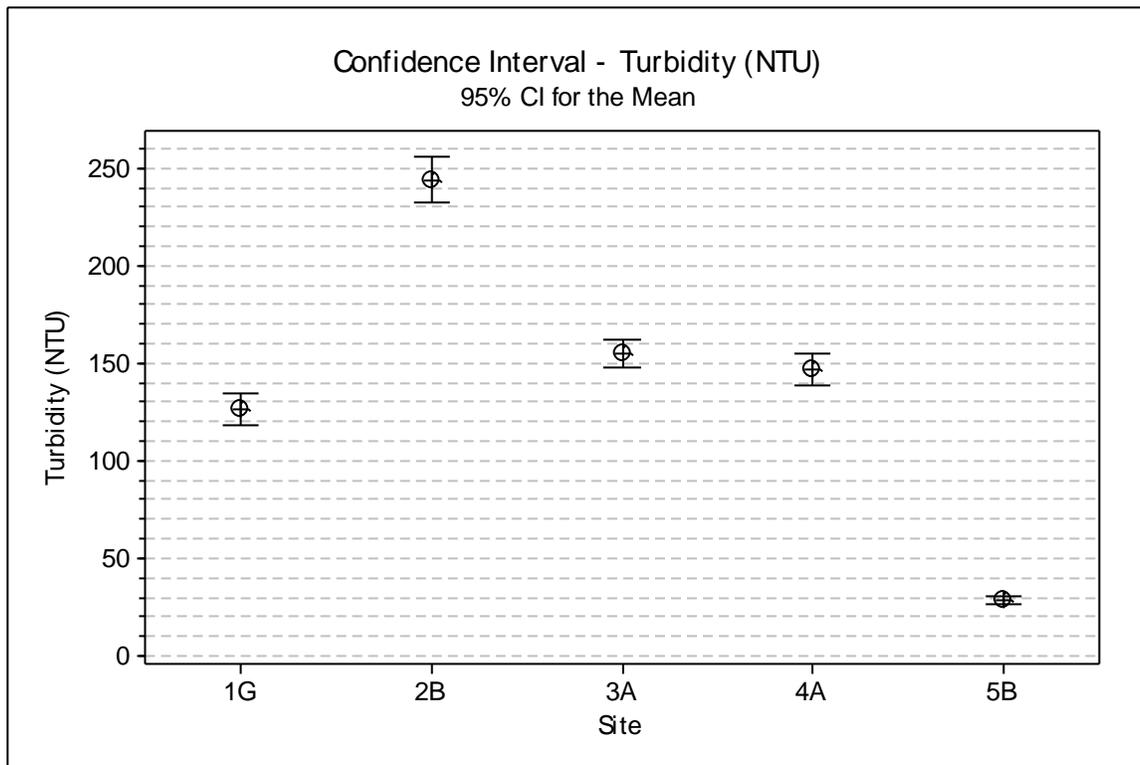
Figure 42. Estimates of average and associated 95% confidence intervals for NTU recorded by automated samplers during the study in 2011.

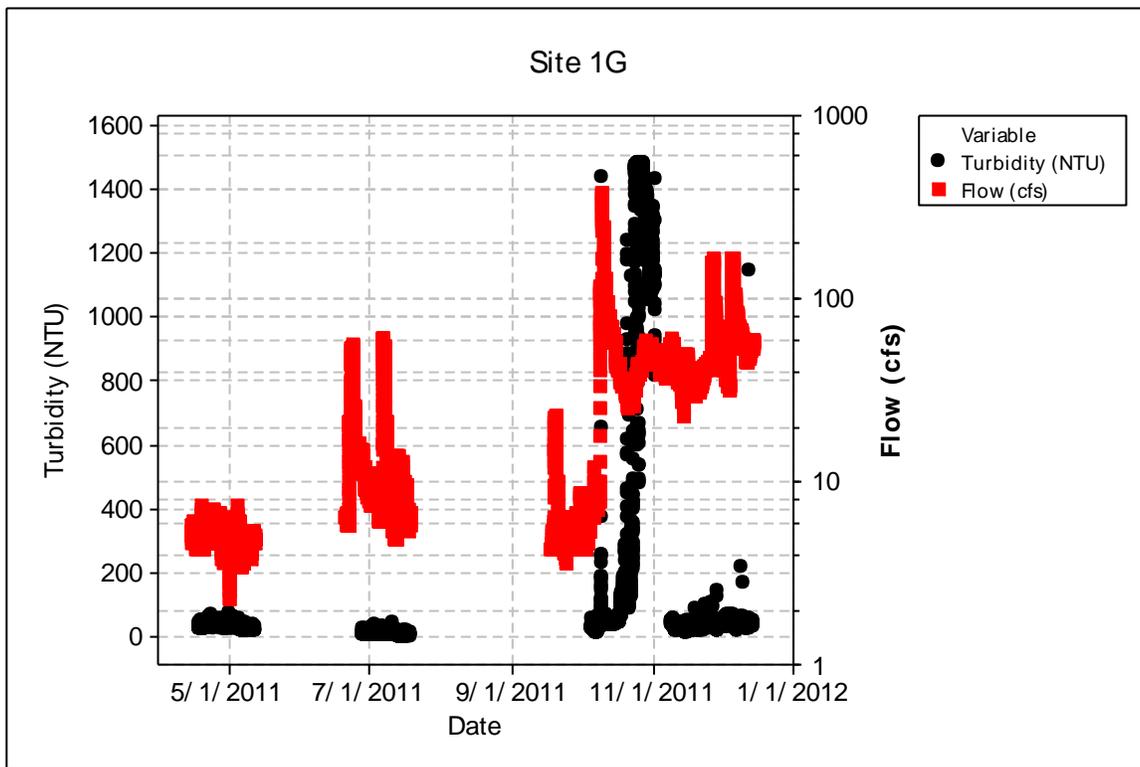
Figure 43. Turbidity (NTU) and flow (log scale) observed at site 1G from May to September 2011. Note: this analysis contains some negative NTU values that were not truncated.

During the study period, the datasonde deployed at site 1G recorded extremely high turbidities (>1000 NTU) during October. At this site, it does appear streamflow did, in many cases, increase prior to parallel increases in NTU levels. This suggests that increased flows resuspended or introduced suspended particles and increased turbidity (Figure 43). Furthermore, the highest NTU levels generally occurred at intermediate levels of streamflow, suggesting that the increased energy, from rising water levels and associated runoff, contributes new sediment from the watershed and resuspends bottom sediment, quickly increasing turbidity (Figure 44).

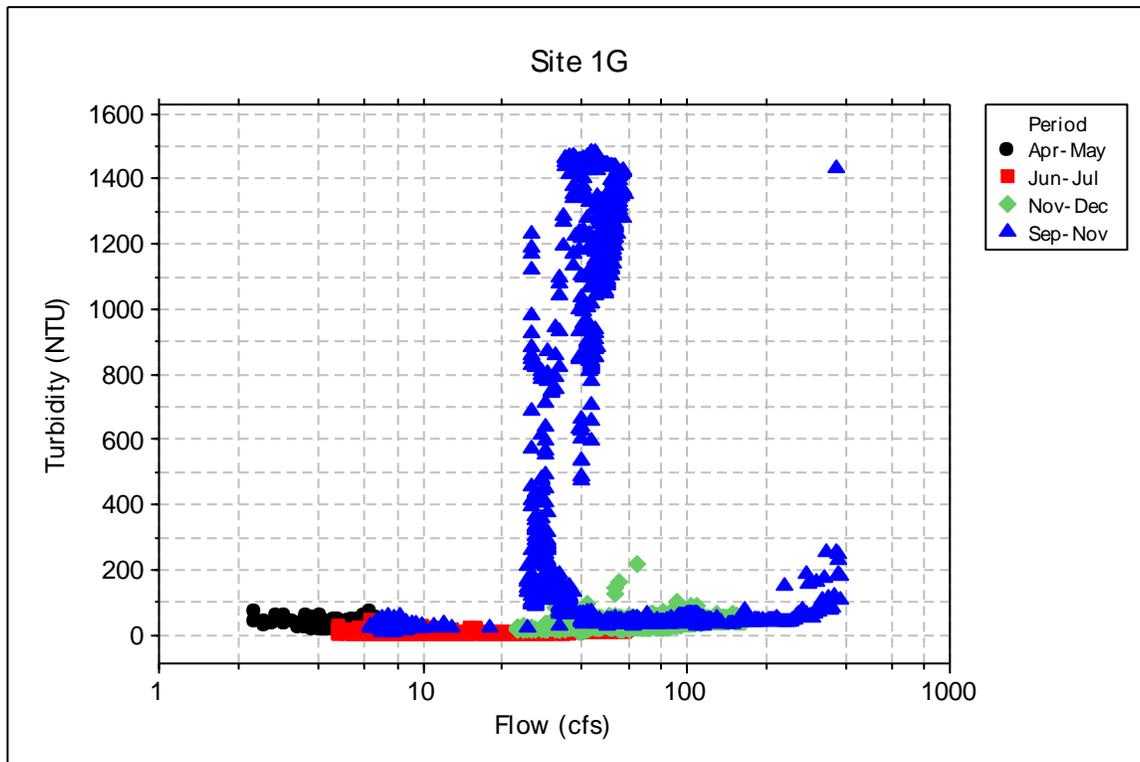
Figure 44. Turbidity vs. flow (log scale) at site 1G observed during the study. Note: this analysis contains some negative NTU values that were not truncated.

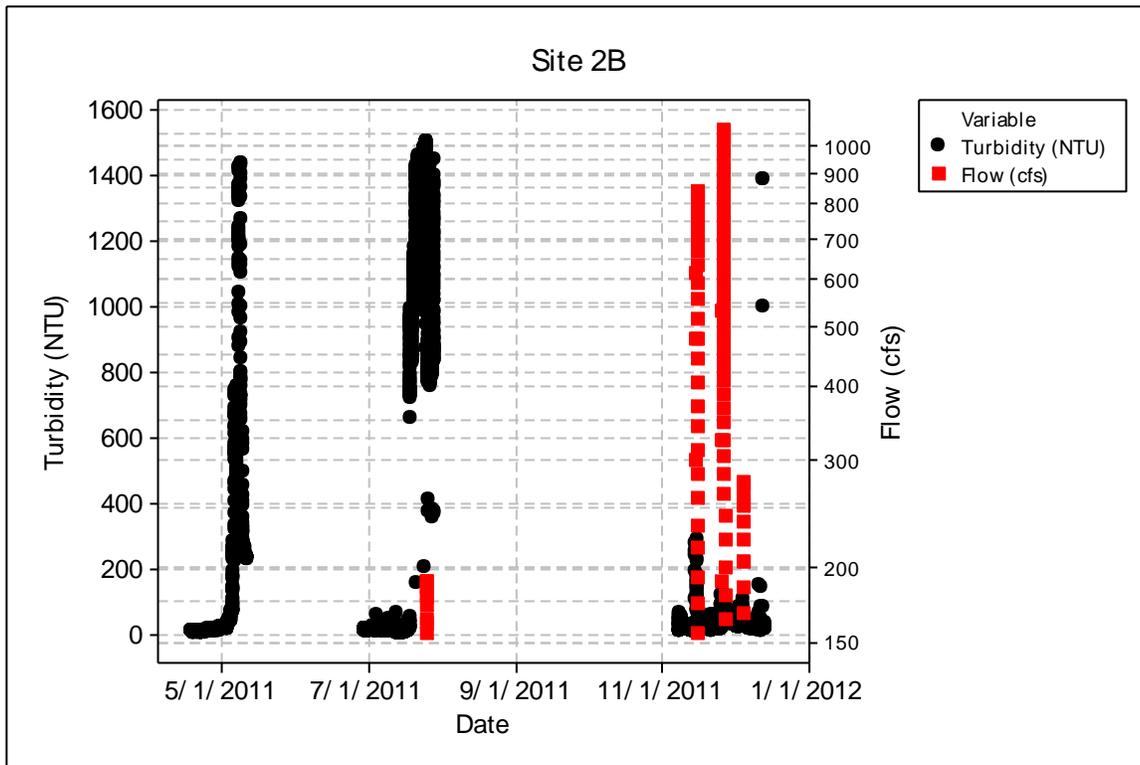
Figure 45. Turbidity (NTU) and flow (log scale) observed at site 2B from May to September 2011. Note: this analysis contains some negative NTU values that were not truncated.

As previously mentioned, the low flows or limited datasonde data at sites 2B and 3A, limited our ability to derive strong inferences regarding the role of streamflow on turbidity (Figure 46 - Figure 48). Very high turbidity (>1000 NTU) was recorded during spring and fall months at both sites. These elevated turbidity readings did not appear to be associated with high streamflow conditions. At site 2B, water levels were frequently too low to obtain a reliable gage reading and converted flow estimate. We spoke to USGS and obtained a rating curve for this site. But we have been unable to obtain matching streamflow and lower gage readings to extend the rating curve to estimate flows in that range. One possible method to extend the streamflow record at lower flows is to use the nearest upstream and downstream gage to develop a predictive relationship for the missing data period. This method should be explored in future analyses.

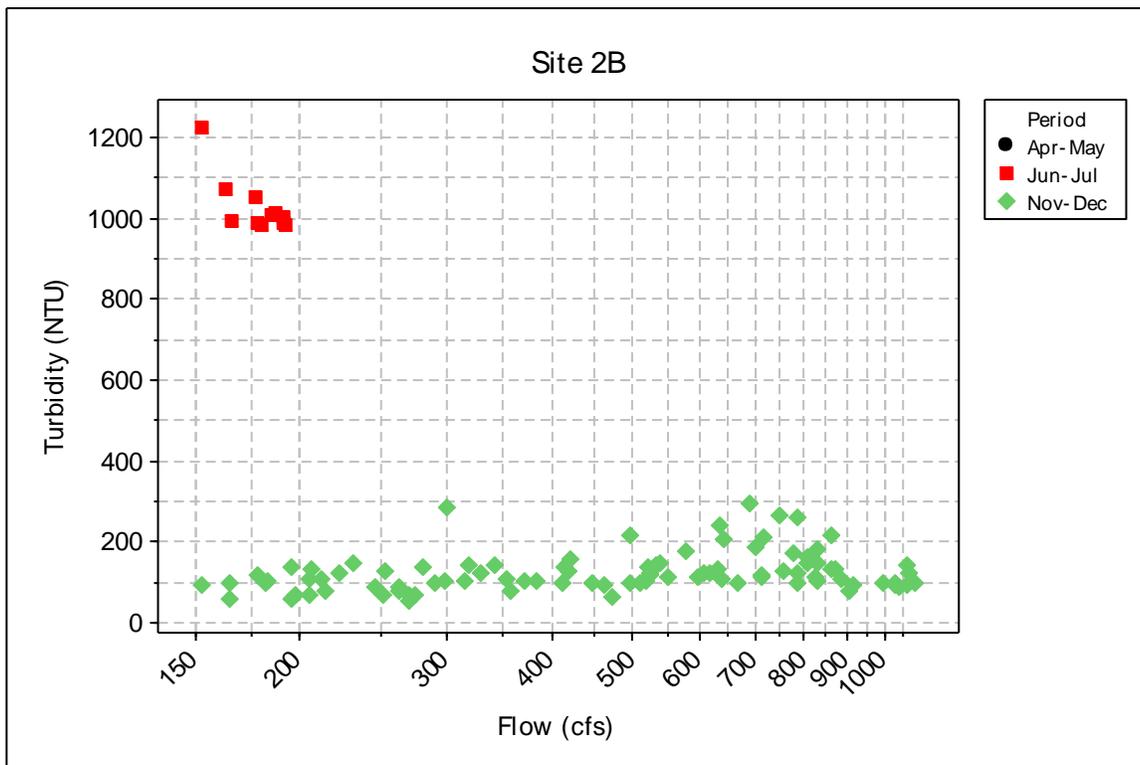
Figure 46. Turbidity vs. flow (log scale) at site 2B observed during the study. Note: this analysis contains some negative NTU values that were not truncated. During most of the project, lower stream flows (< 150cfs) below the rating curve for this site not recorded by the USGS gage. Consequently, matching turbidity values are not depicted for those periods.

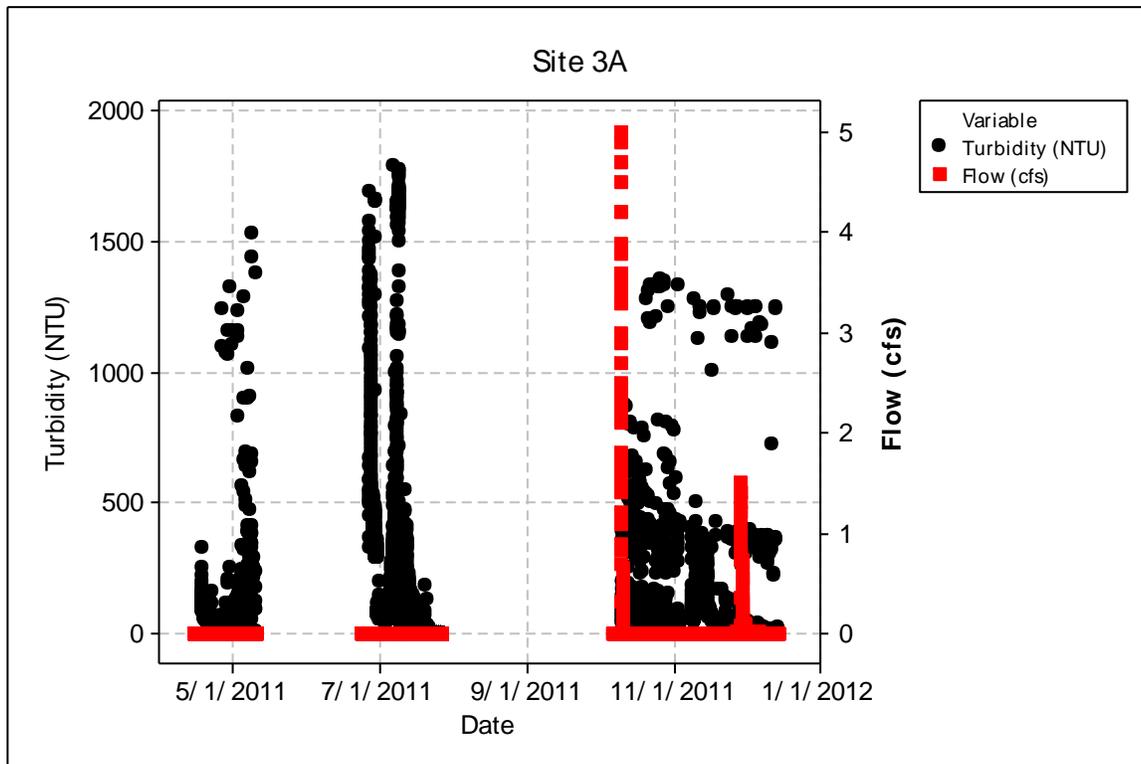
Figure 47. Trends in turbidity (NTU) measured by the YSI datasonde and streamflow (cfs) at site 3A during the study period. All NTU values were utilized for this display, including negative numbers.

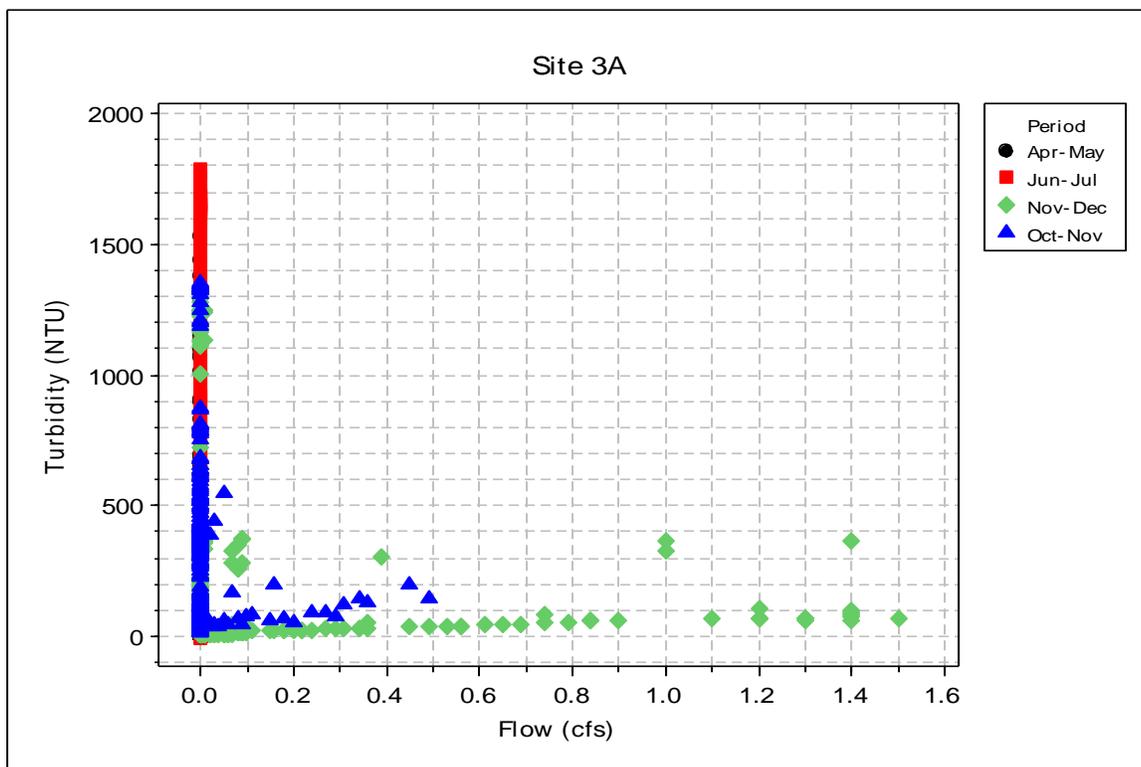
Figure 48. Relationship of turbidity versus streamflow based on automated monitoring data at site 3A. All NTU values were utilized for this display, including negative numbers.

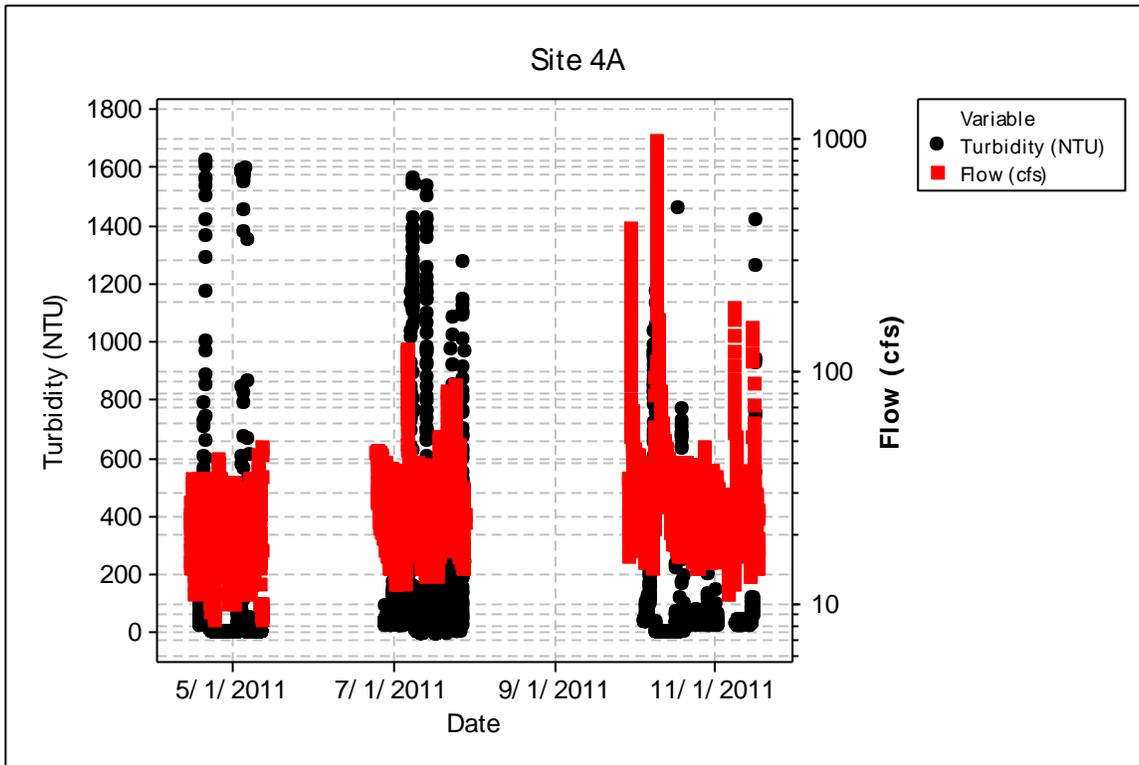
Figure 49. Trends in turbidity and streamflow based on automated monitoring data at site 4A during the study period. All NTU values were utilized for this display, including negative numbers.

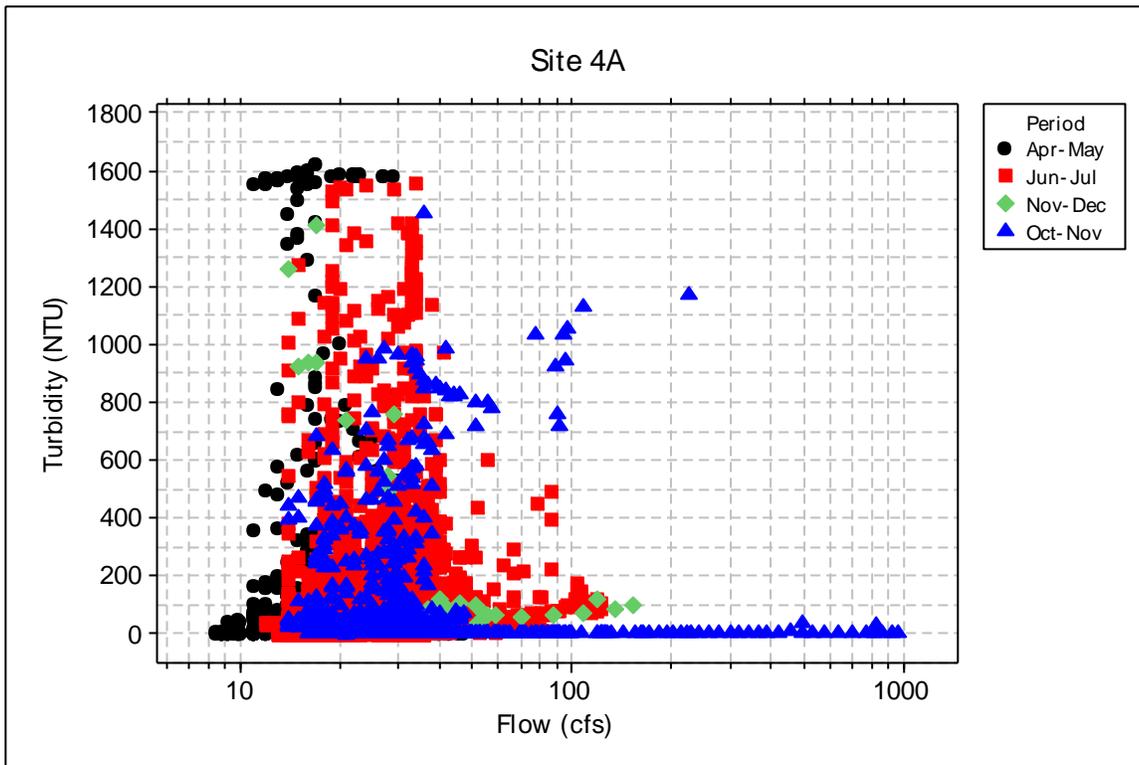
Figure 50. Relationship between turbidity versus streamflow based on automated monitoring data at site 4A. All NTU values were utilized for this display including negative numbers. Note log scale of x-axis (flow).

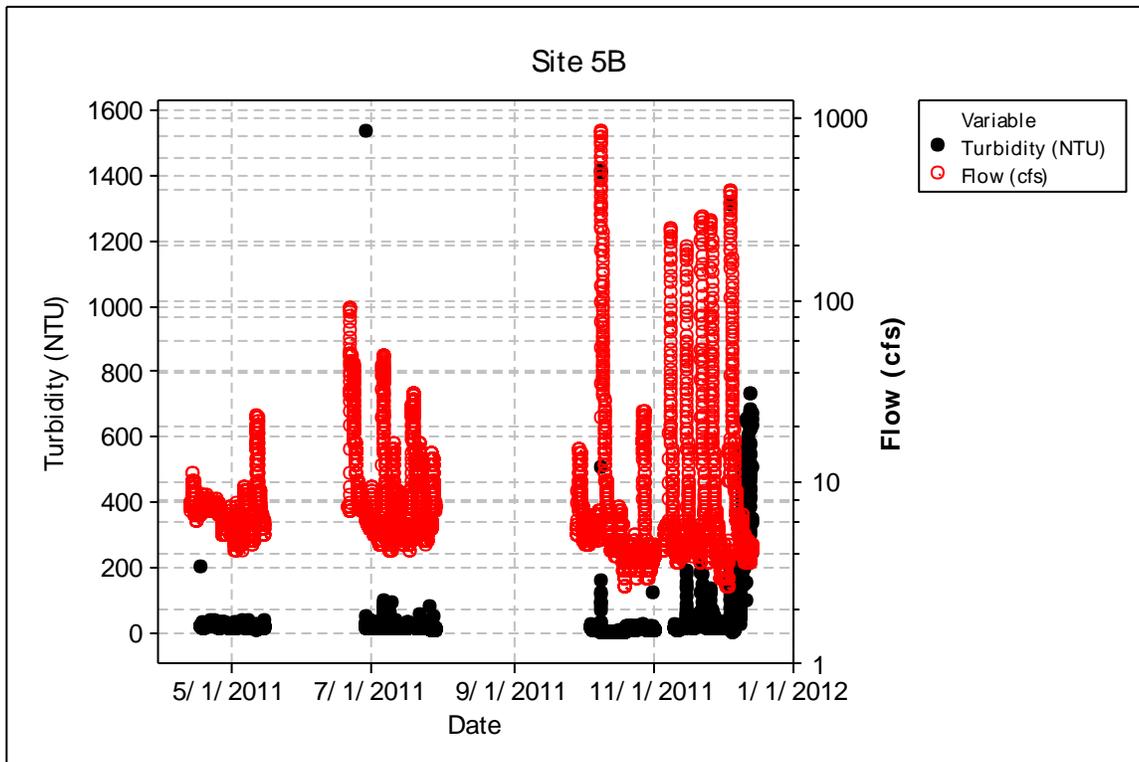
Figure 51. Trends in turbidity and streamflow based on automated monitoring data observed at site 5B during the study period. Note that all NTU values were utilized for this display, including negative number, and the log scale used for streamflow.

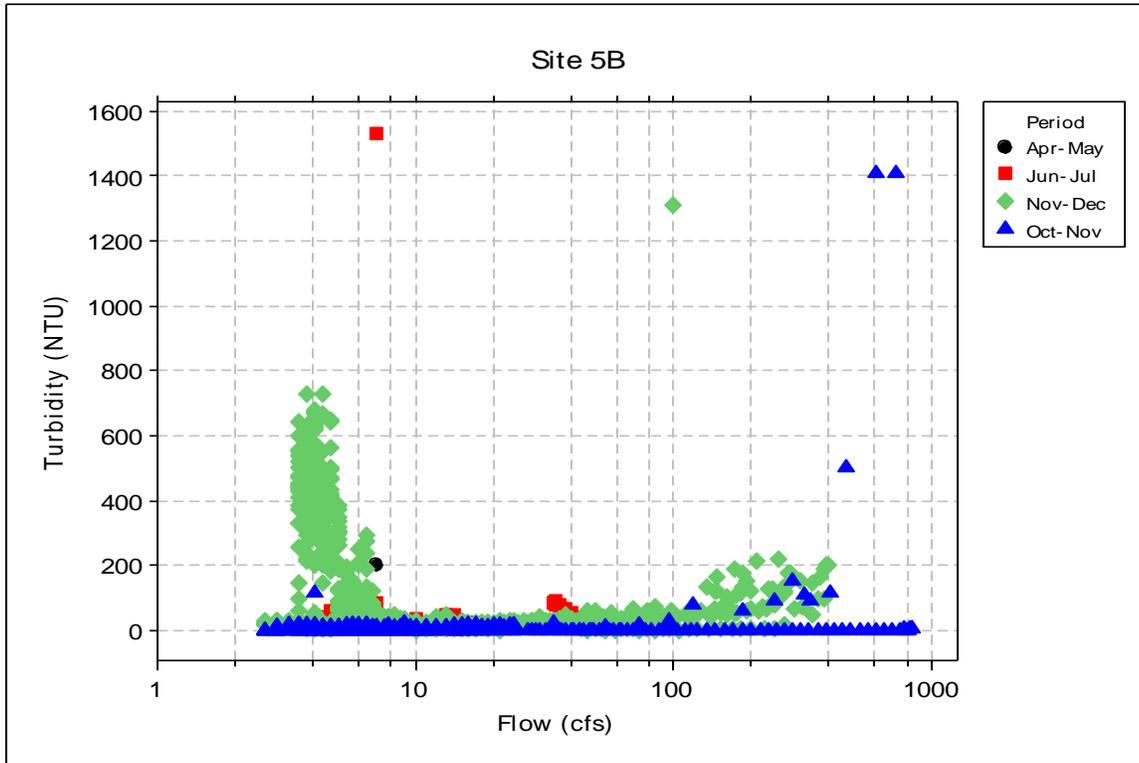
Figure 52. Relationship between turbidity versus streamflow at site 5B based on automated monitoring data. All NTU values were utilized for this display, including negative numbers. Note log scale of x-axis (flow).

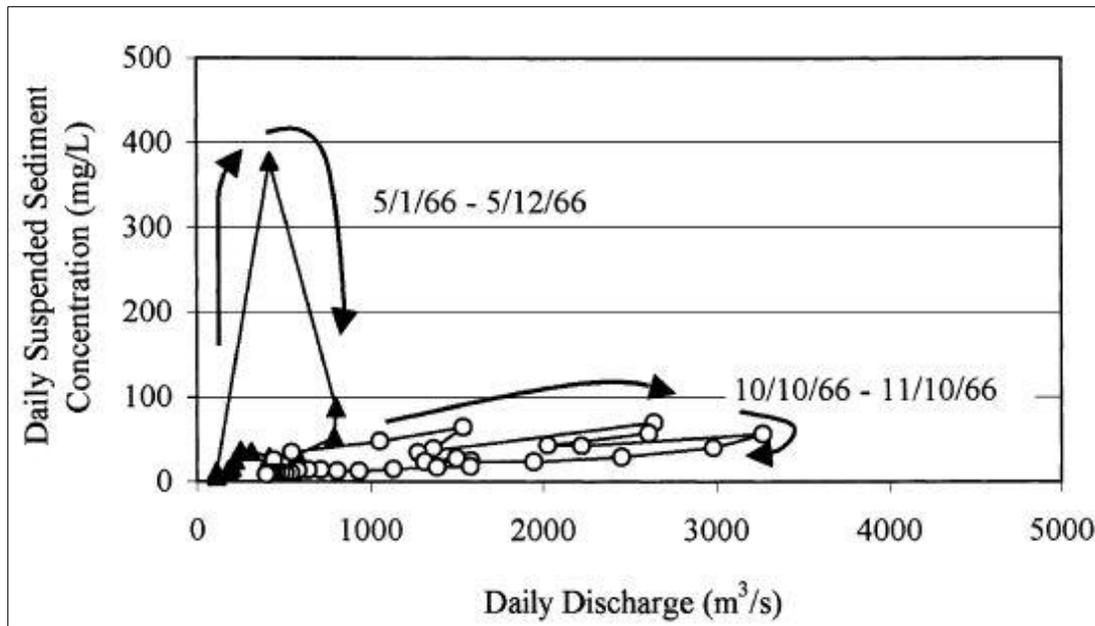
Figure 53. Type-1 hysteresis loop or suspended-sediment concentrations for two stormflow events showing (1) concentrations higher on the rising limb than the falling limb and (2) sediment exhaustion effects for the second, larger flood (from Hudson (2003) referenced in Brandes et al. (2009)).

Empirical levels of NTU observed in this study and others show that turbidity levels can be highly variable and elevated immediately after storm flows and/or when bottom sediment is disturbed. Land use and the type of soils influence the various measures of turbidity with high amounts of impervious surface influencing the amount of runoff, streamflow and associated measures of turbidity. This recognized pattern was not consistent in this study. This may be due to the non-linear response associated with sediment transport in streams. In order to evaluate the role of the hydrological sequence of flood pulses on sediment mobilization, we recommend a closer examination of individual hydrographs, and analyzing not only the relationship of absolute streamflow versus turbidity, but also evaluating the rate of change (+ or – delta change in flow) in flow and how it influences sediment transport. Past literature has documented that stormflow hydrographs are frequently characterized by higher suspended sediment concentrations during the rising limb than the falling limb, referred to as a type-1 hysteresis loop.

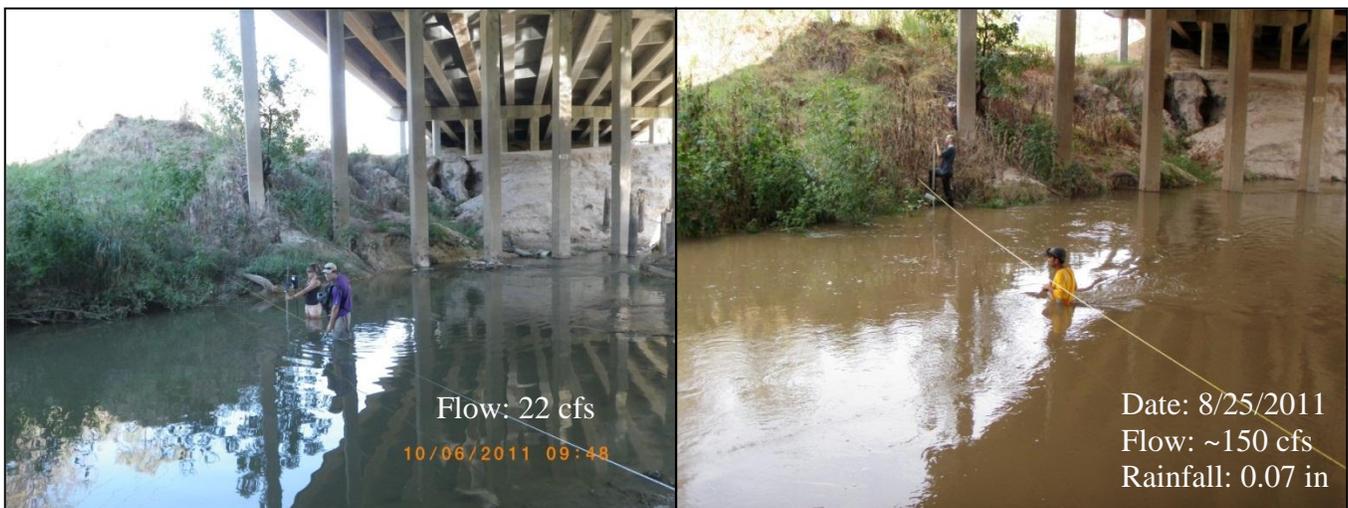
Figure 54. Example of site 2B (located in a large watershed), comparing normal “dry” conditions (left) and rain influenced “wet” conditions (right). Note the appearance of increased suspended sediment in the fast flowing water.

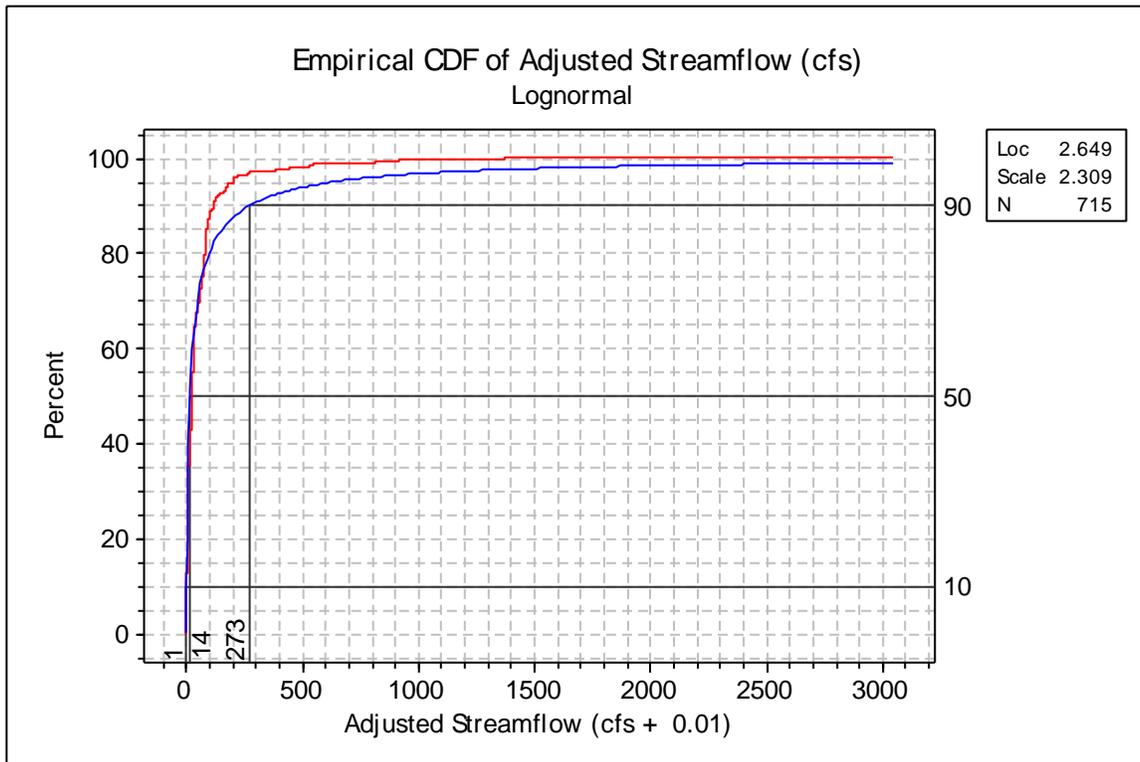
Figure 55. Cumulative distribution of adjusted streamflow (cfs + 0.01) across all sites during this study. Lognormal CDF = blue line.

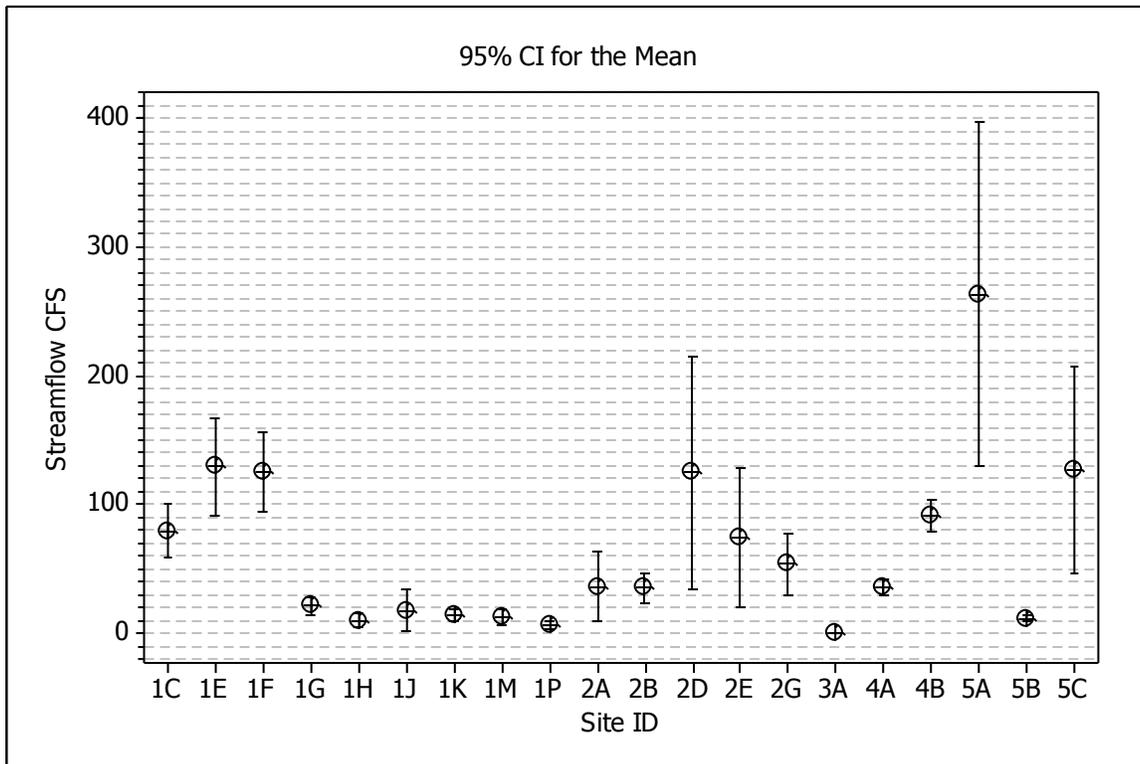
Figure 56. Streamflow levels observed during collection of TSS and NTU samples in 2011.

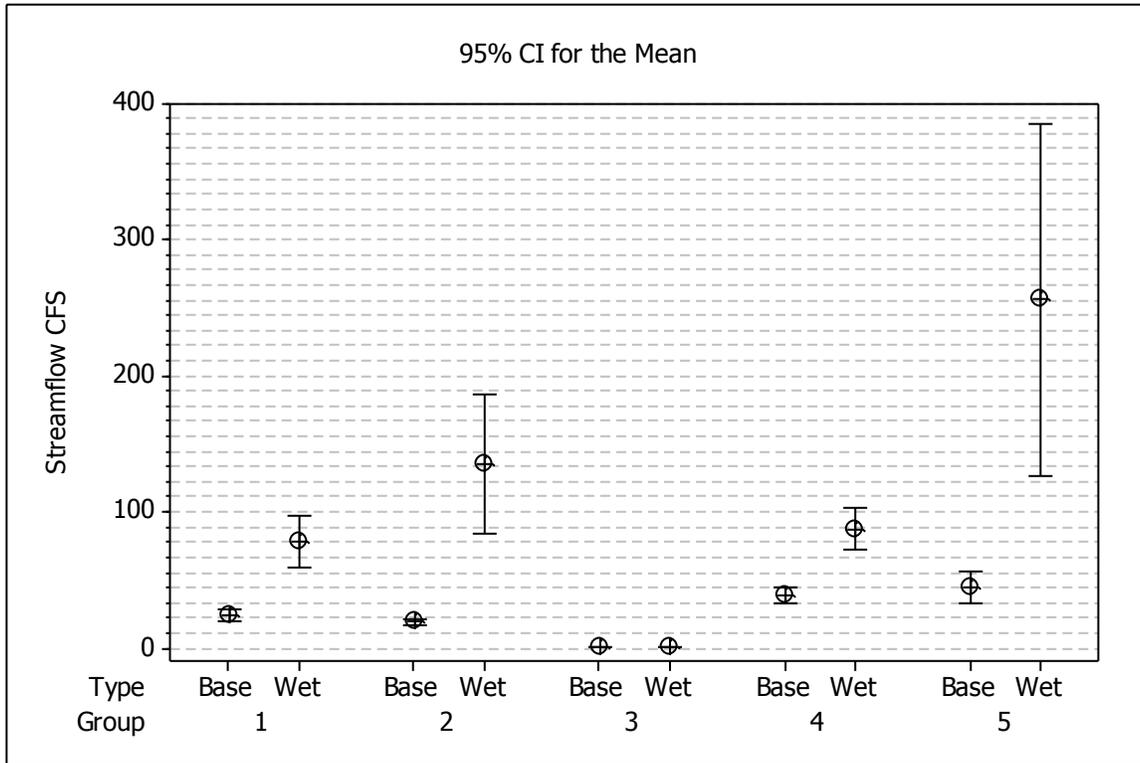
Figure 57. Streamflow measurements during base flow conditions and wet weather sampling for TSS and NTU at each site grouping.

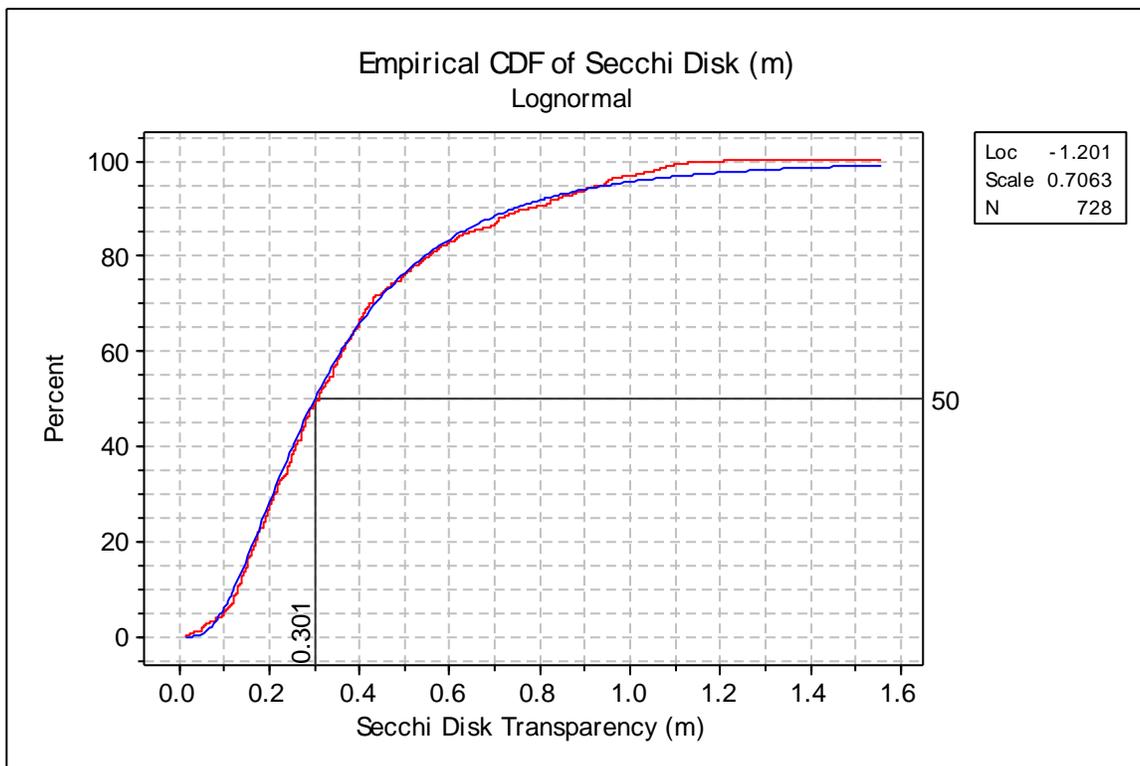
Figure 58. Empirical cumulative distribution function (CDF) of SD (m) across all sites during this study. Lognormal CDF = blue line

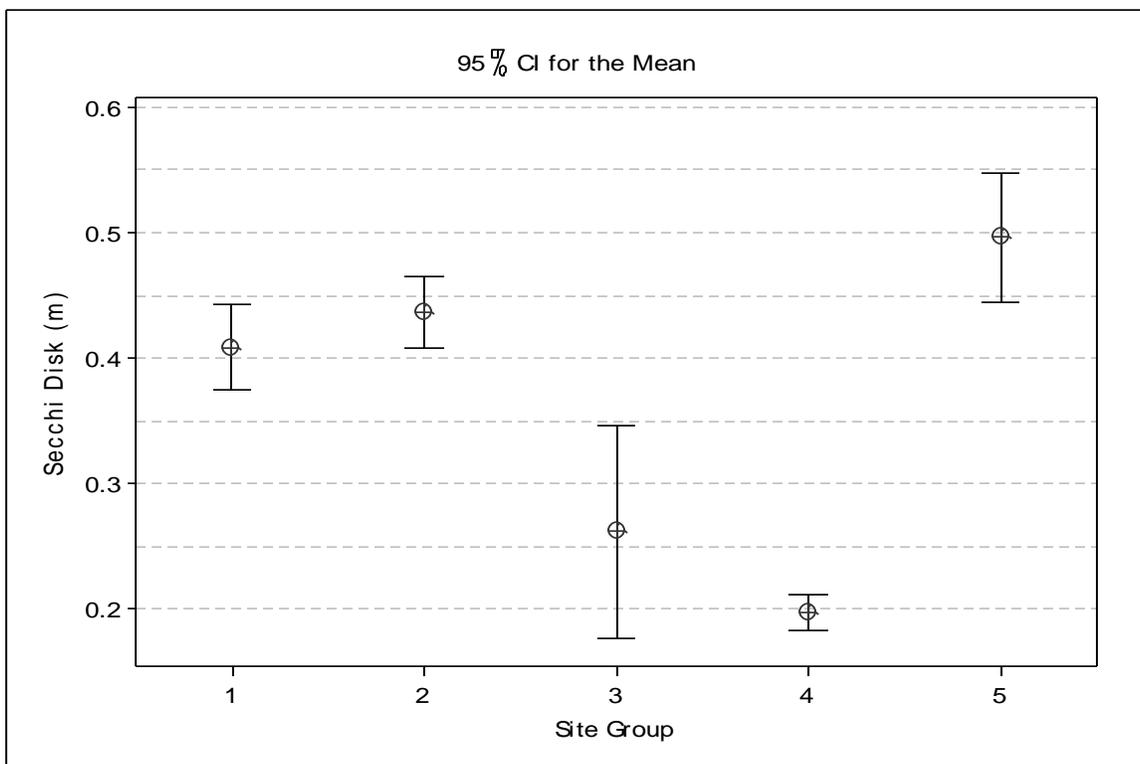
Figure 60. Secchi disk readings for each site group. N = 761

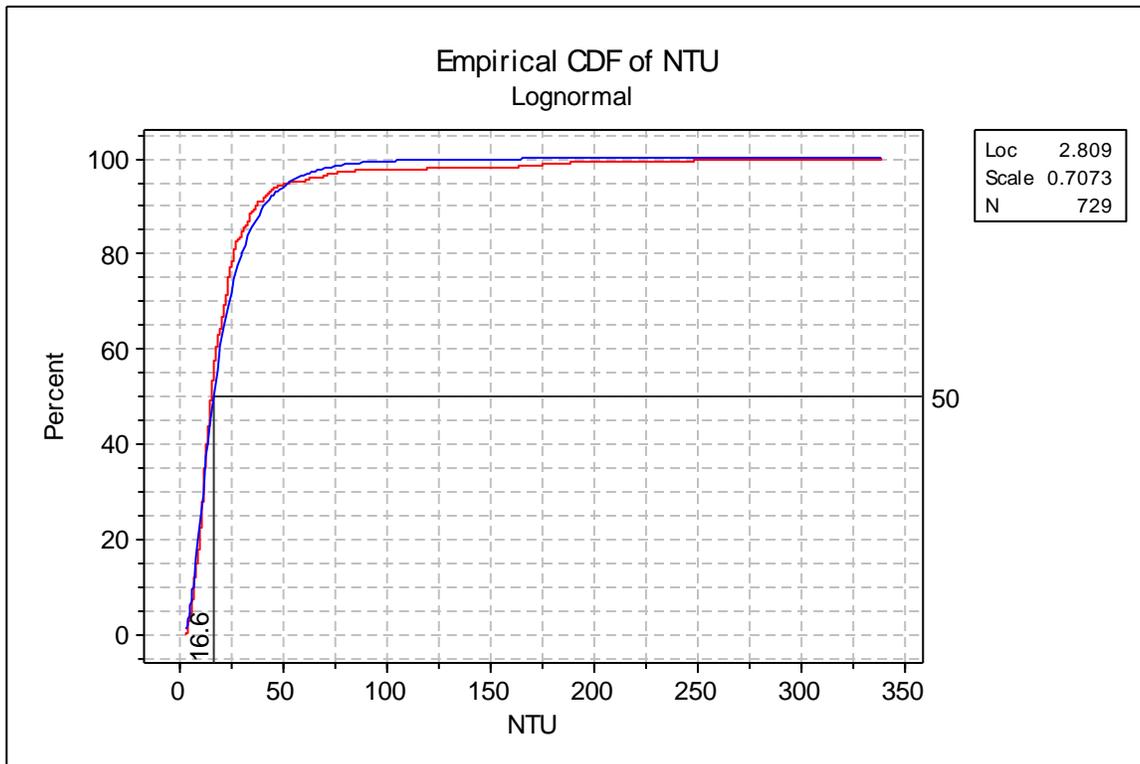
Figure 61. Empirical cumulative distribution function (CDF) of NTU across all sites during this study. Lognormal CDF = blue line

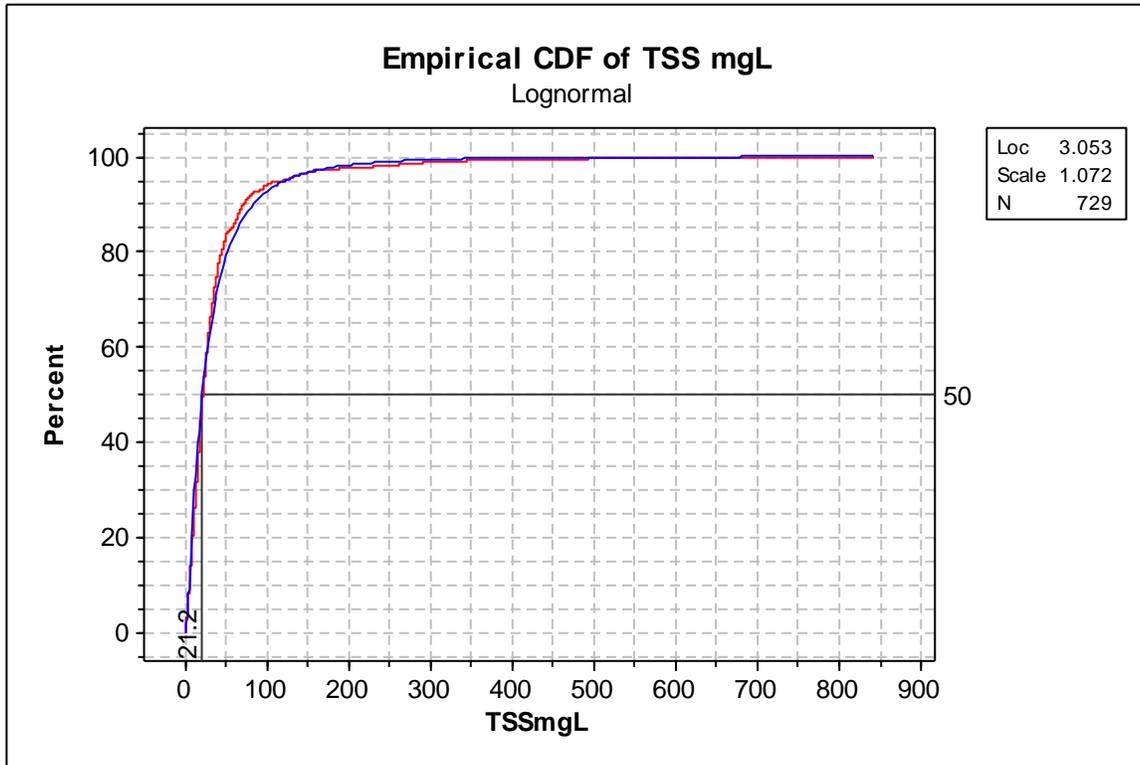
Figure 64. Empirical cumulative distribution function (CDF) of TSS. Lognormal CDF = blue line.

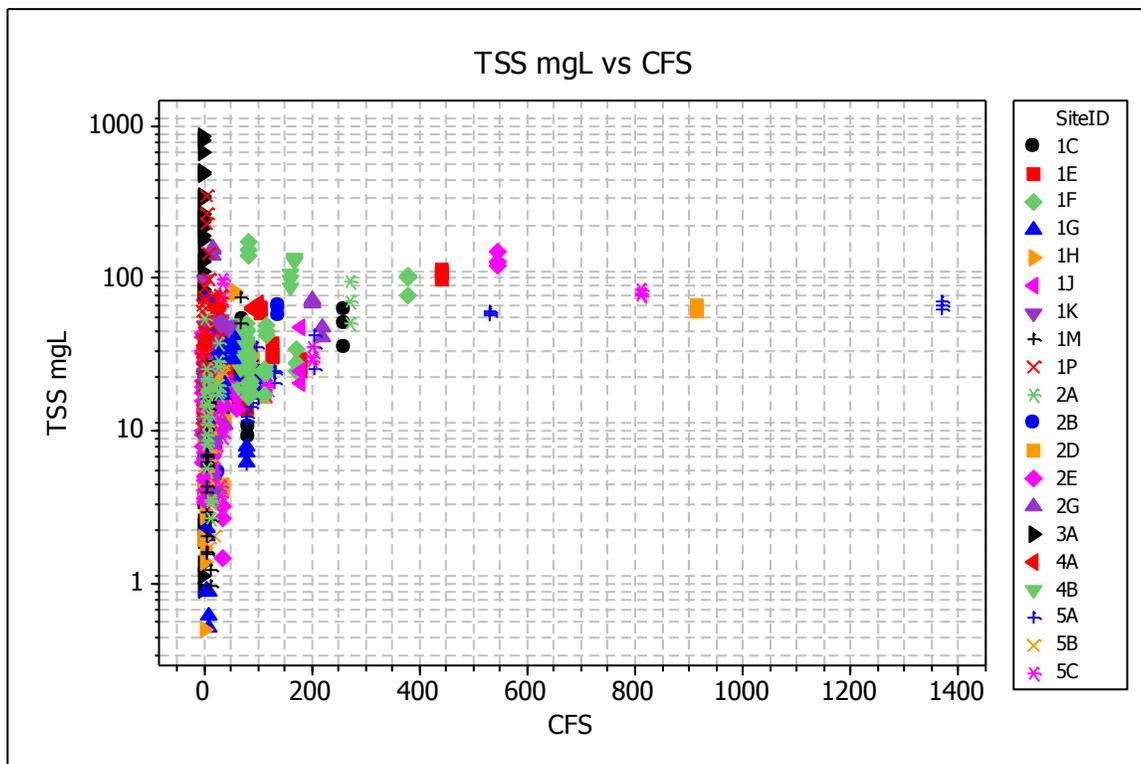
Figure 67. The relationship of TSS versus streamflow for each site based on data from periodic monitoring (PM) events.

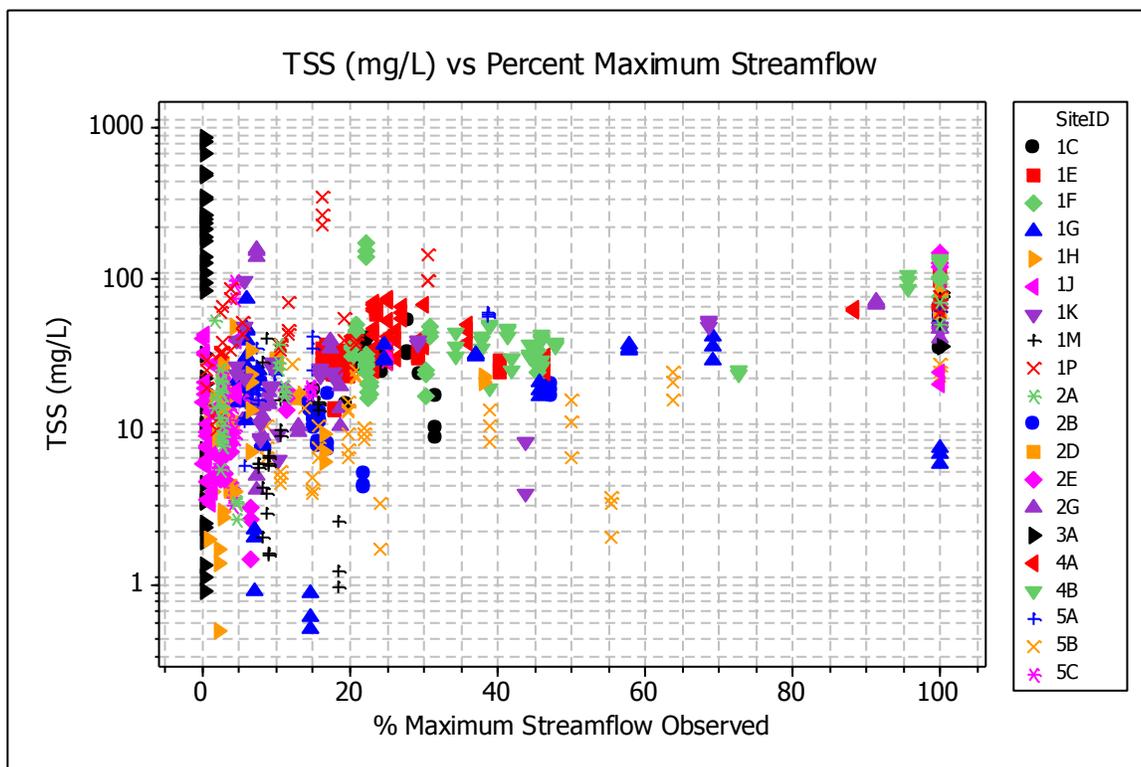
Figure 68. Trends in TSS (log scale) vs. percent maximum streamflow for all monitored sites.

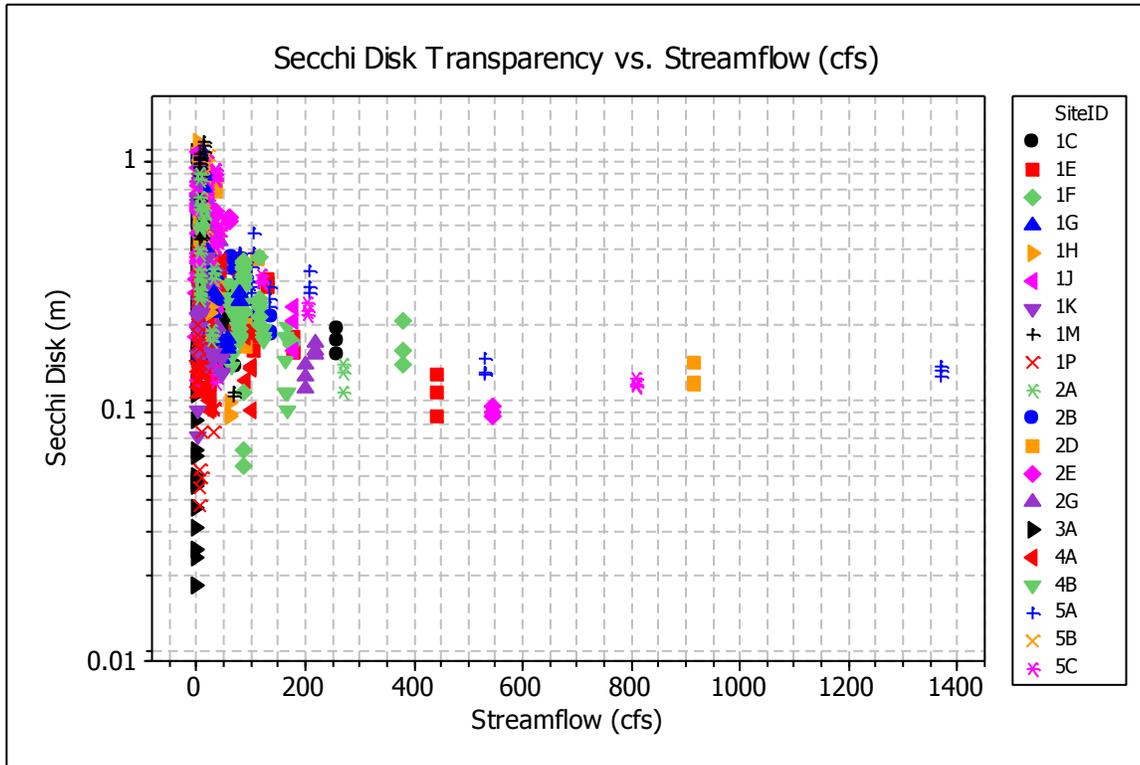
Figure 69. Trends in SD (log scale) versus streamflow for all monitored sites.

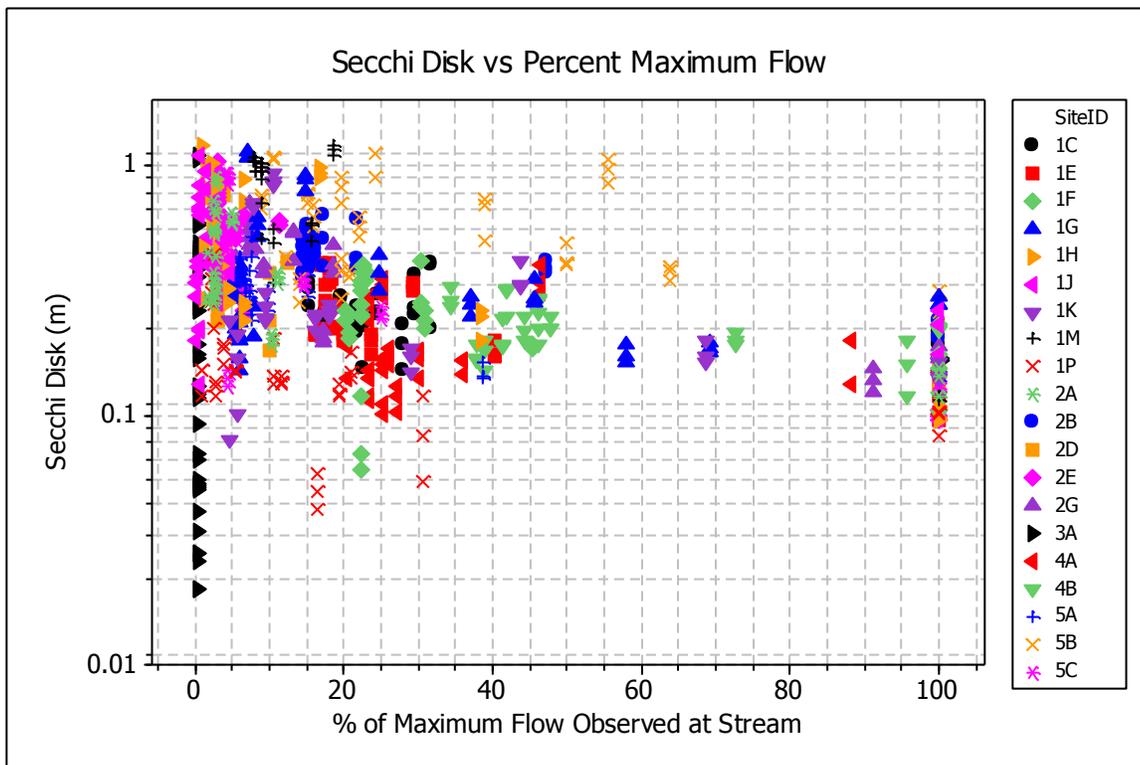
Figure 70. Trends in SD (log scale) versus percent maximum streamflow for all sites.
