Harris County Texas Comprehensive Turbidity Study Results Report

Prepared in cooperation with the Harris County Flood Control District

EIH Technical Report # 12-001

2/28/2012
University of Houston-Clear Lake
Environmental Institute of Houston

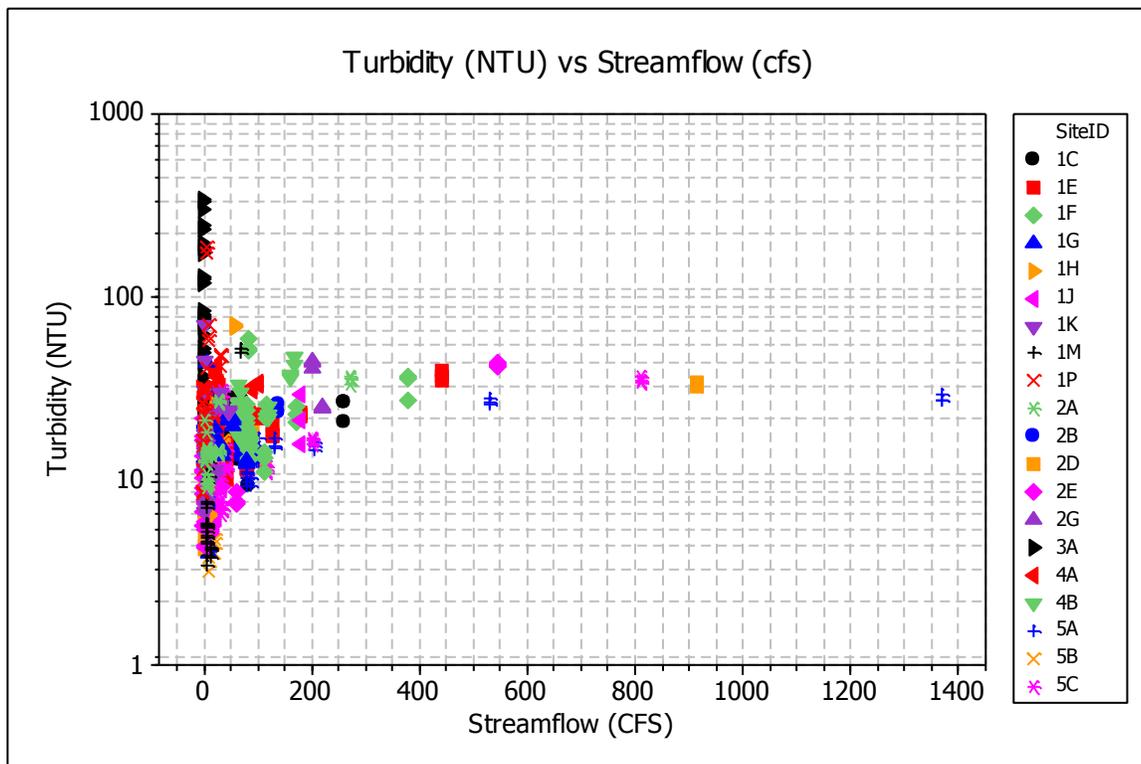
Figure 71. Turbidity (NTU) (log scale) versus streamflow for all sites.

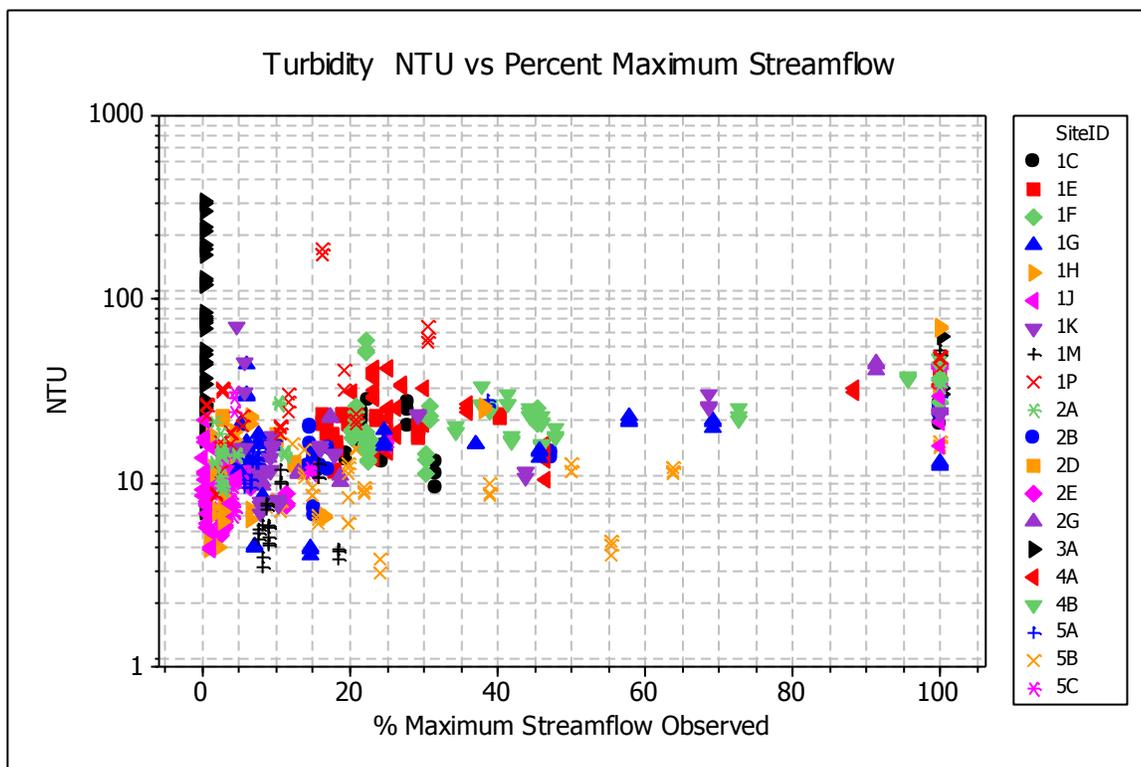
Figure 72. Turbidity (NTU) (log scale) versus percent maximum streamflow for all sites. Streamflow data was obtained from matching values.

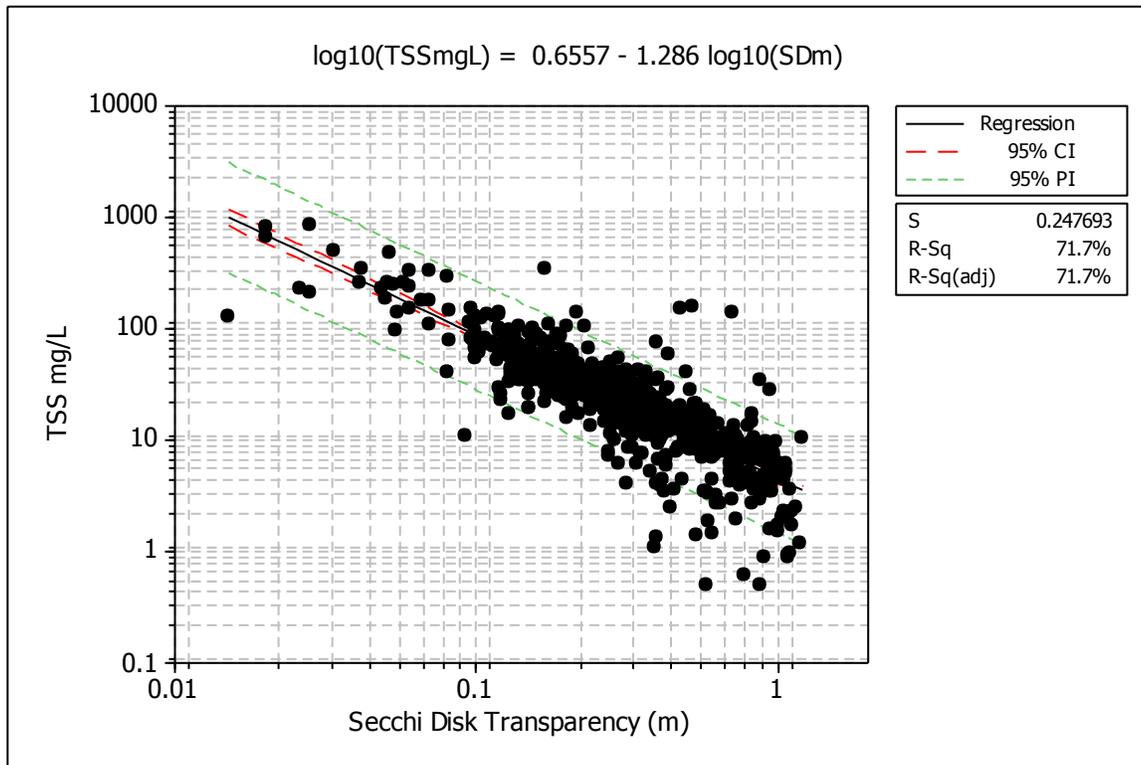
Figure 73. Regression of \log_{10} TSS versus \log_{10} SD based on 727 grab samples. Note log scale.

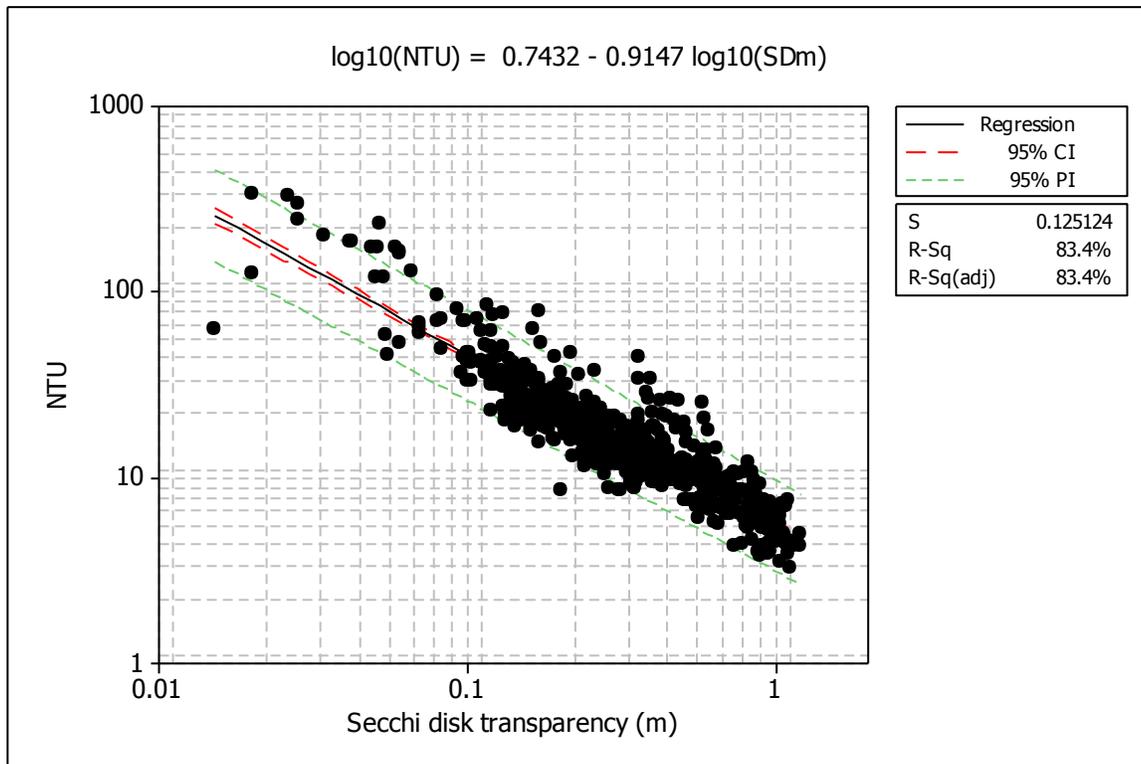
Figure 75. Regression of Log_{10} NTU versus Log_{10} SD transparency based on 727 grab samples. Note log scale.

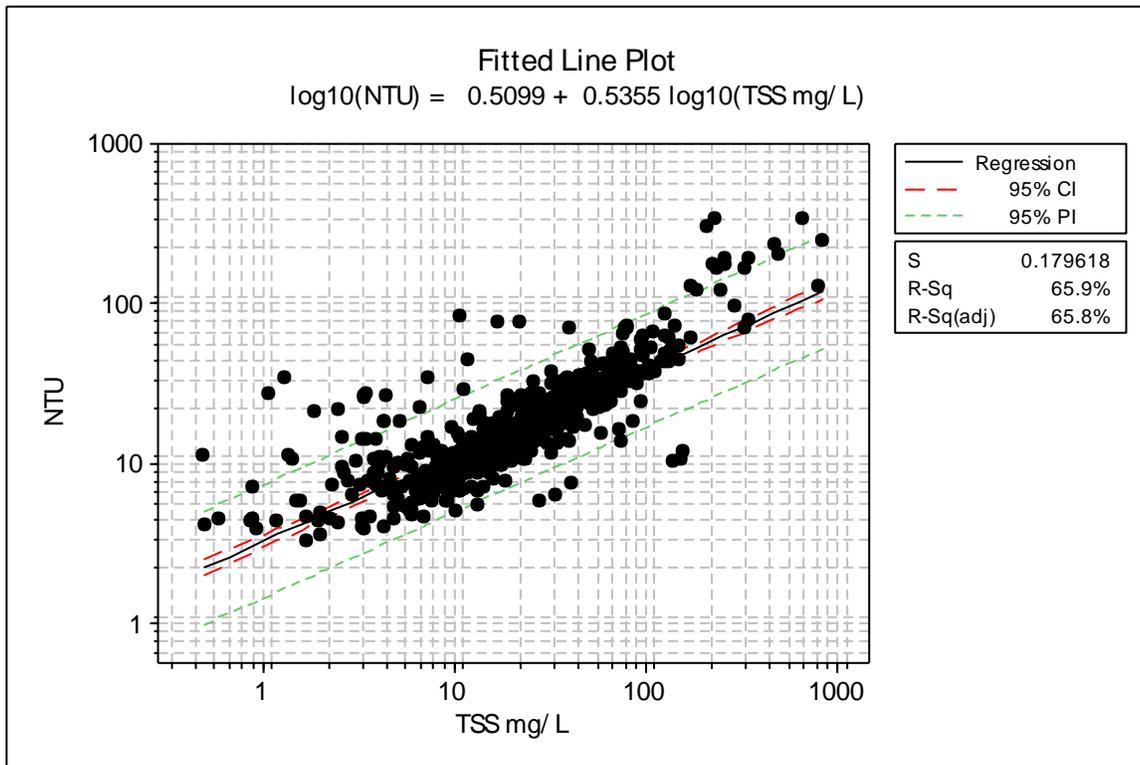
Figure 77. Regression of \log_{10} NTU versus \log_{10} TSS using grab sample results from this study. Note log scale axis.

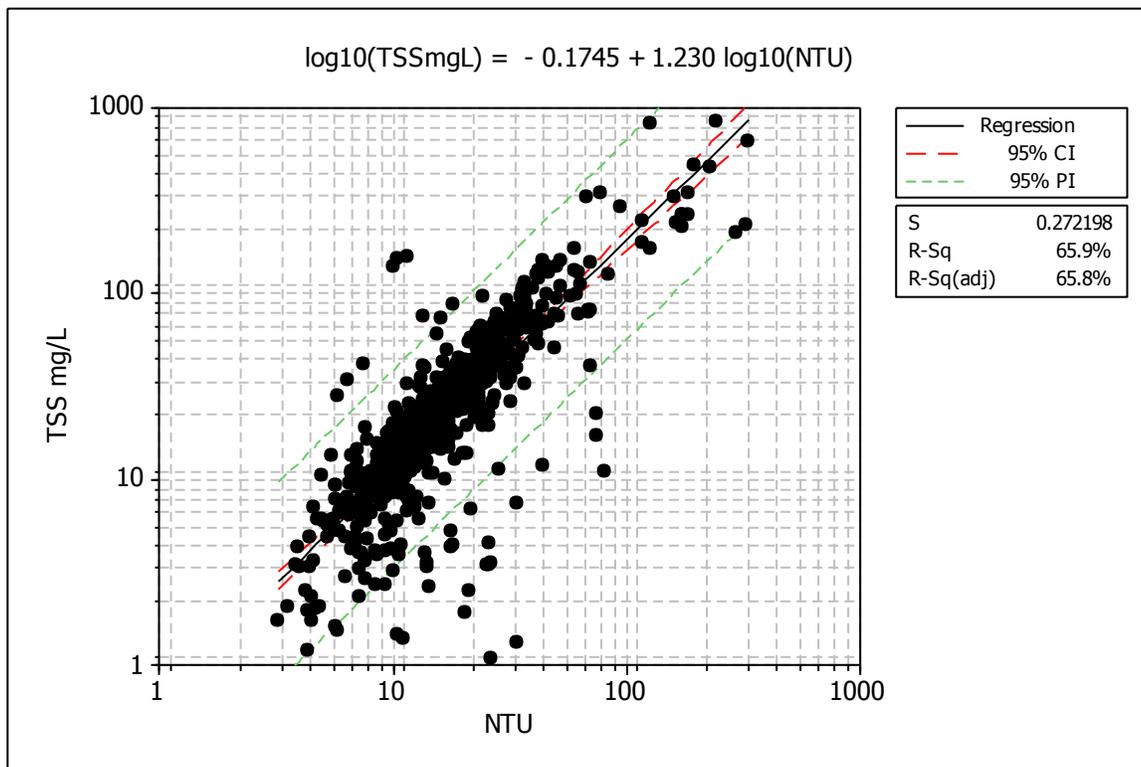
Figure 79. \log_{10} TSS versus \log_{10} NTU regression model based on 728 grab samples. Note log axis scale.

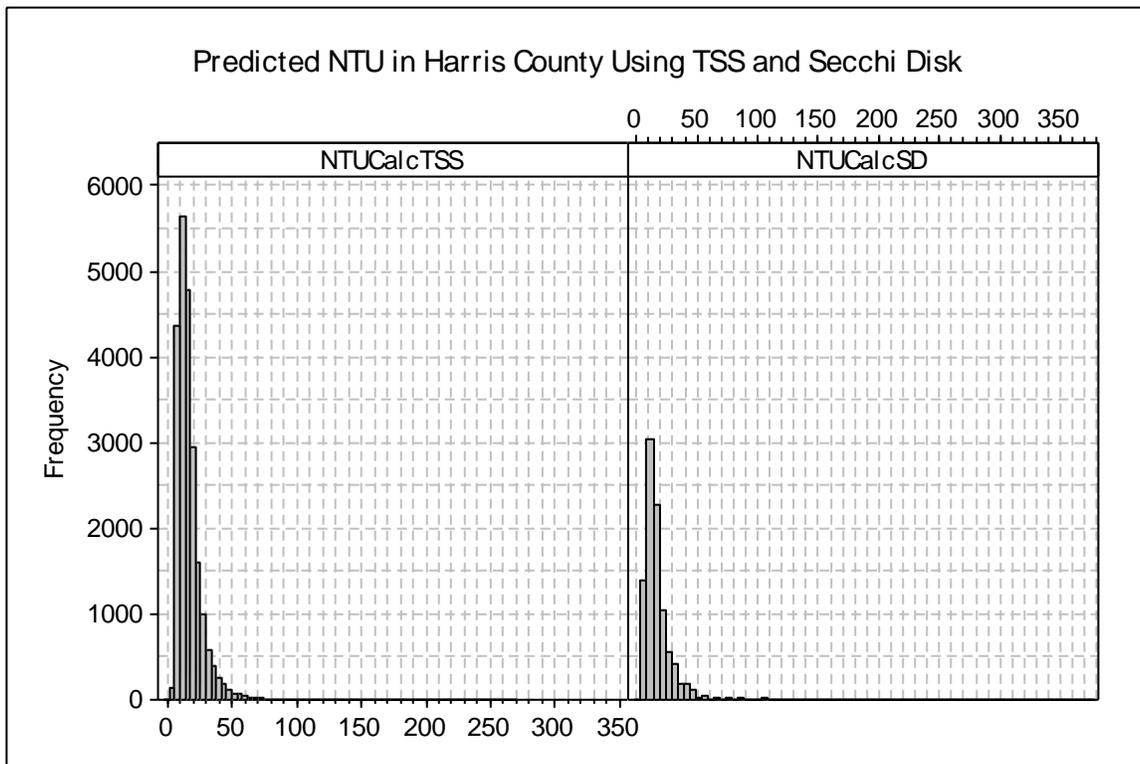
Figure 81. Estimated distribution of derived NTU levels for historical Harris County sites (1/01-9/11) using predictive log-log regression model from current study for TSS and SD.

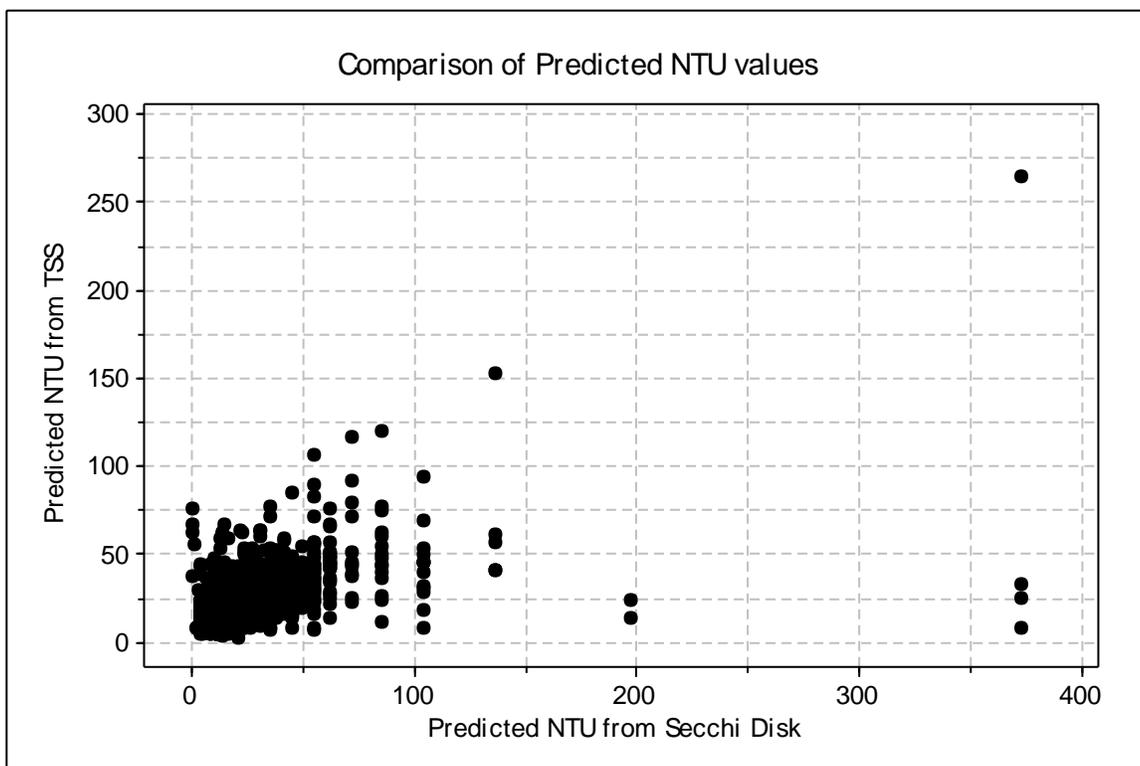
Figure 82. Comparison of derived NTU values for Harris County sites using historical TSS versus SD values during the last 10 years. 1/01 to 9/11. (Pearson correlation coefficient (r) for NTU values derived from TSS vs. SD = 0.658, $p = 0.000$)

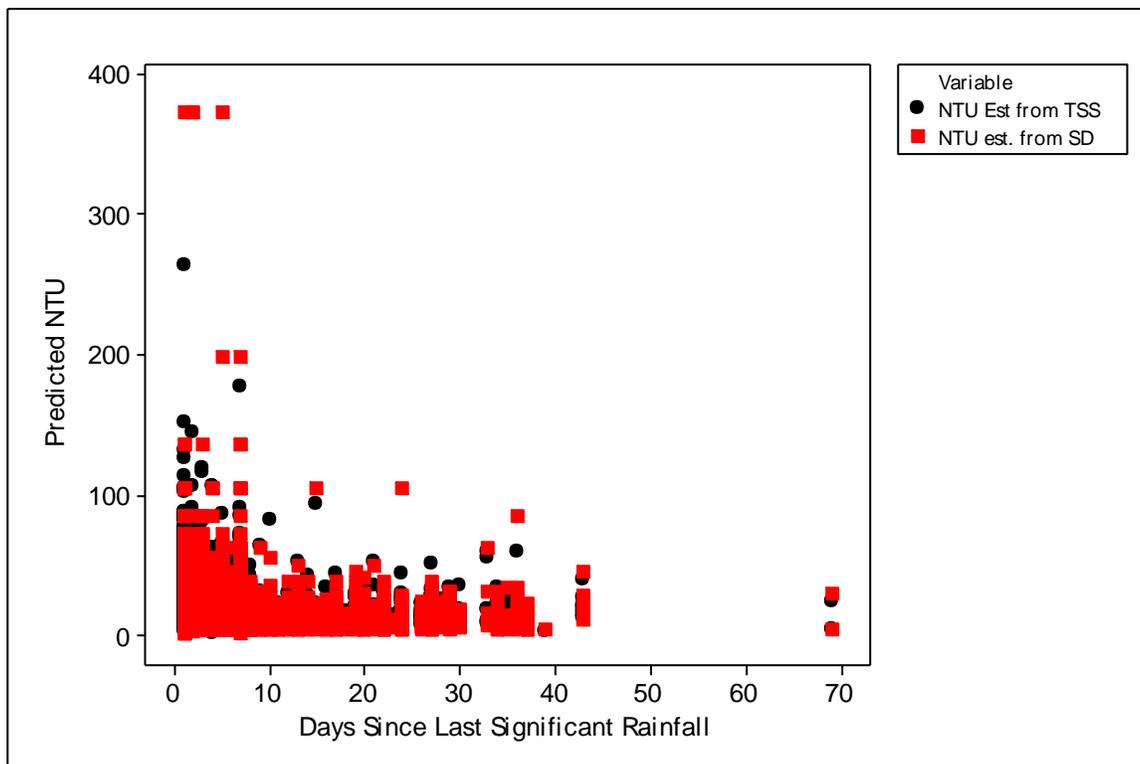
Figure 84. Distribution of predicted NTU versus historical rainfall incidence in Harris County applying the regional regression model to past SD data.

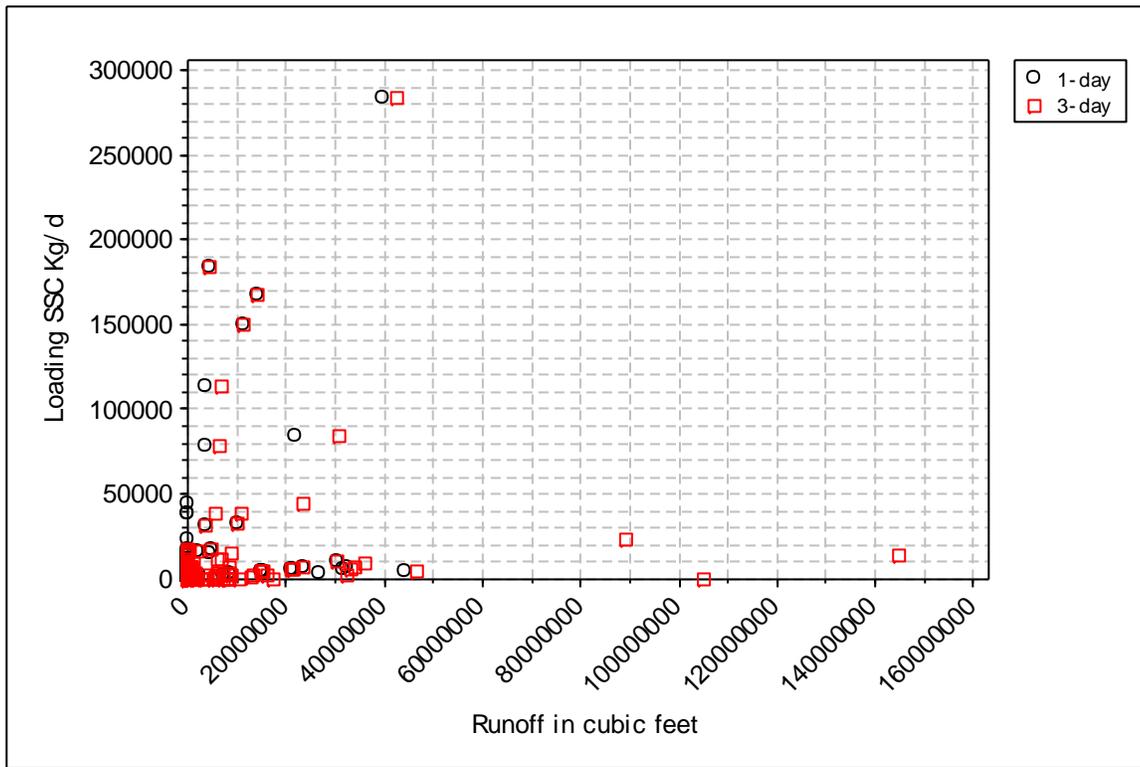
Figure 87. Estimated loading in kg SSC/d extrapolated from 1) streamflow derived from USGS gage readings and SSC measurements and 2) estimated quantities of total runoff from the upstream watershed derived from rainfall-runoff model predictions adjusted for land use and rainfall patterns.

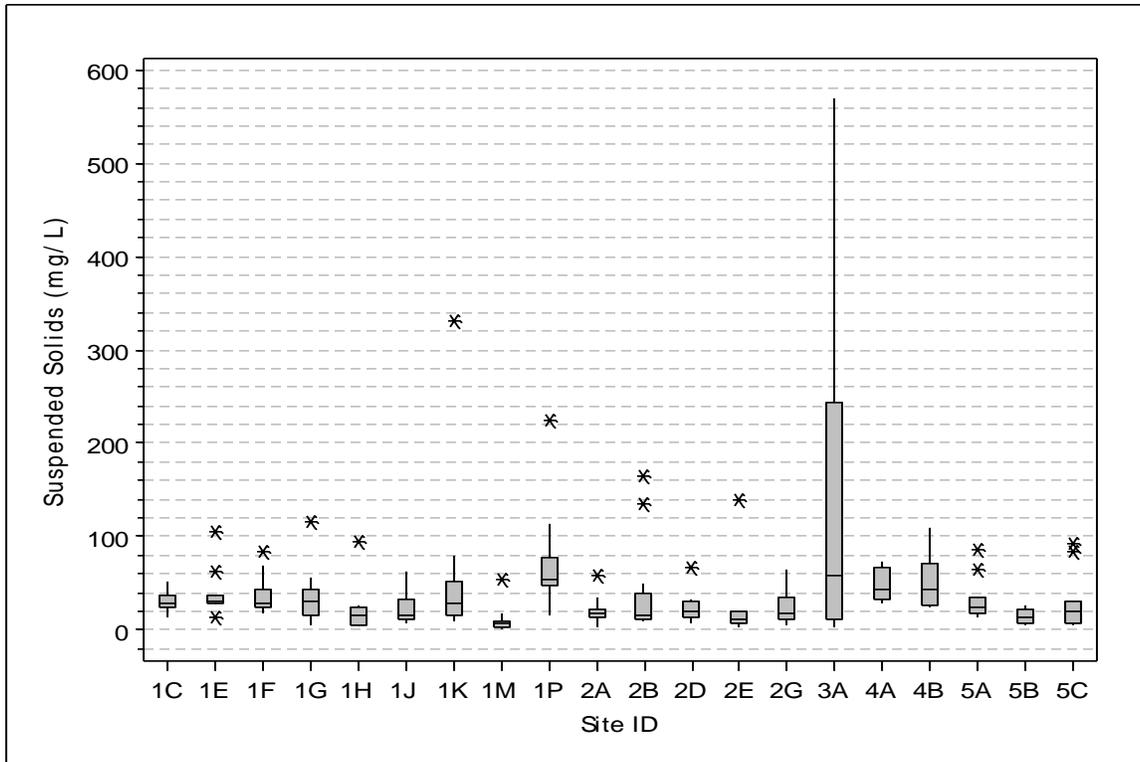
Figure 89. Distribution of suspended solids concentration (SSC) observed at each monitoring site during 2011.

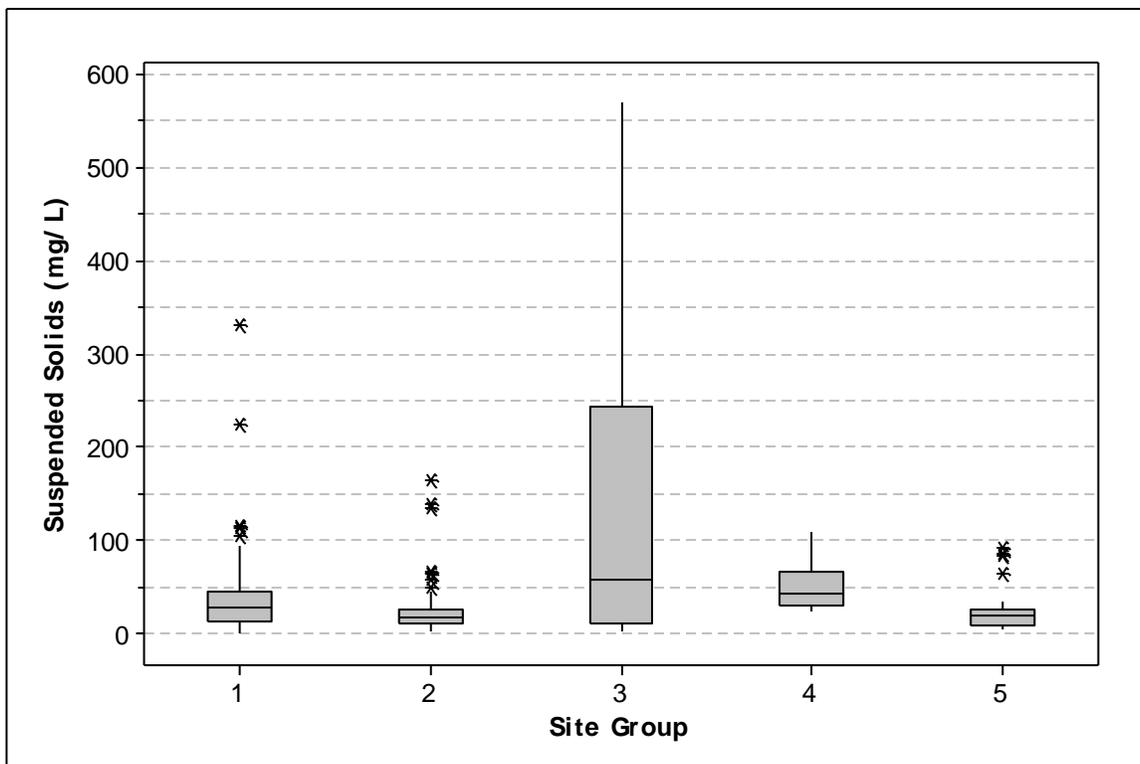
Figure 90. Distribution of SSC by site group during 2011.

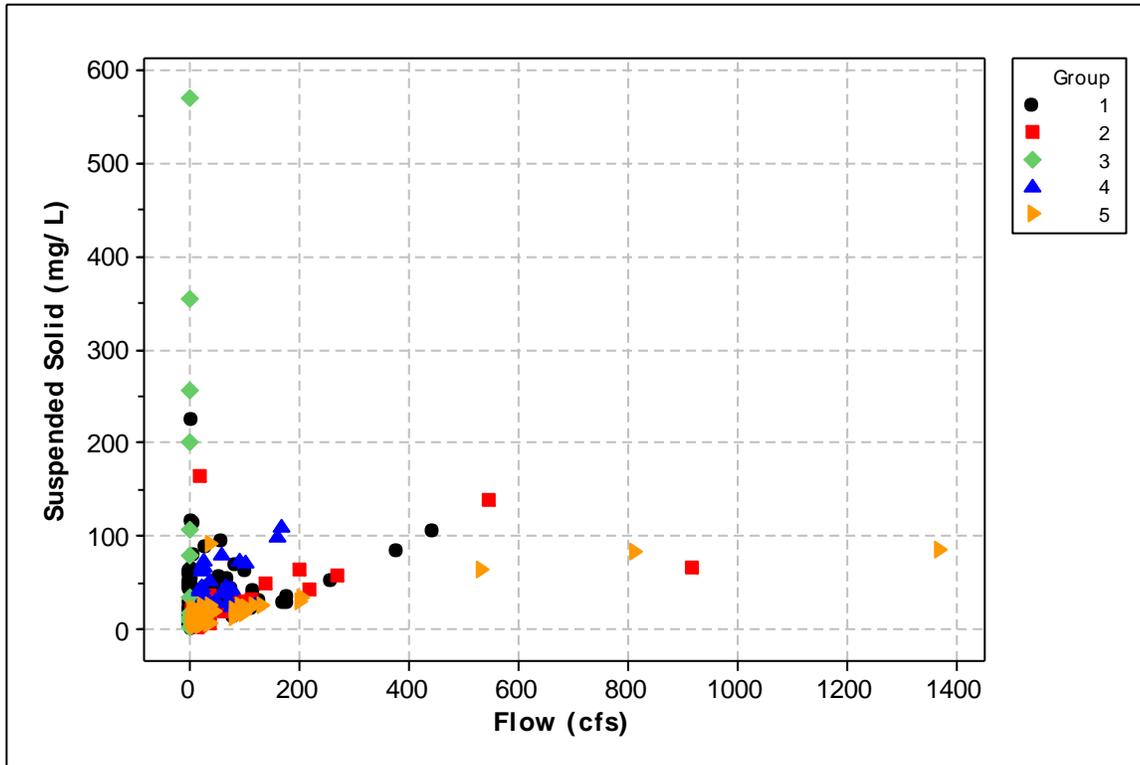
Figure 91. Relationship of measured SSC versus observed streamflow across all study sites.

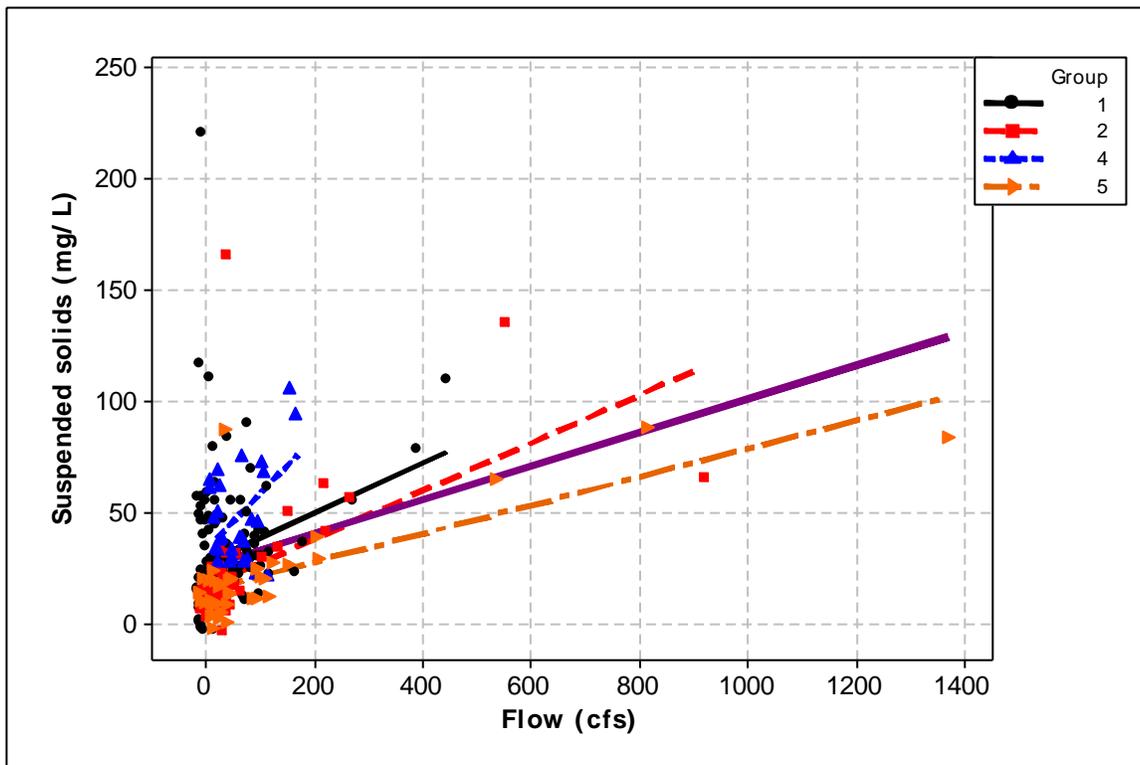
Figure 92. Relationship of measured suspended solids versus observed streamflow across all study sites excluding site 3A. Lines on graph represent linear regression model fits for each group and combined (purple line fit). Corresponding r^2 values for each group model are overall = 12.5%, 1 = 6.4%; 2 = 29.3%, 4 = 20.9%, and 5=56.0%.

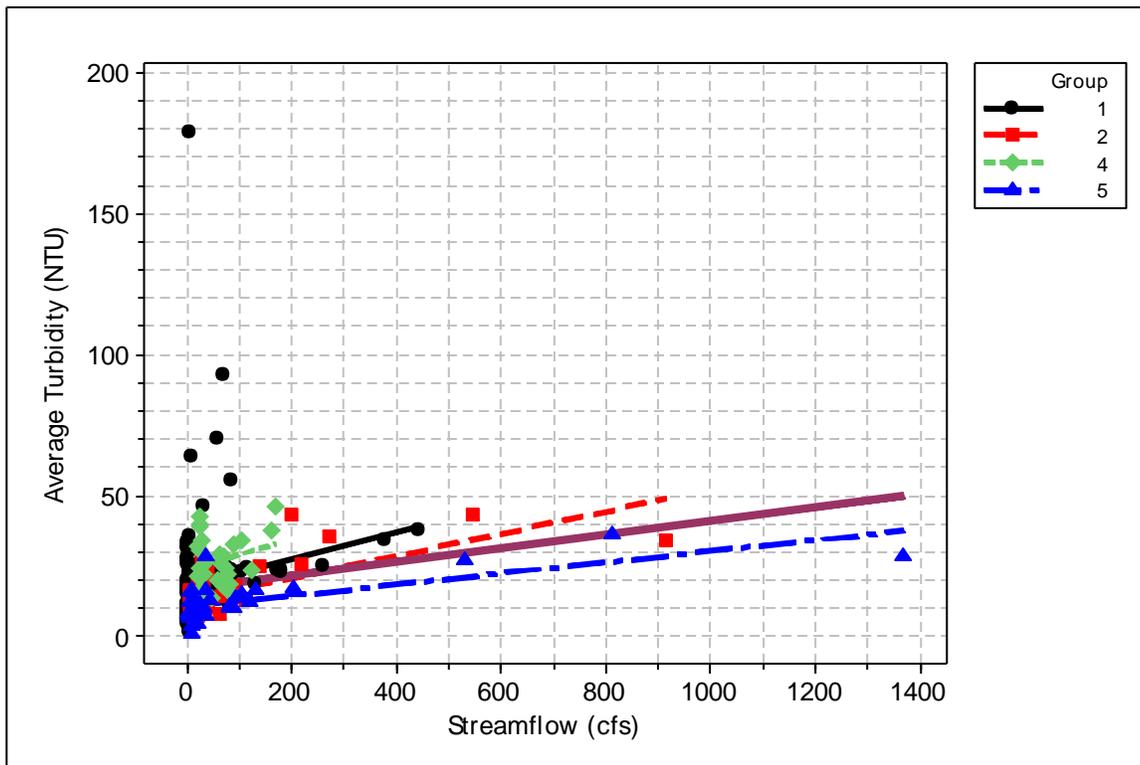
Figure 93. Relationship of measured turbidity (NTU) versus observed streamflow across all study sites excluding site 3A. Lines on graph represent linear regression model fits for each group and combined (purple line fit). Corresponding r^2 values for each group model are overall = 4.5%, 1 = 2.5%; 2 = 48.4%, 4 = 6.2%, and 5=51.0%.

Similar relationships were observed between turbidity (NTU) and streamflow and are depicted below in Figure 93.

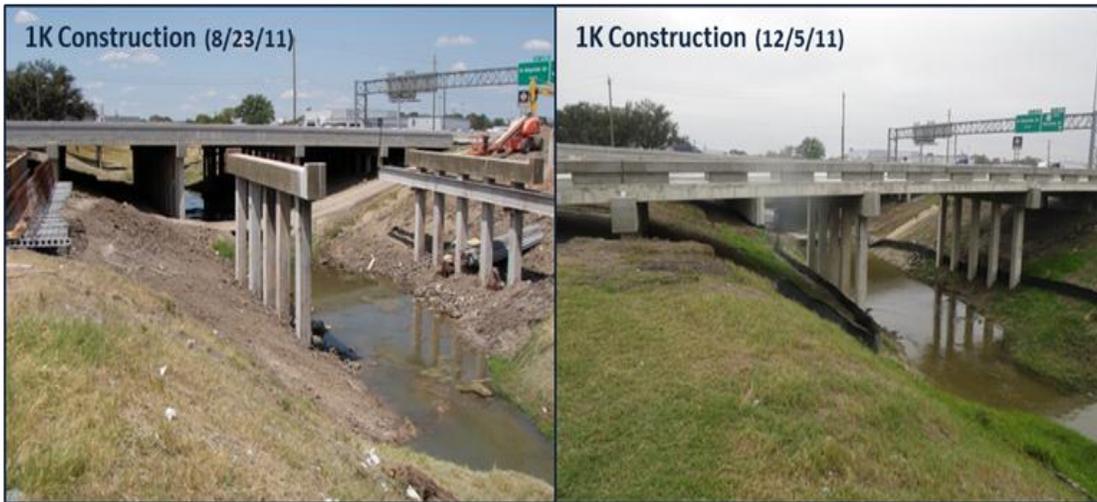
Figure 94. Example of construction activity observed during the study period at site 1K.

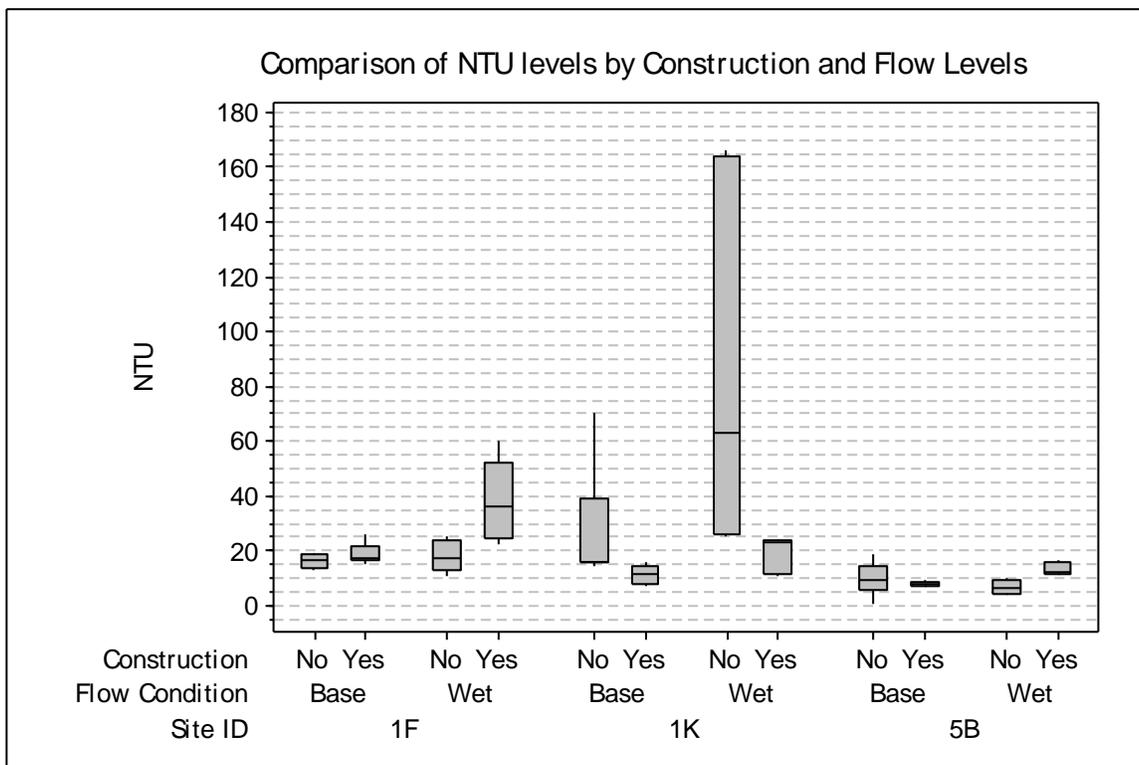
Figure 95. Comparison of NTU levels at sites where construction activities were observed during varying streamflow conditions.

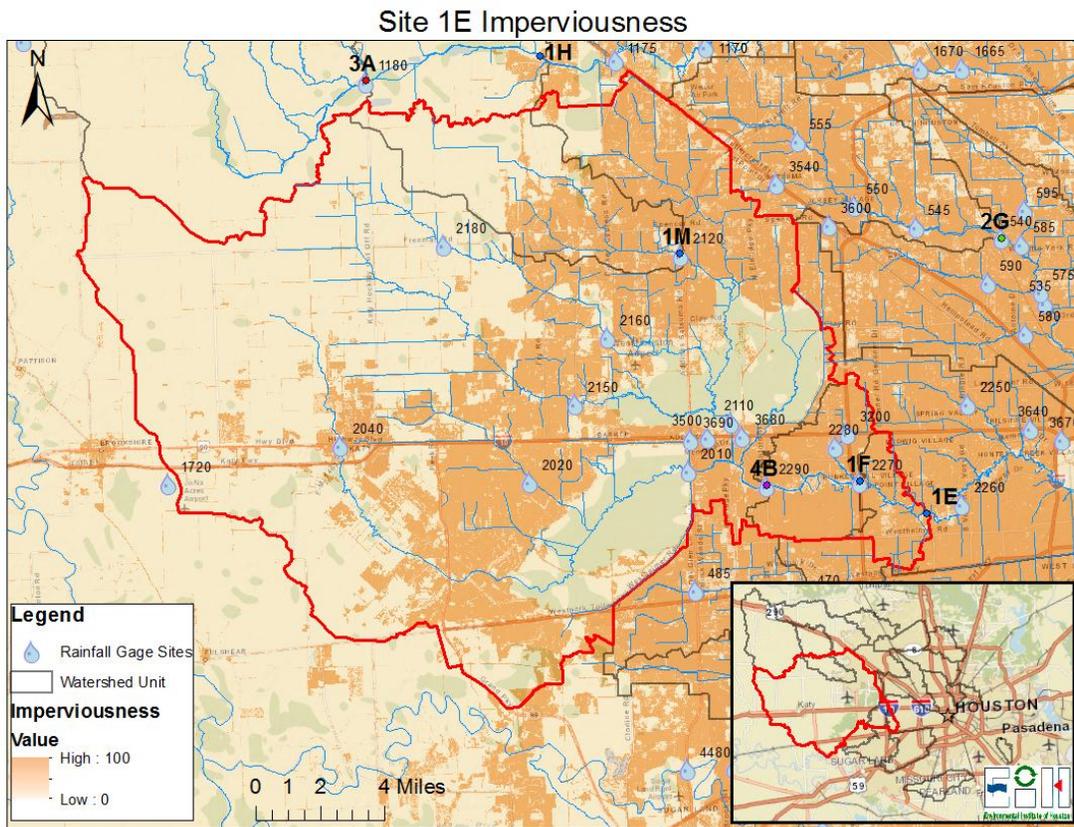
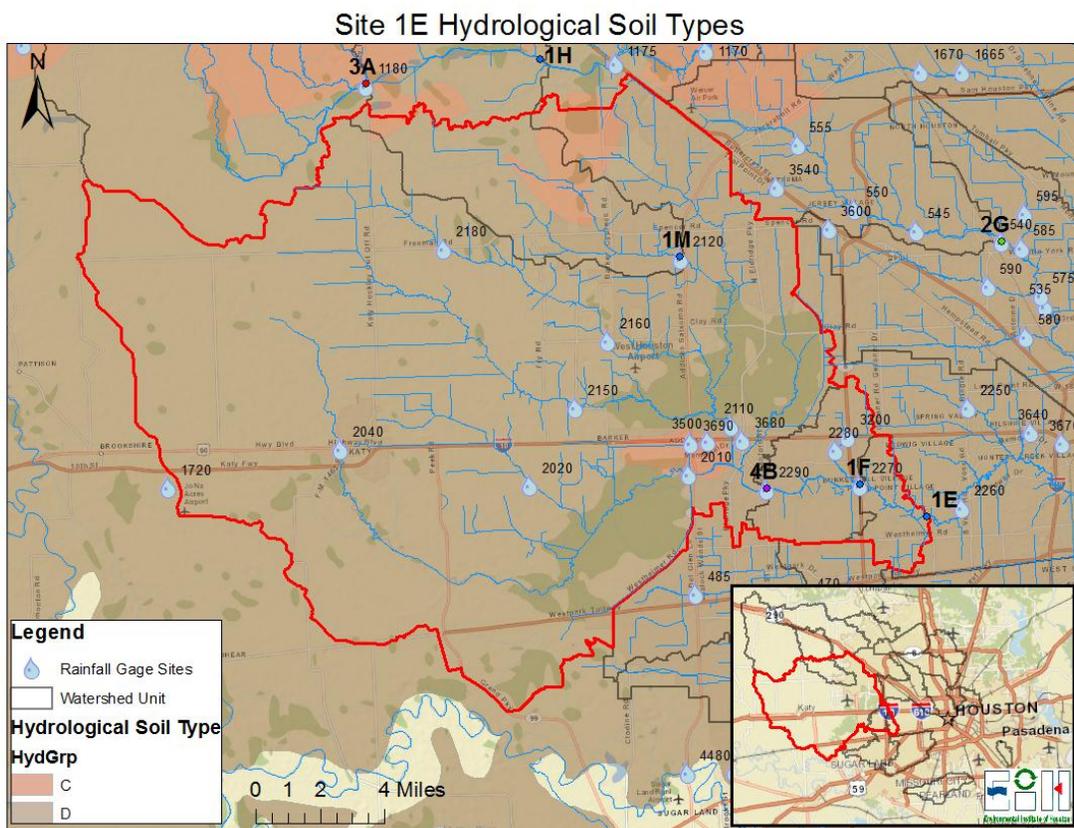
Figure A7.2. Site 1E imperviousness and hydrological soil types.

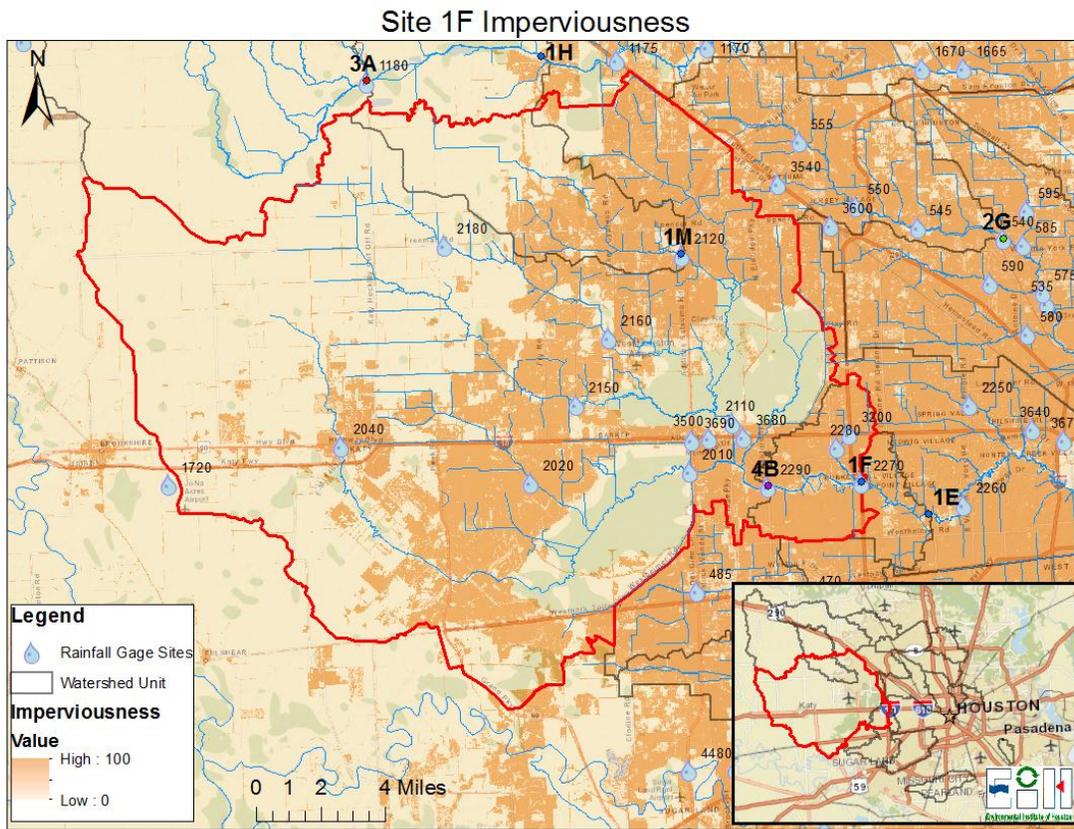
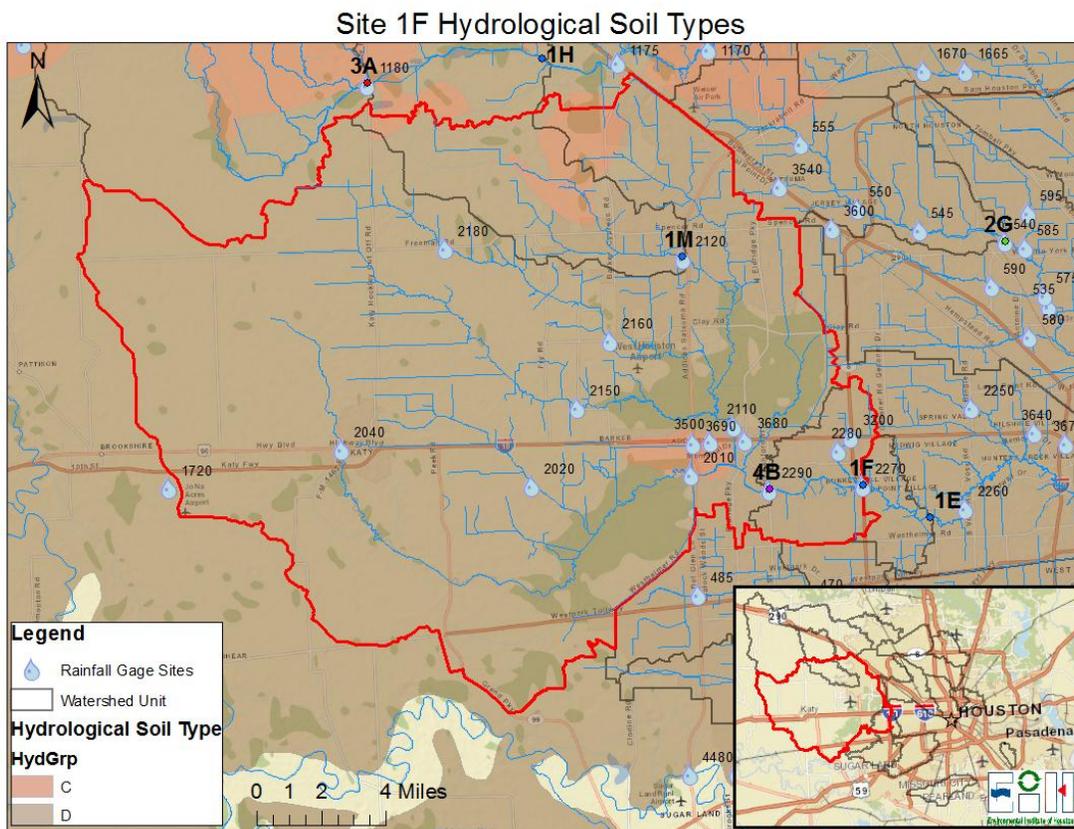
Figure A7.3. Site 1F imperviousness and hydrological soil types.

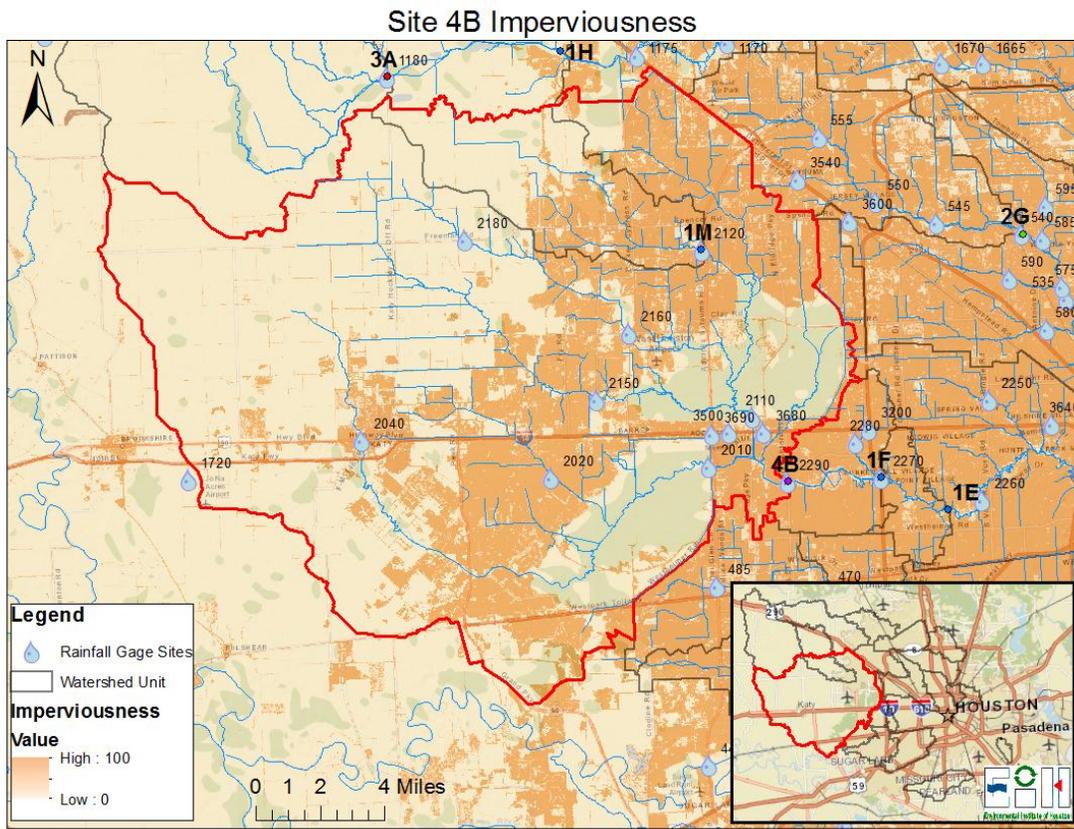
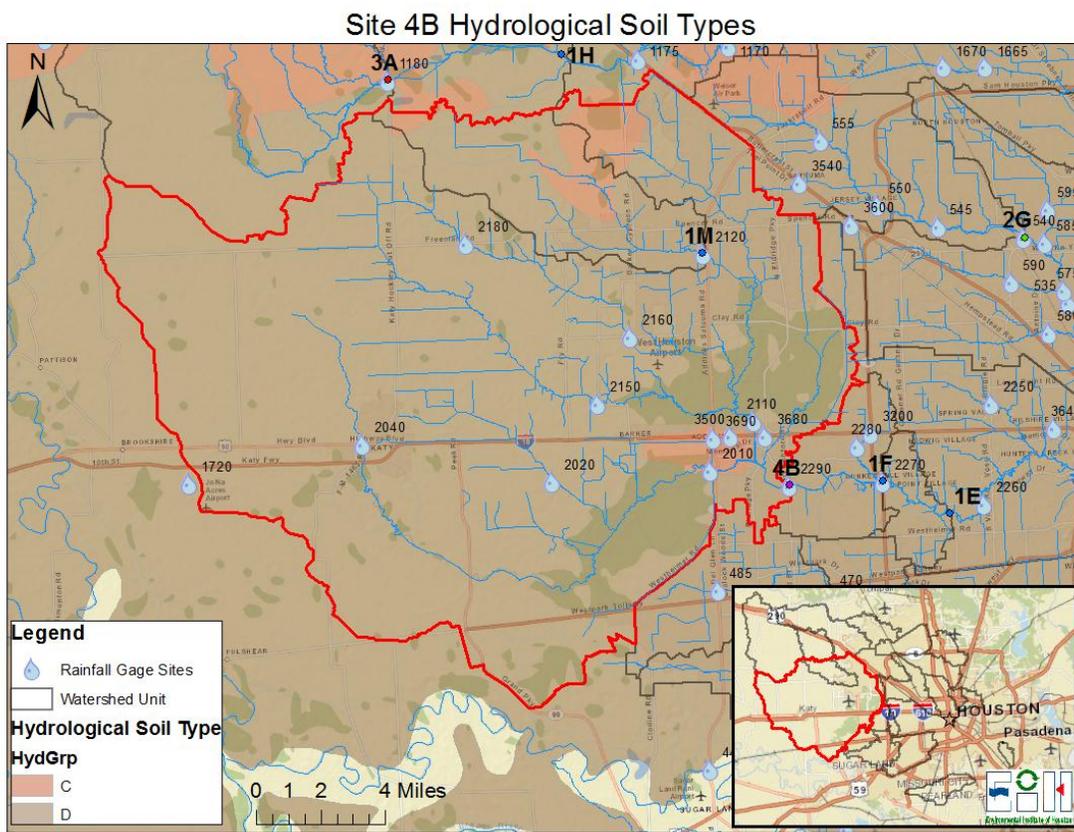
Figure A7.17. Site 4B imperviousness and hydrological soil types.

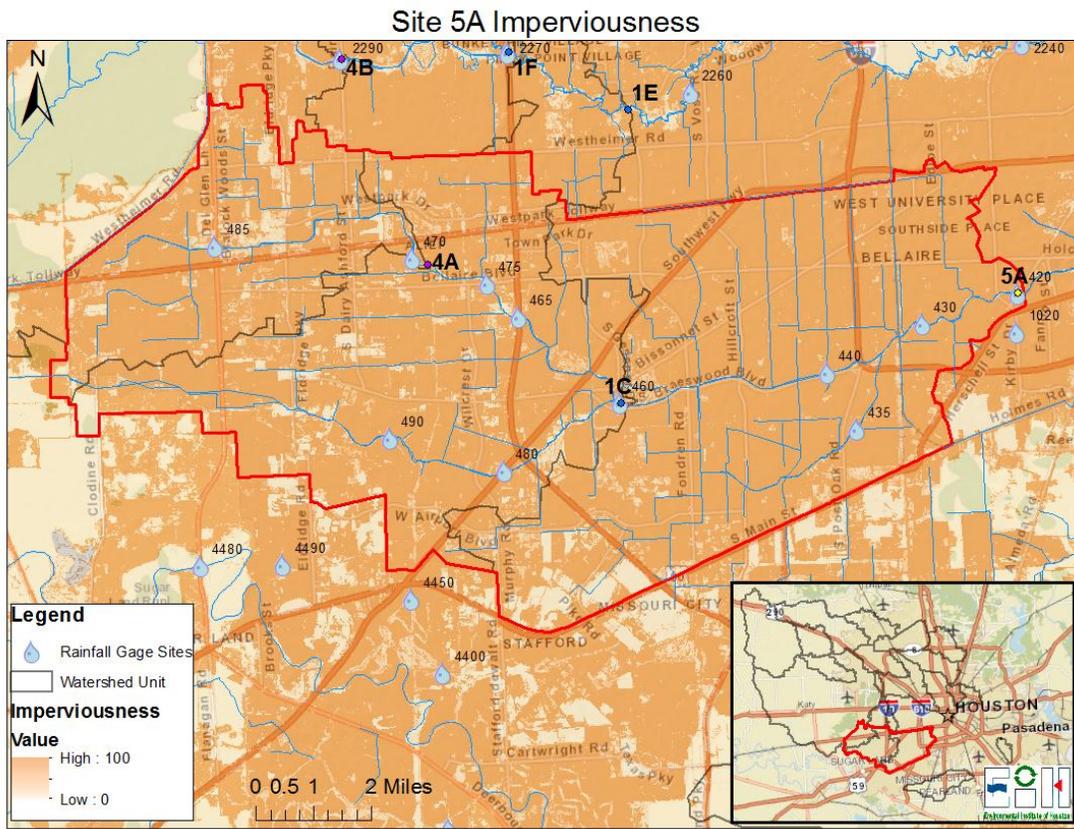
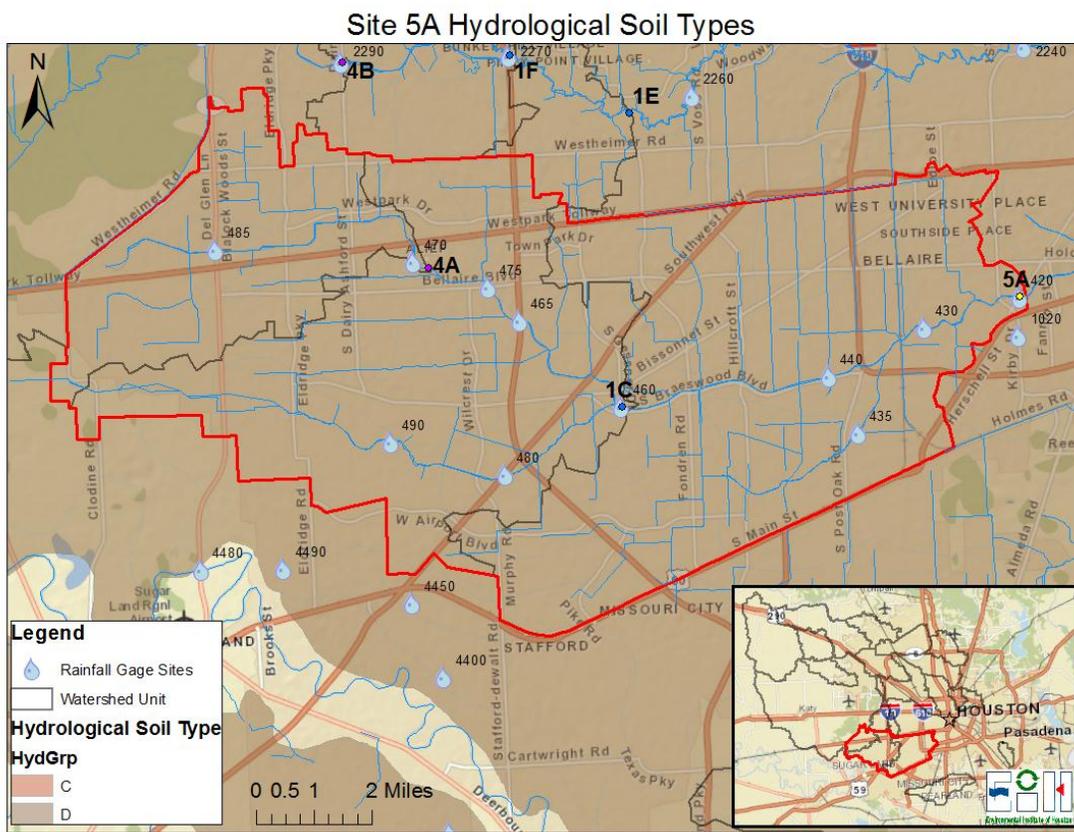
Figure A7.18. Site 5A imperviousness and hydrological soil types.
