Springwoods Subdivision Study Final Report

Prepared in cooperation with the Harris County Flood Control District
Project ID: Z100-00-00-Y053

EIH Technical Report # 12-003a

Environmental Institute of Houston
University of Houston-Clear Lake

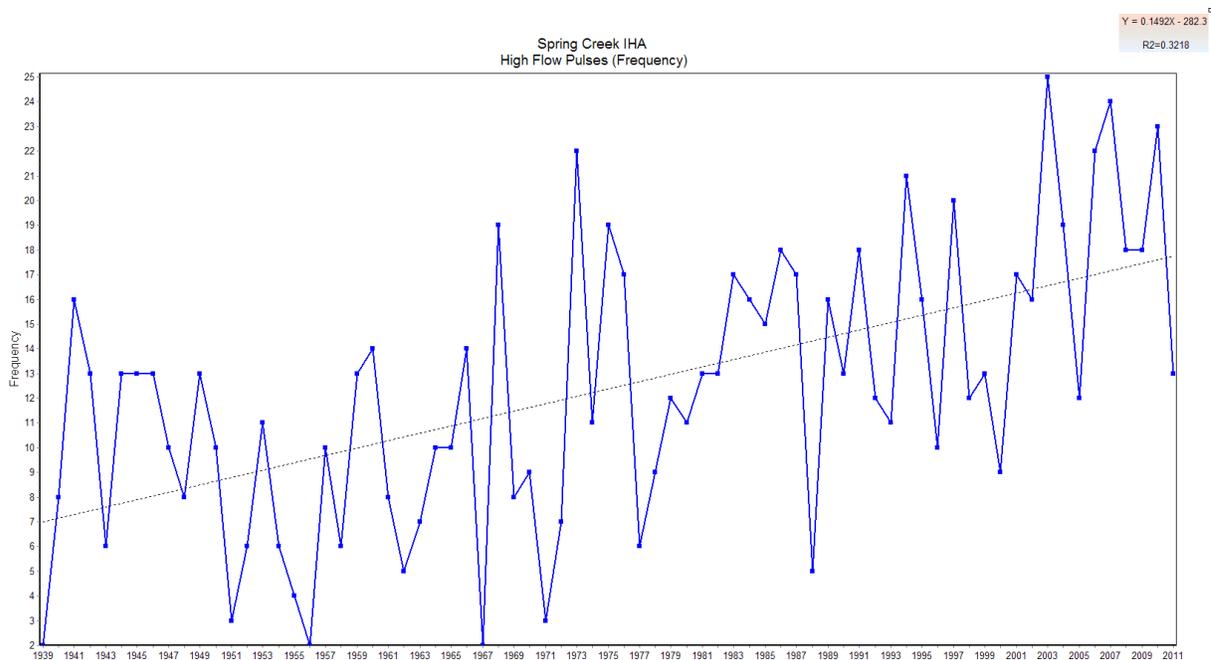
Figure 4. Annual frequency of daily high flow pulses recorded at the USGS 08068500 Spring Creek gage based on IHA software analysis.

In order to evaluate trends in hydrology EIH utilized the Index of Hydrologic Alteration (IHA) to evaluate selected flow regime indices of the stream (Gao et al. 2009; The Nature Conservancy 2009). In particular EIH estimated the number of high flow pulses that occurred annually using the IHA algorithm that classifies high flows as any daily average flow exceeding the 75th percentile of all daily flows recorded during the period of record. The period of record examined was from 1939 through 2011. Based on the IHA algorithm the flow gage records indicate urbanization has steadily increased and affected the rainfall runoff relationship in this watershed (Figure 4). High flow events have increased over time suggesting the stream has become flashier responding quickly to rainfall events.

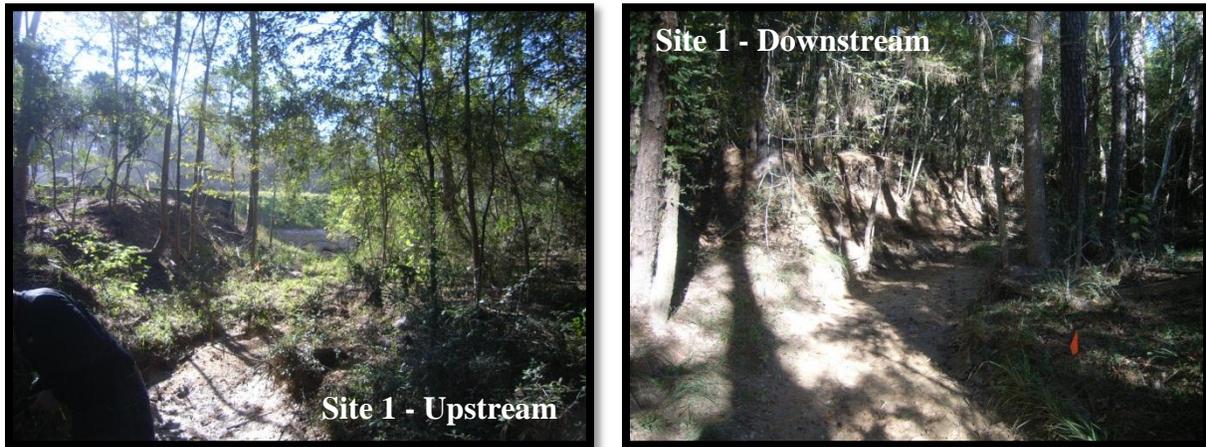
Figure 5. Upstream (left) and downstream (right) view of site 1 stormwater sampling location.

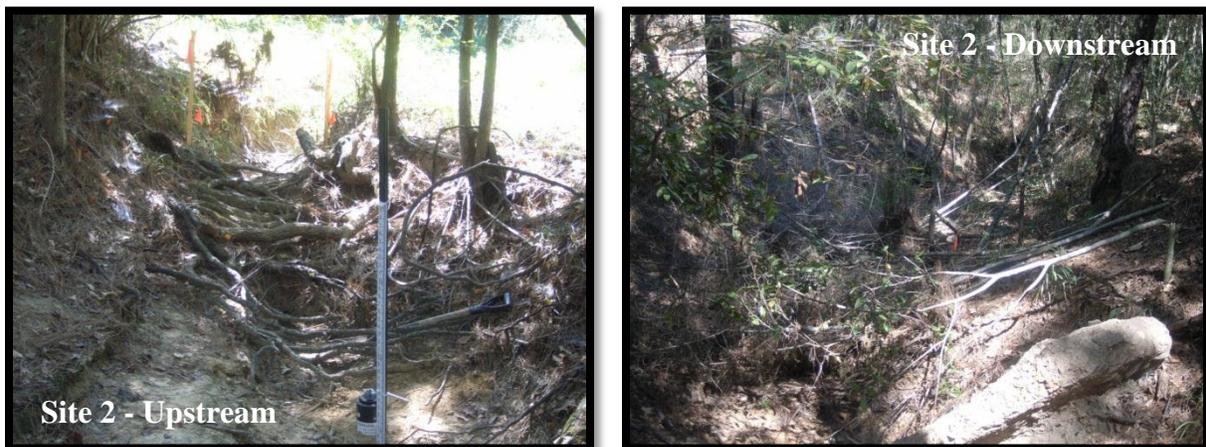
Figure 6. Upstream (left) and downstream (right) view of site 2 stormwater sampling location.

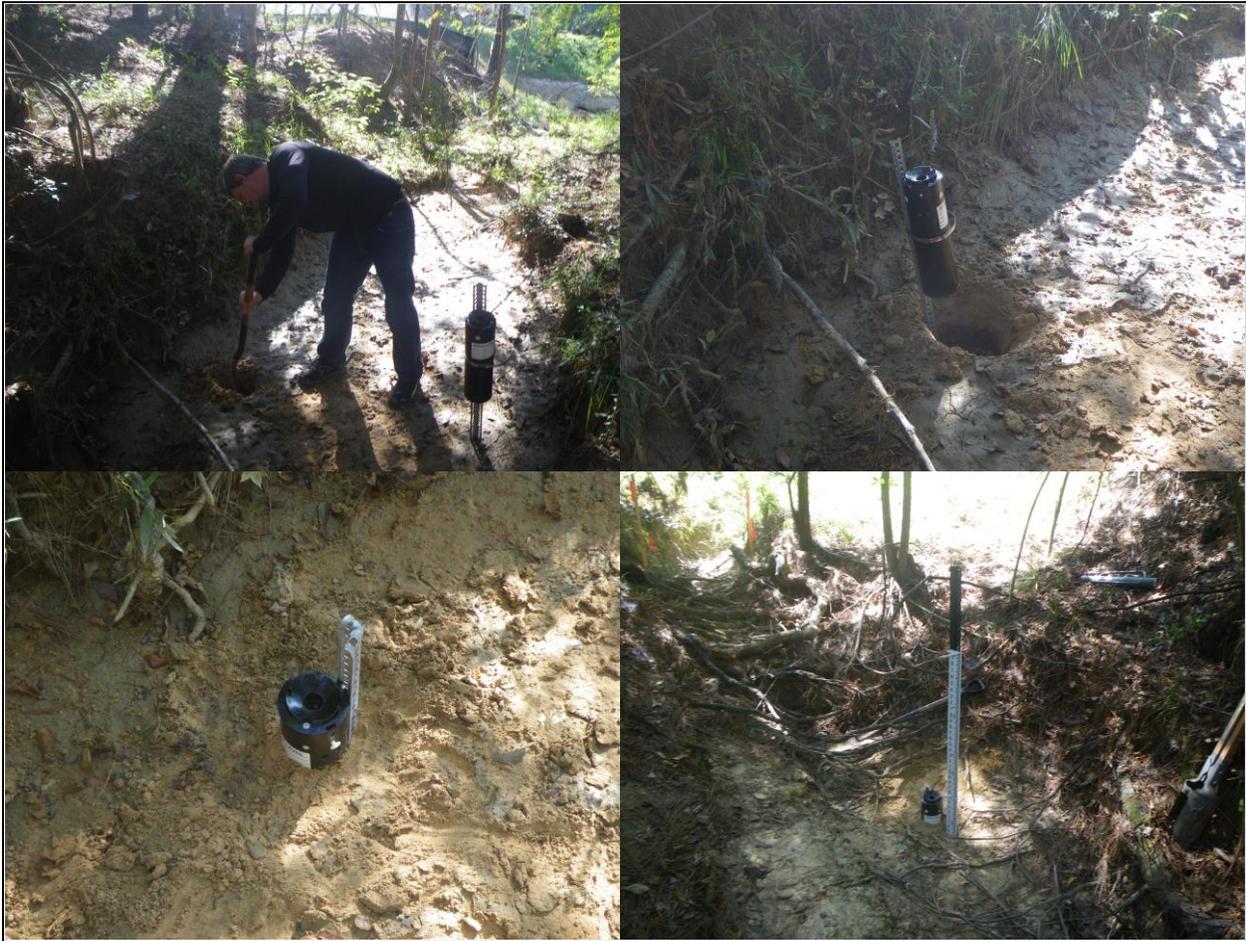
Figure 9. Deployment of the stormwater sampler used during this study.

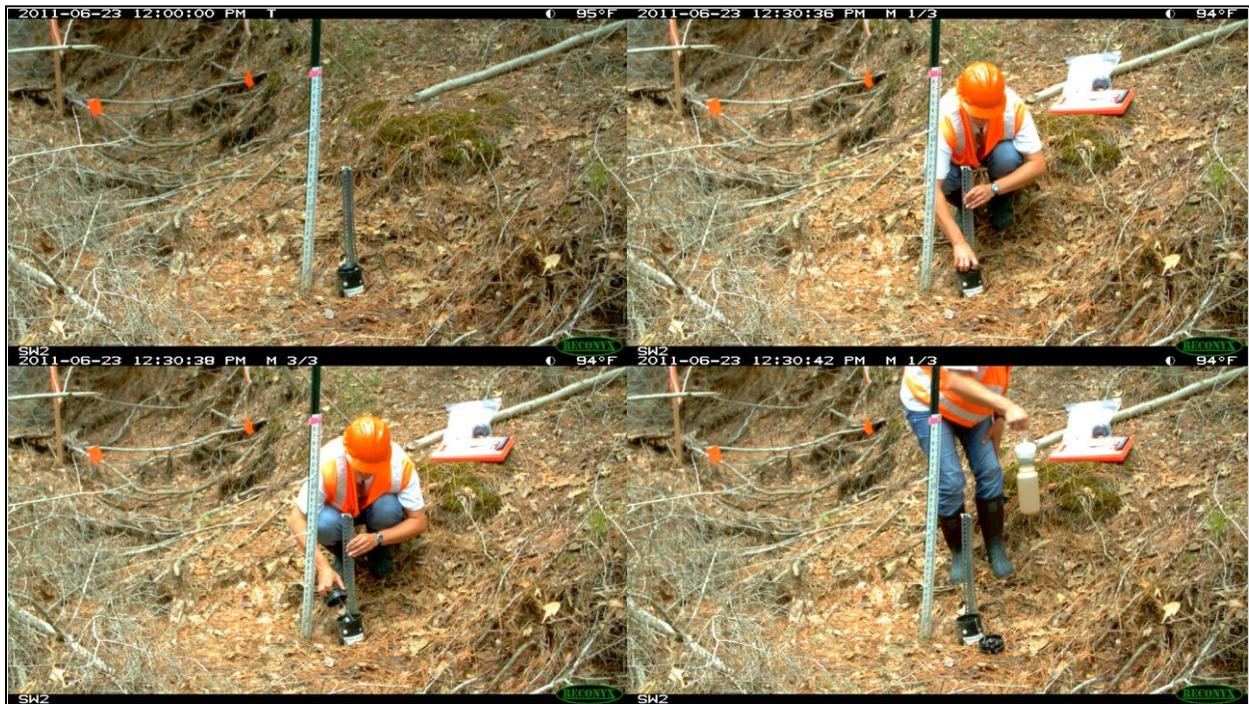
Figure 10. Retrieval of stormwater sample at Site 2.

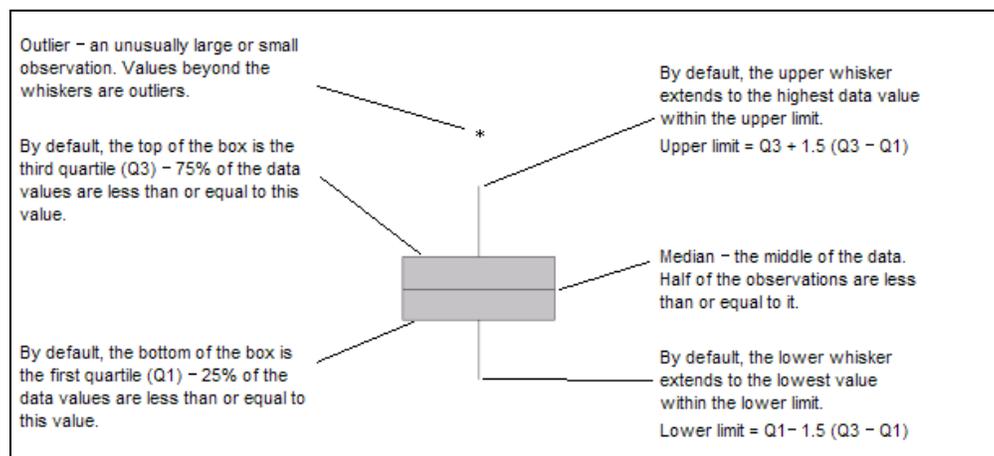
Figure 11. Illustration of boxplot used to analyze distribution of data.

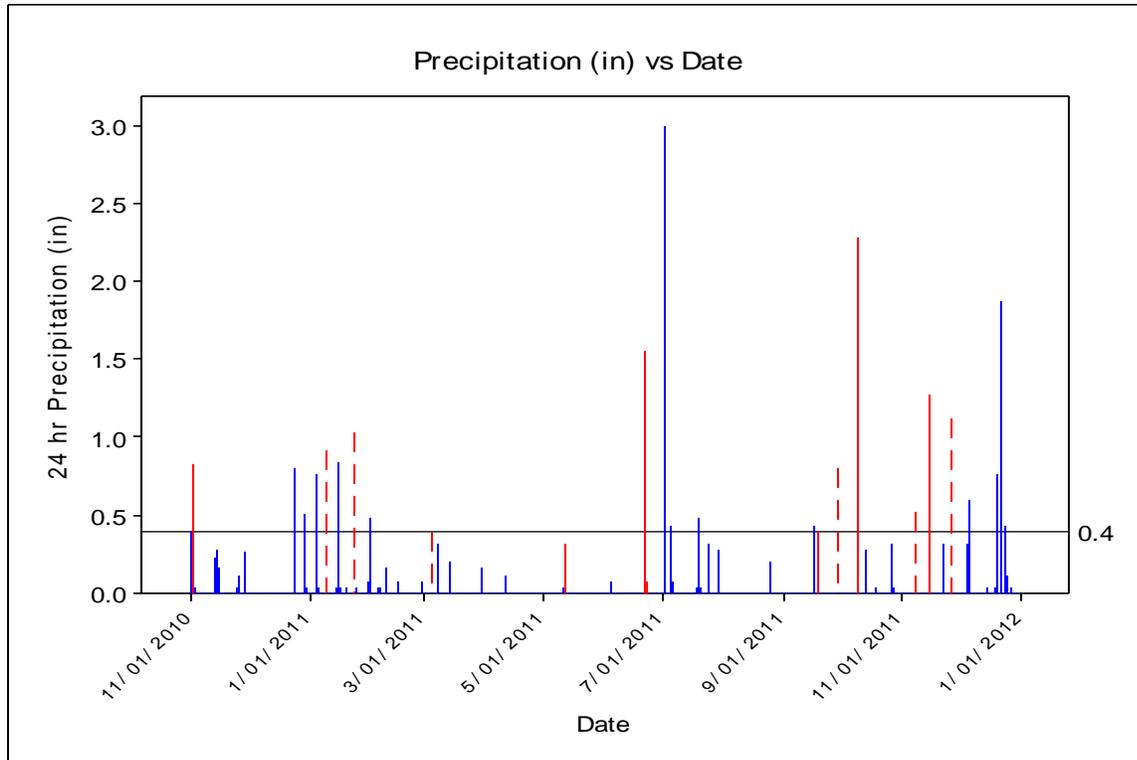
Figure 12. Recorded 24 hour precipitation at the HCFCF 1050 rain gage co-located at the USGS 08068500 site on Spring Creek and I-45. Red lines denote dates when sampling was conducted at the site. Dashed red lines denotes dates when unsuccessful sampling attempts were made on that date or afterwards. The horizontal reference line is the 0.4 inch decision level for sampling when combined with 72 previous hours of dry weather.

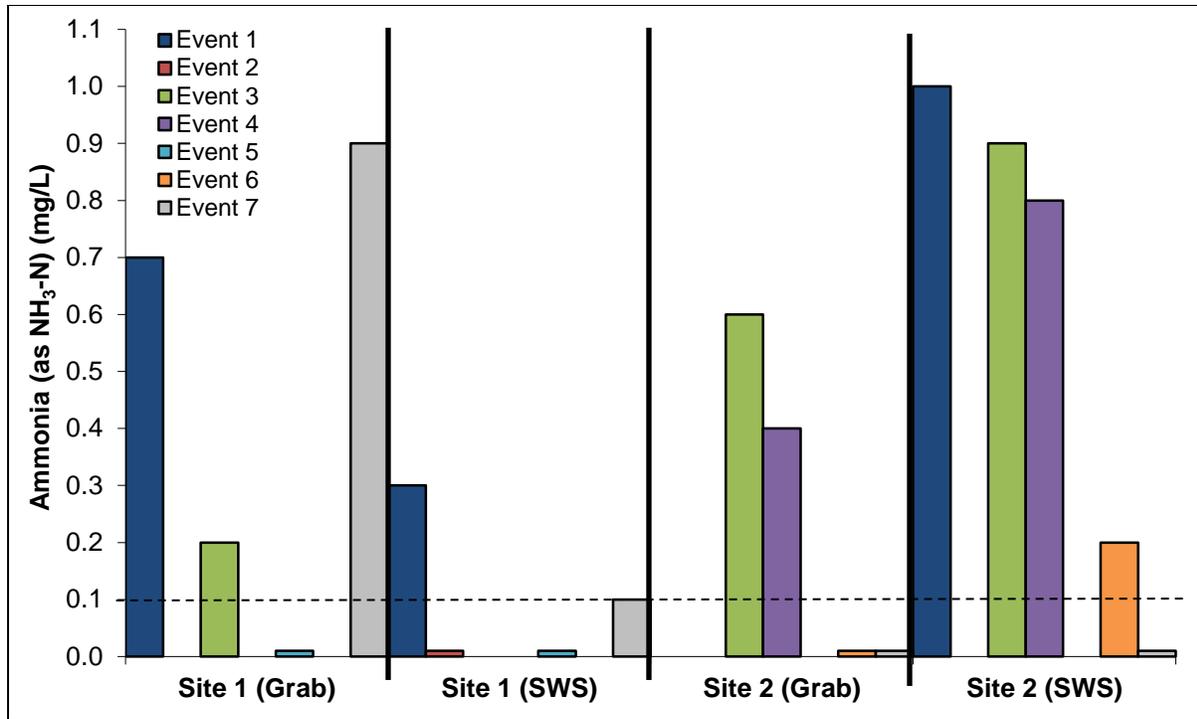
Figure 13. Ammonia nitrogen levels in runoff during rainfall events. Dashed line represents detection limit for this test (<0.01 mg/L); values below this line indicate presence at levels below the detection limit. Grab = grab samples; SWS = stormwater sampler.

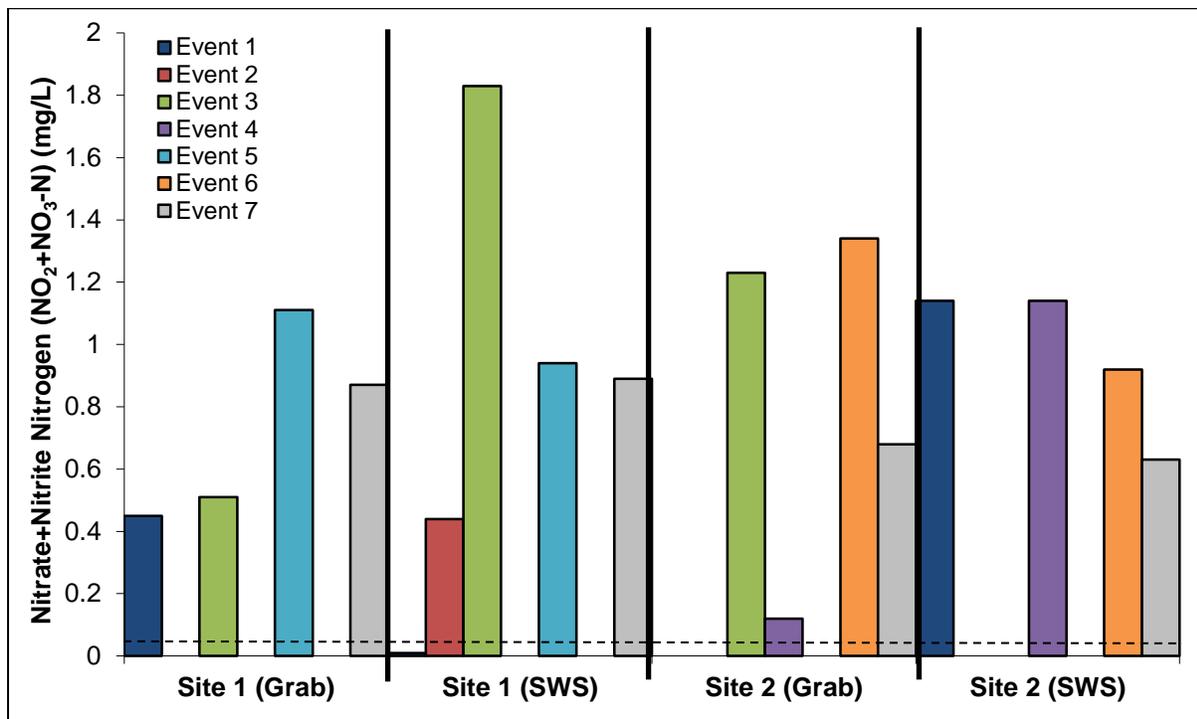
Figure 14. Nitrate and nitrite nitrogen levels in runoff during rainfall events. Dashed line represents detection limit for this test (<0.04 mg/L); values below this line indicate presence at levels below the detection limit. Grab = grab samples; SWS = stormwater sampler.

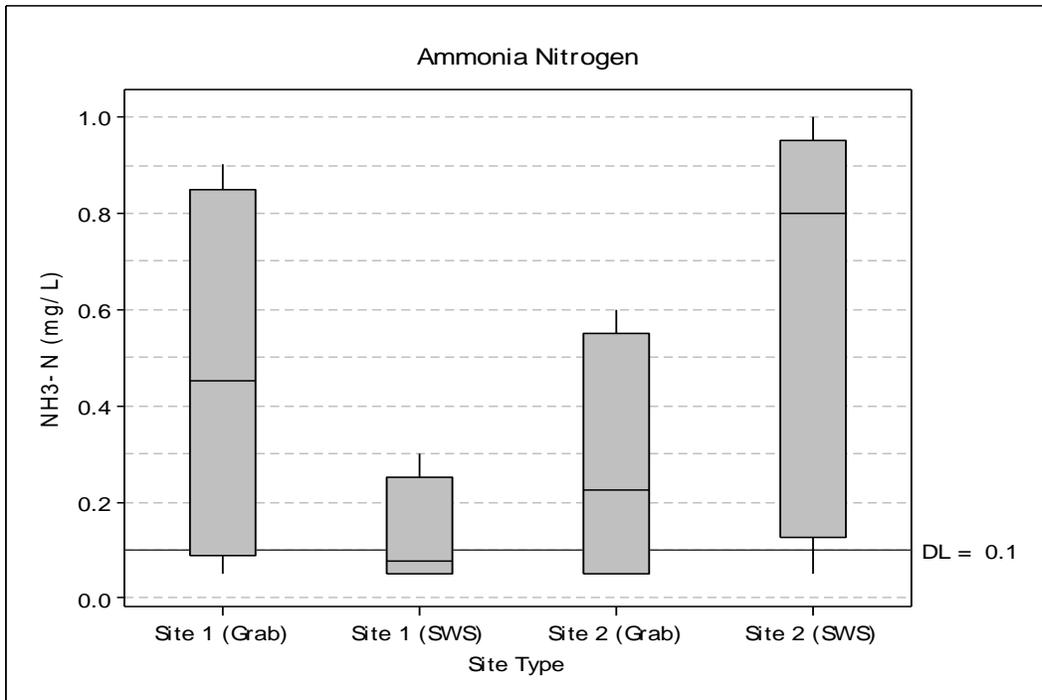
Figure 15. Boxplot of ammonia nitrogen levels measured at each site and type of sample over all sampling periods of the study.

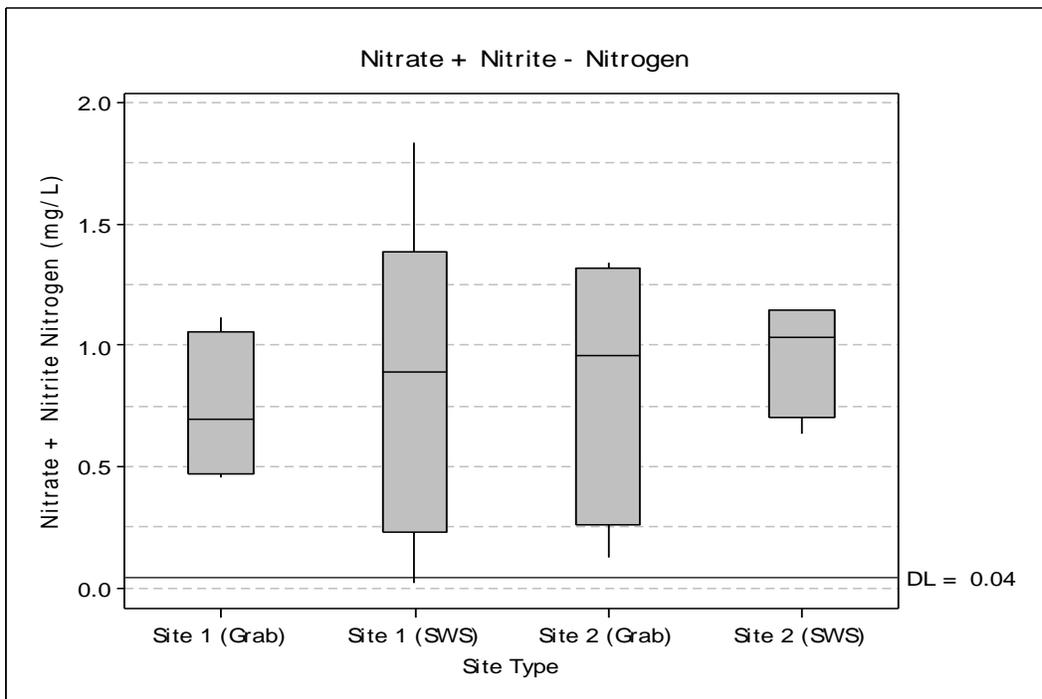
Figure 16. Boxplot of nitrate + nitrite nitrogen levels measured at each site and type of sample over all sampling periods of the study.

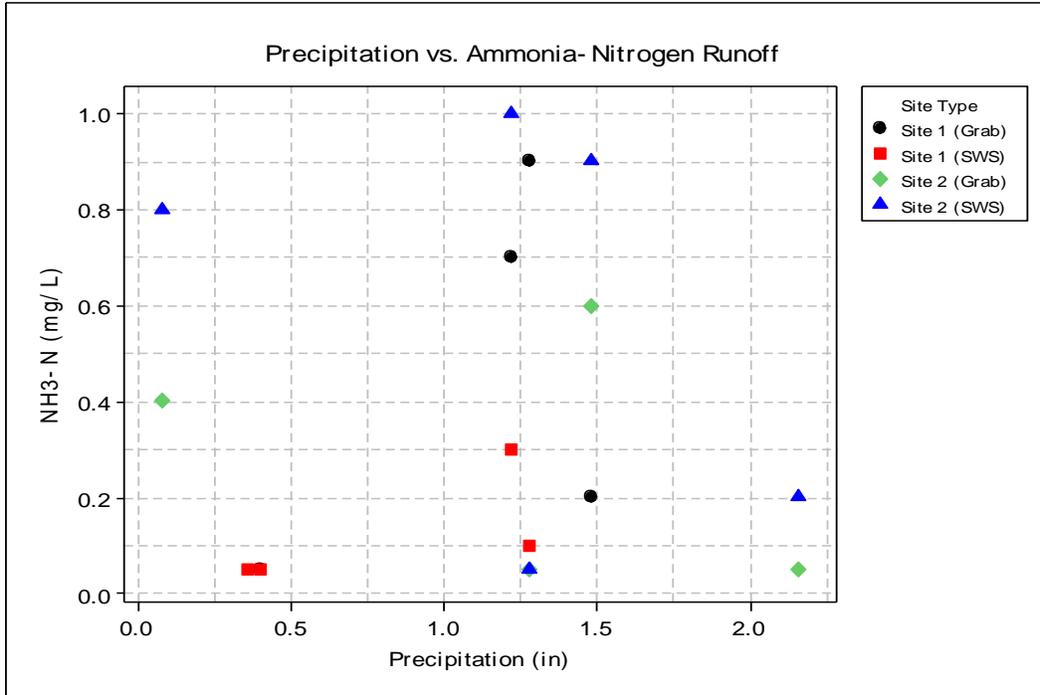
Figure 17. Relationship between precipitation and ammonia nitrogen runoff levels at each site by collection method.

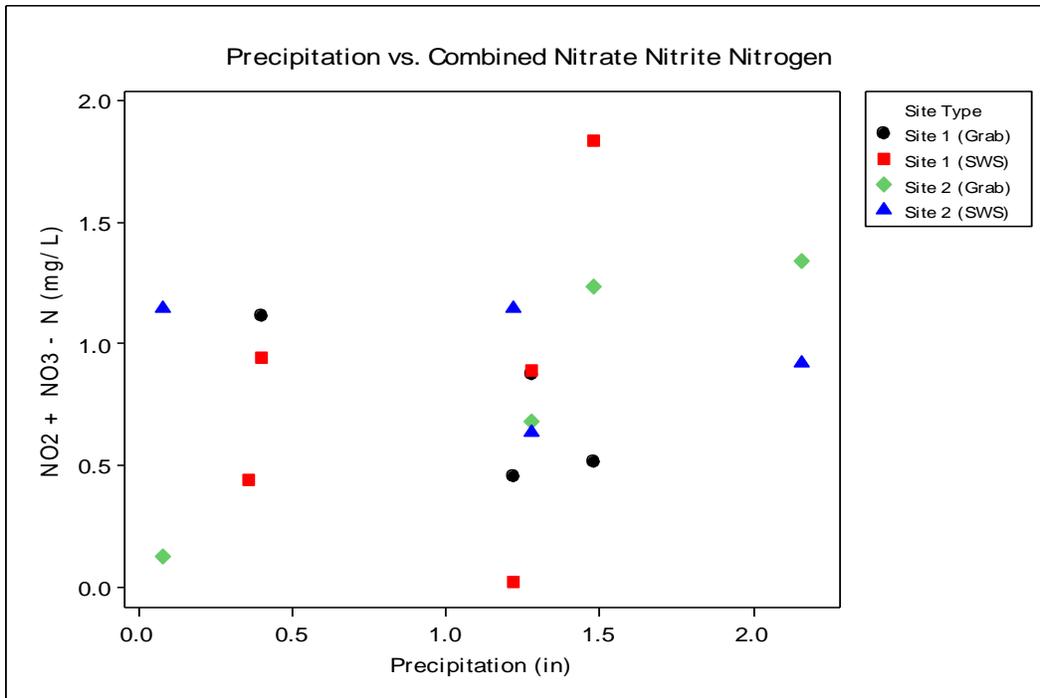
Figure 18. Relationship between precipitation and combined nitrate nitrite nitrogen runoff levels at each site by collection method.

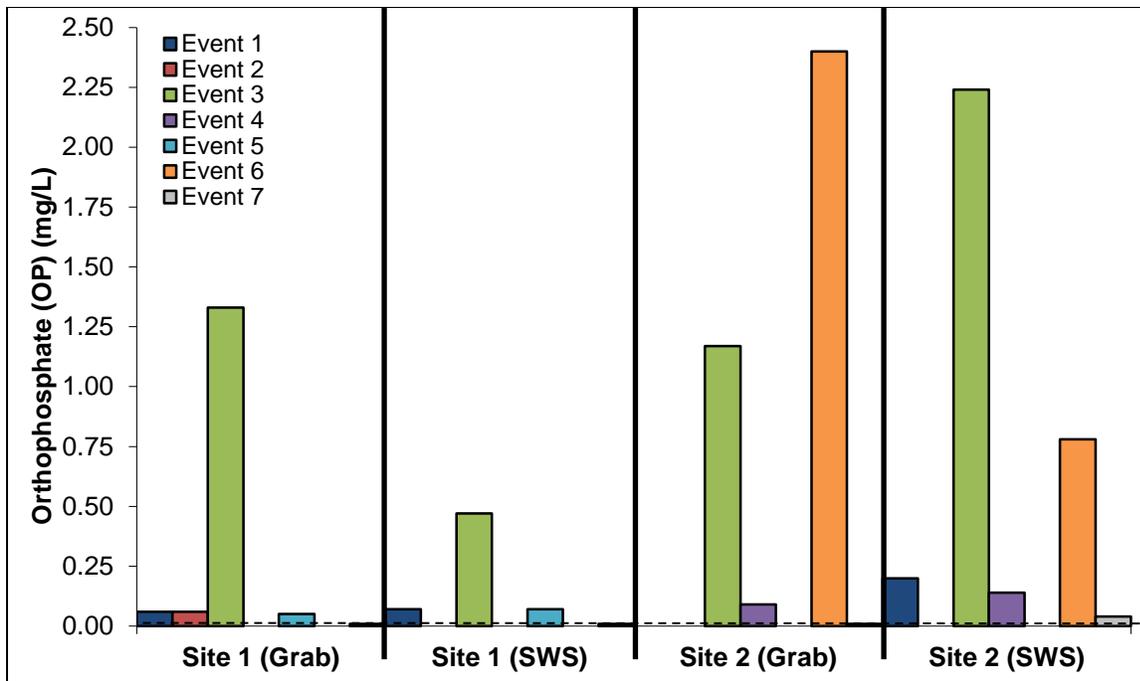
Figure 19. Orthophosphate levels in runoff during rainfall events. Dashed line represents detection limit for this test (<0.02 mg/L); values below this line indicate presence at levels below the detection limit. Grab = grab samples; SWS = stormwater sampler.

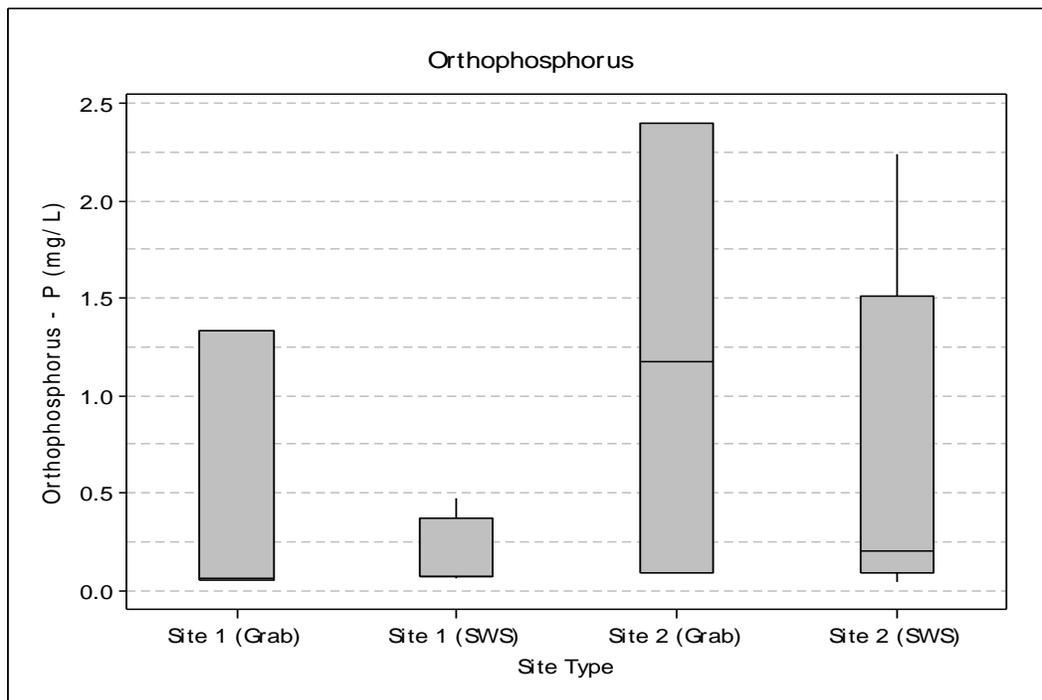
Figure 20. Boxplot of orthophosphorus levels measured at each site and type of sample over all sampling periods of the study.

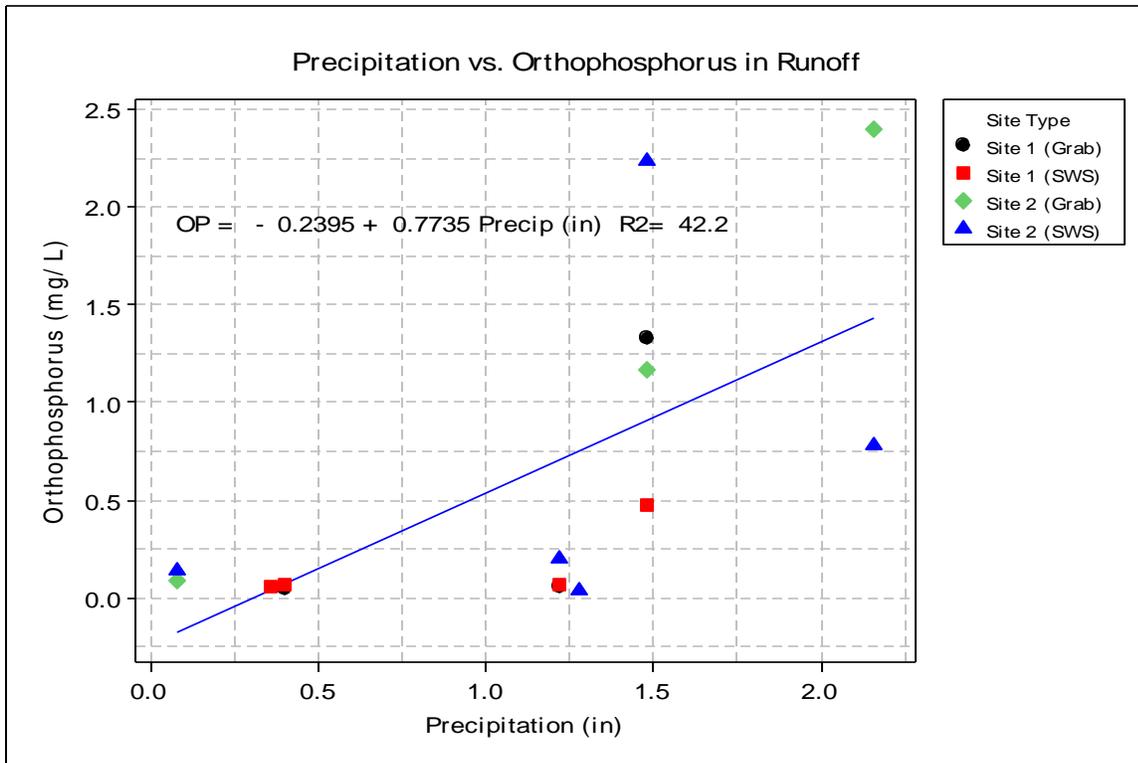
Figure 21. Relationship between precipitation and orthophosphorus levels in runoff at each site by collection method. Slope of regression line was significant at p = 0.009.

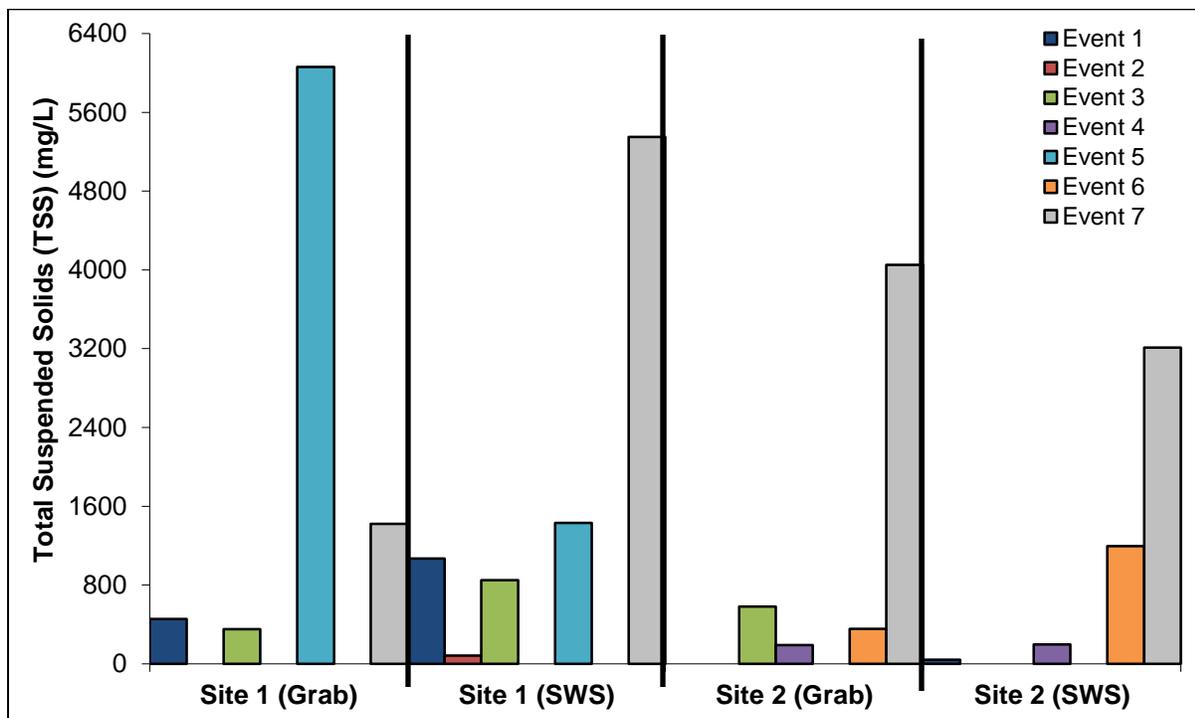
Figure 22. Total suspended solid levels in runoff during rainfall events. Grab = grab samples; SWS = stormwater sampler.

During the early phases of the project, measured runoff flows and suspended solids were generally lower, but gradually increased through time as new development occurred at both sites (Figure 22 and Figure 23, and Figure 53 to Figure 82). This trend was first observed at site 1 and subsequently after June, 2011 at site 2 as well. The ultimate cause of increased sediments and turbidity appears to be increased road construction near each site. The background levels of each monitored pollutant were likely only present near the beginning of the project before road construction activity had begun at each site. In the case of site 1, it appears that construction activity had already affected water quality at the site before sampling started. At site 2, observed turbidity in the field, and associated turbidity measurements increased near the end of the project and were likely associated with the increased road construction that were observed on 11/15/12 (Figure 22 and Figure 23; Figure 76 to Figure 78). The general appearance of the turbid water at both sites was a yellowish clay color.

The TSS levels measured during this study appeared to peak during the high rainfall events, and seldom fell below 200 mg/L (Figure 22, Figure 24 and Figure 26). This pattern was observed most often at site 1, which was adjacent to more active construction activity. In contrast Guillen et al. (2012) found that for waterbodies in Harris County TSS values seldom exceeded 100 mg/L, with an overall median value of 21.2 mg/L. They also found that TSS increased as a percentage of the maximum flow in a stream. These data suggest that erosion of soil and/or road material was occurring at both sites. Based on water quality monitoring data, increased transport of surface sediments was occurring at site 1 and to a lesser extent site 2. This trend probably reflects increased road construction activity.

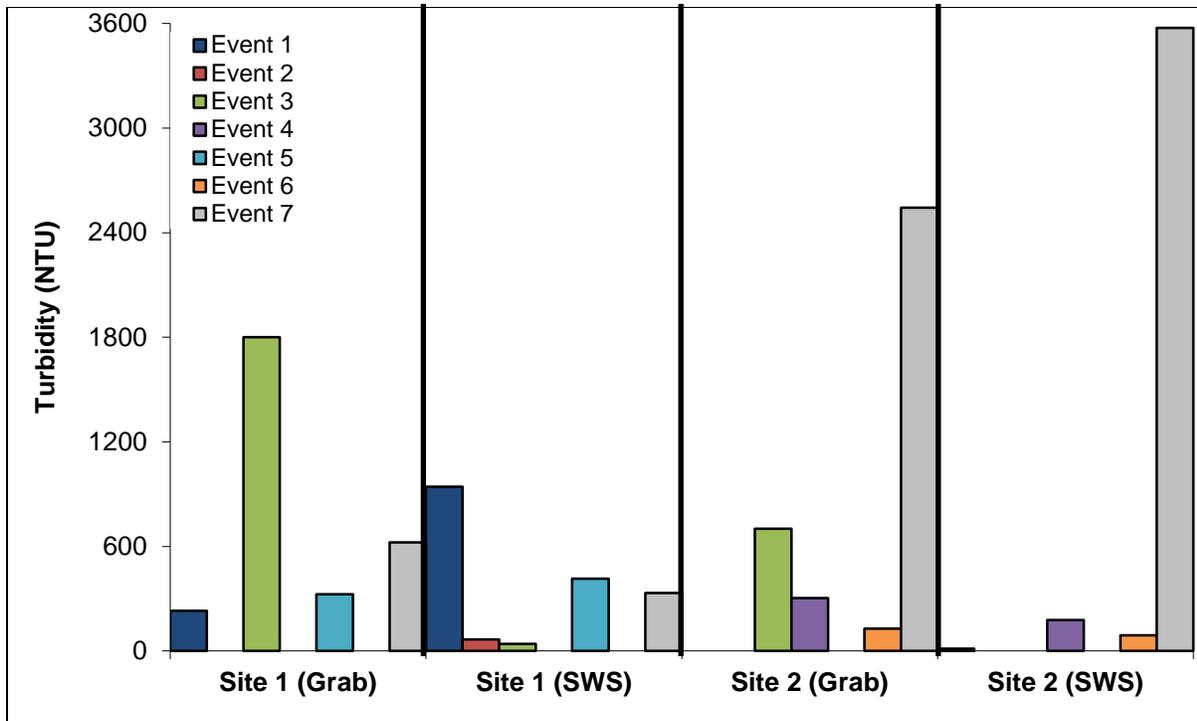
Figure 23. Turbidity levels in runoff during rainfall events. Grab = grab samples; SWS = stormwater sampler.

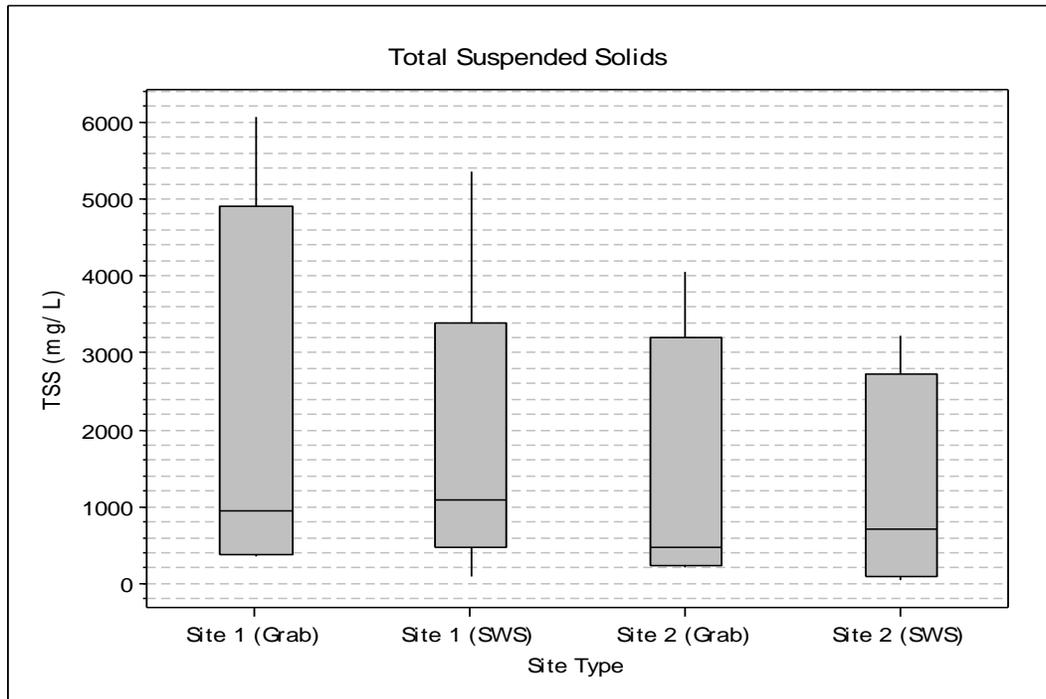
Figure 24. Boxplot of total suspended solids (TSS) levels measured at each site and type of sample over all sampling periods of the study.

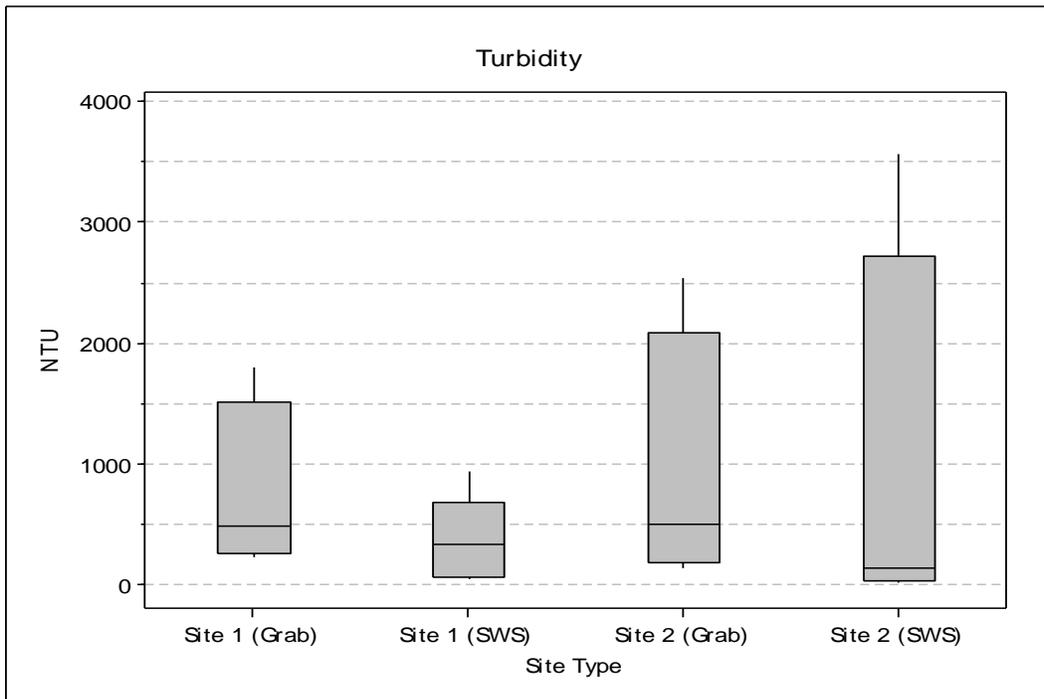
Figure 25. Boxplot of turbidity (NTU) levels measured at each site and type of sample over all sampling periods of the study

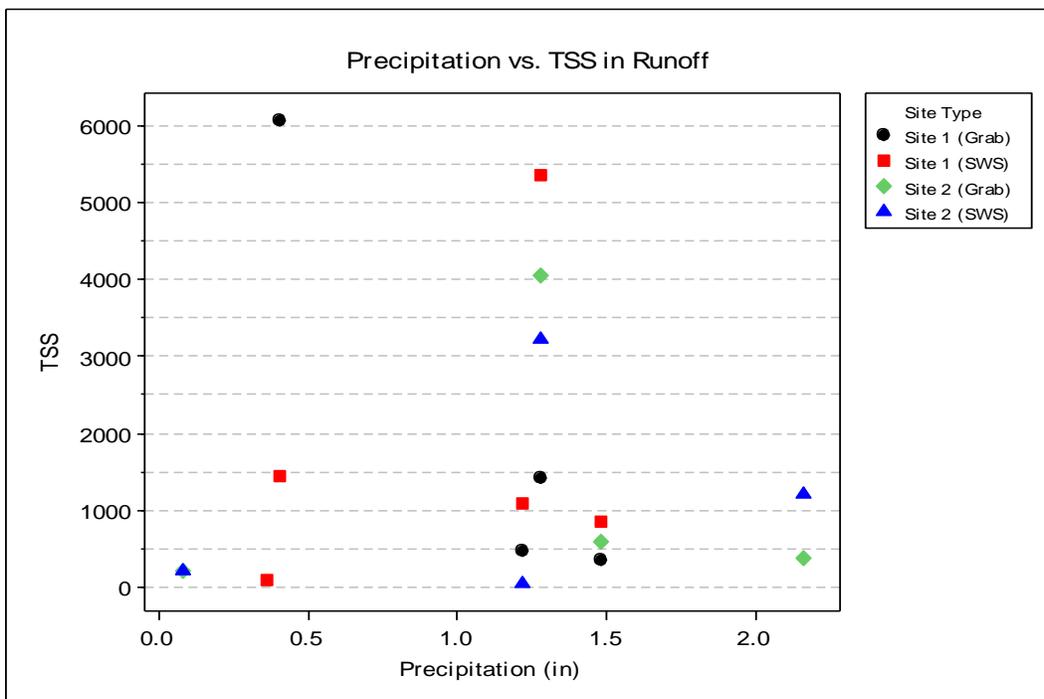
Figure 26. Relationship between precipitation and total suspended solids (TSS) levels in runoff at each site by collection method. There was no significant ($p < 0.01$) linear relationship between variables.

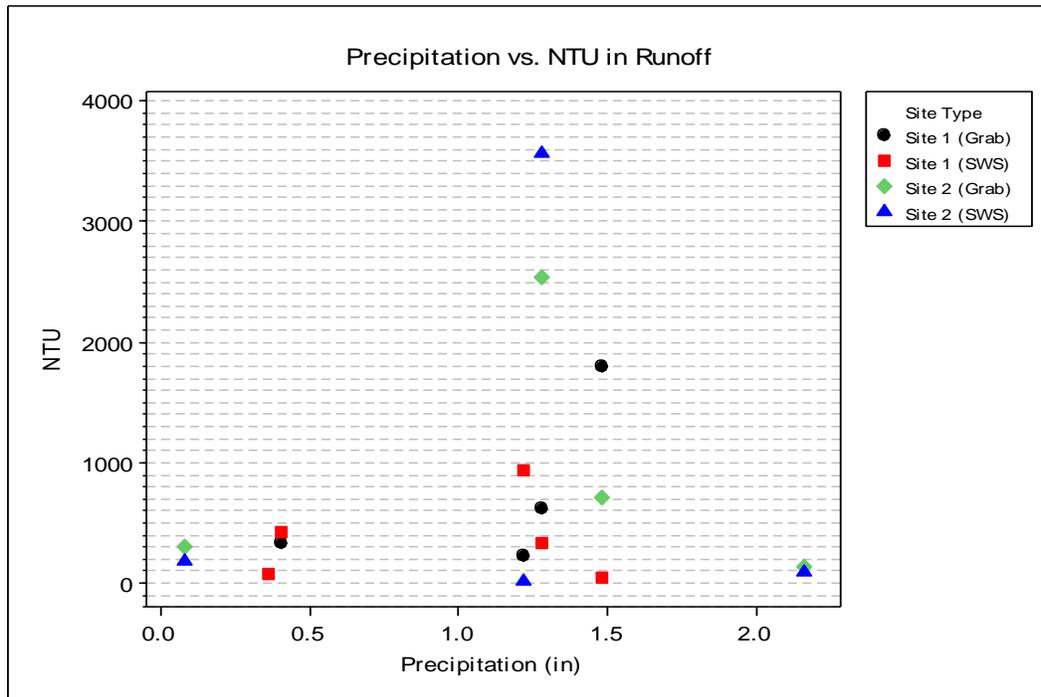
Figure 27. Relationship between precipitation and turbidity (NTU) levels in runoff at each site by collection method. There was no significant ($p < 0.01$) linear relationship between variables.

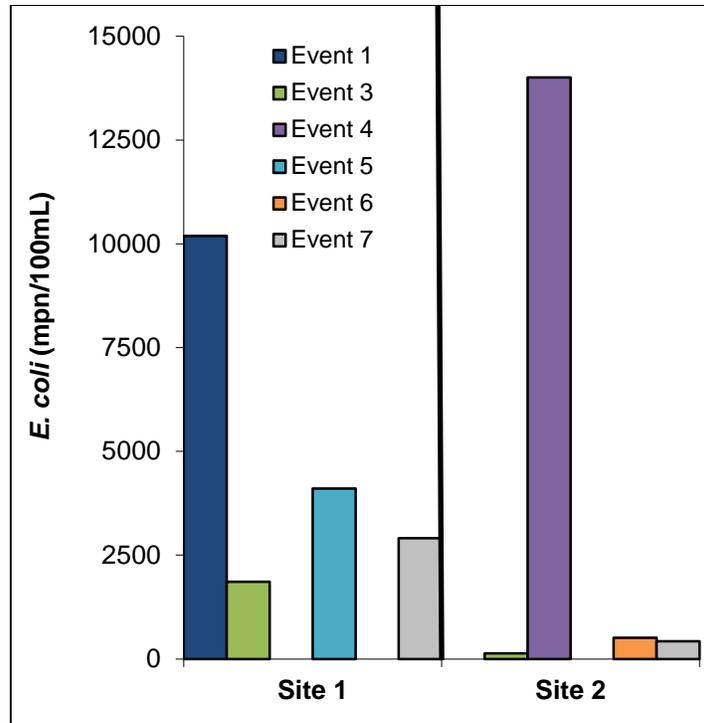
Figure 28. *E. coli* levels in runoff during rainfall events. Data based on grab samples only.

E. coli levels exhibited considerable variation between sites and sample dates. *E. coli* levels ranged between 135 and 14,101 mpn/100 ml (Figure 28). Seven of the eight samples (87.5%) exceeded the single grab criteria for *E. coli* of 394 mpn/100 ml. Due to the limited sample size EIH did not construct box plots or conduct formal ANOVA analysis. However, the majority of higher values (>1000 mpn/100 ml) were observed at Site 1. A significant linear relationship ($p = 0.05$) between precipitation and *E. coli* levels was observed (Figure 29). This relationship indicates that as the precipitation amount increases, the *E. coli* levels generally decrease.

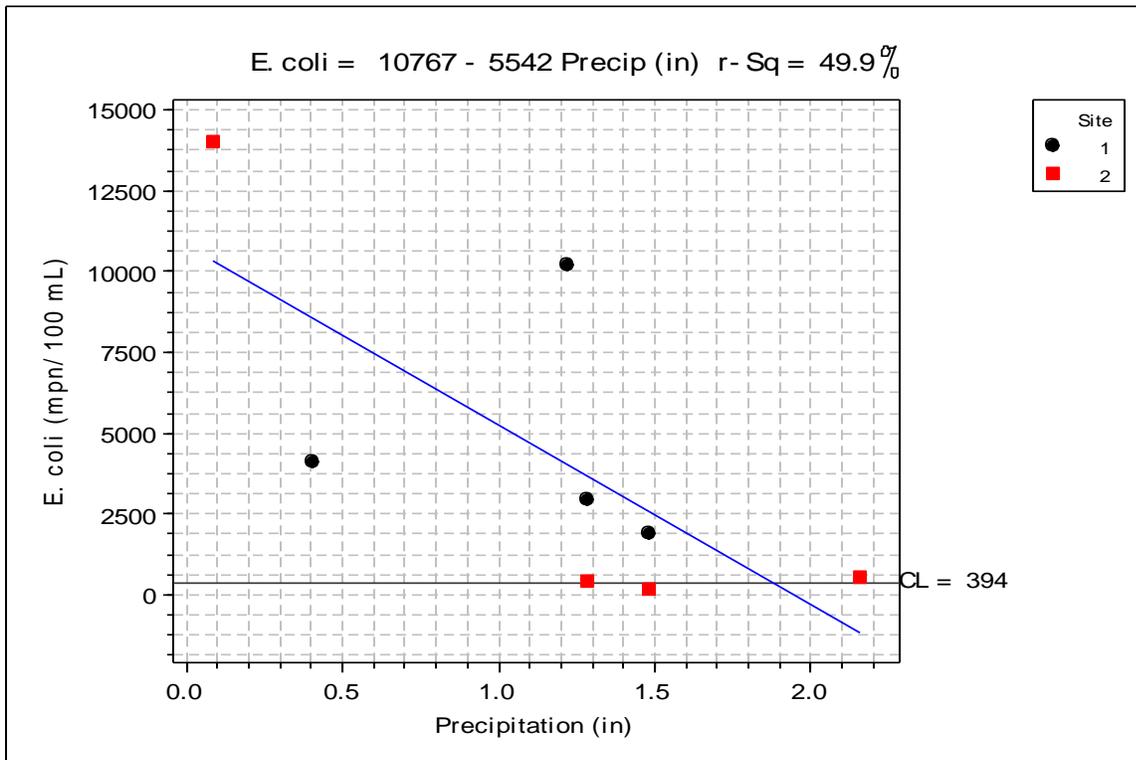
Figure 29. Relationship between precipitation and *E. coli* (mpn/100 mL) levels in runoff at each site. Significant at ($p = 0.05$) linear relationship between variables. CL = TCEQ criteria level.

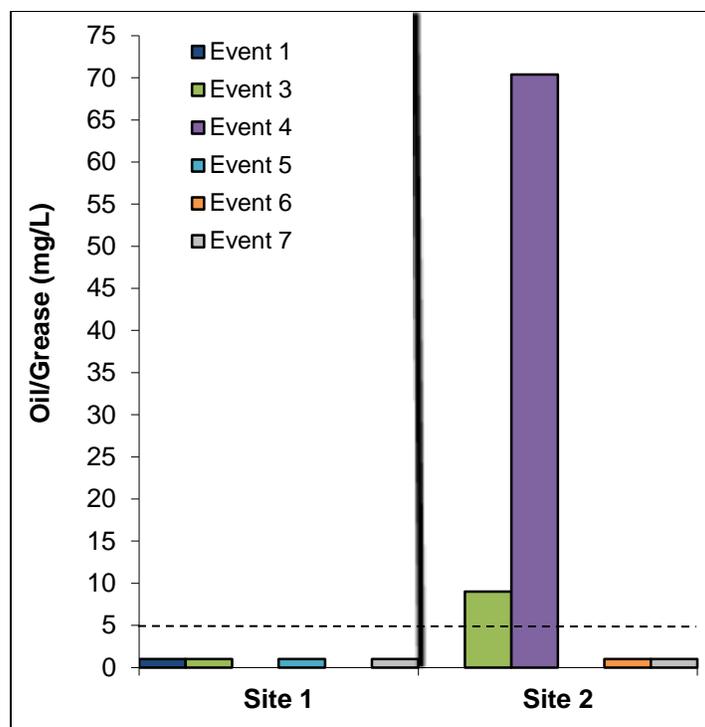
Figure 30. Oil and grease levels in runoff during rainfall events. Dashed line represents detection limit for this test (<5 mg/L); values below this line indicate presence at levels below the detection limit. Grab samples only.

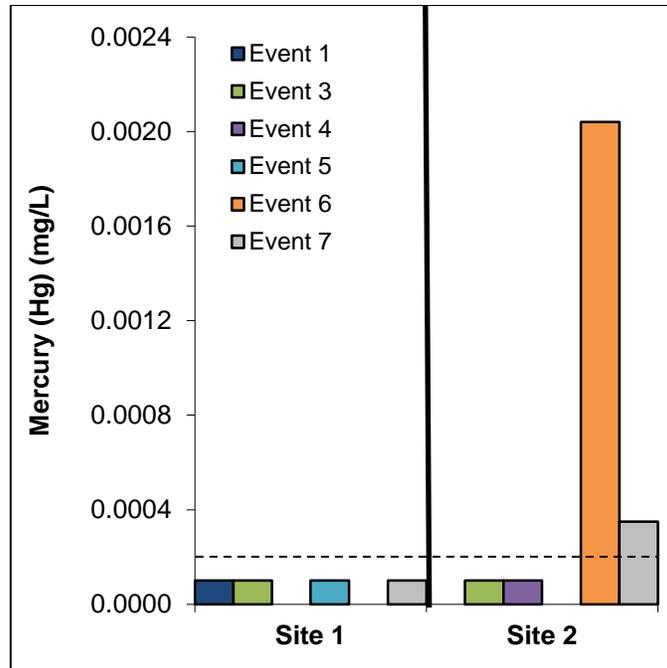
Figure 31. Mercury levels for rainfall events. Dashed line represents detection limit for this test (<0.0002 mg/L); values below this line indicate presence at levels below the detection limit. Grab samples only.

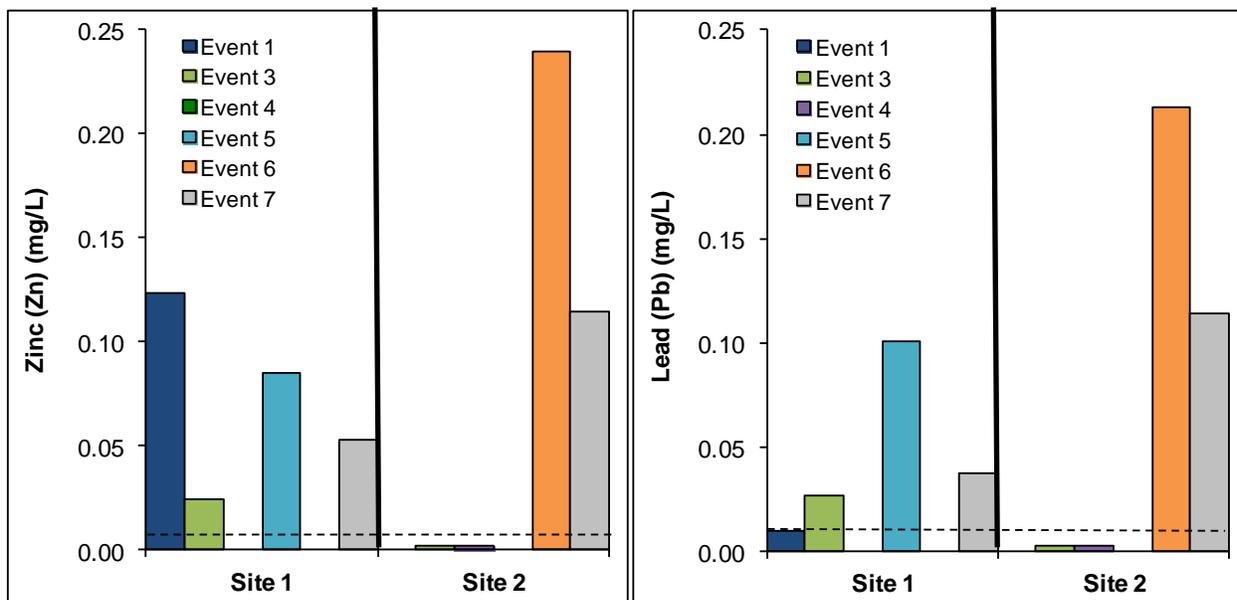
Figure 33. Zinc and lead levels for rainfall events. Dashed line represents detection limit for this test (< 0.01 mg/L); values below this line indicate presence at levels below the detection limit. Grab samples only.

It should be noted that 3 of the 4 metals monitored (mercury, zinc and lead) exhibited peak levels at site 2 during event 6. EIH is uncertain as to why this may have occurred, but may be due to increased vehicular traffic associated with road construction. It was noted that water samples were collected at site 2 in an instream pool located 9 meters upstream from the gage on that date. This was done because of lack of water at the normal sites located closer to the stormwater sampler and gage.

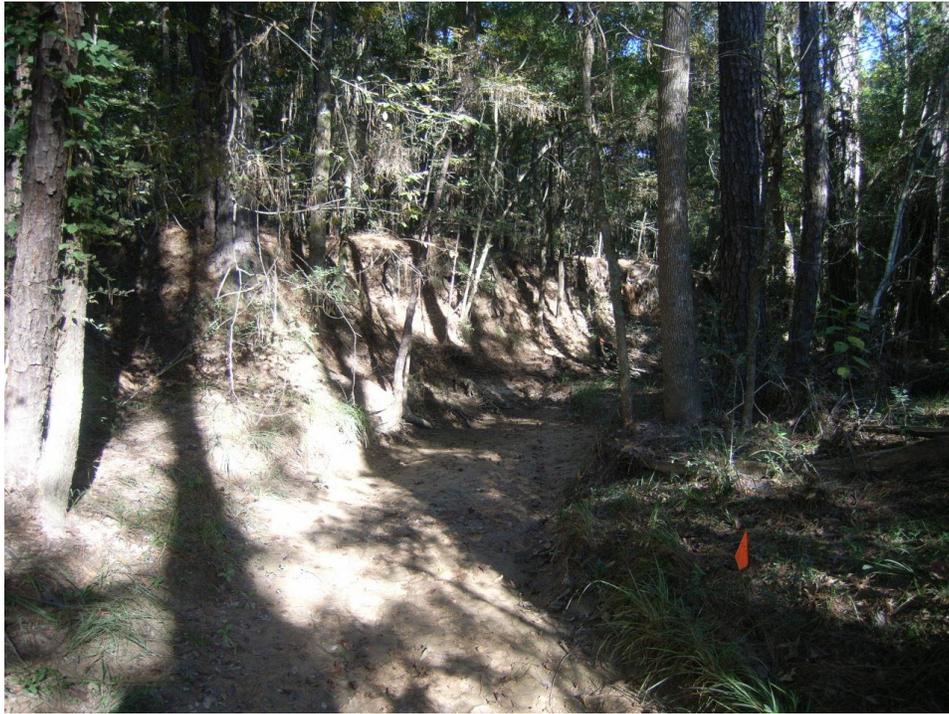
Figure 34. Photograph of site 1, taken on 10/8/10 before deployment of stormwater sampler (Source: hand held camera).
