Springwoods Subdivision Study Final Report

Prepared in cooperation with the Harris County Flood Control District
Project ID: Z100-00-00-Y053

EIH Technical Report # 12-003a

Environmental Institute of Houston
University of Houston-Clear Lake

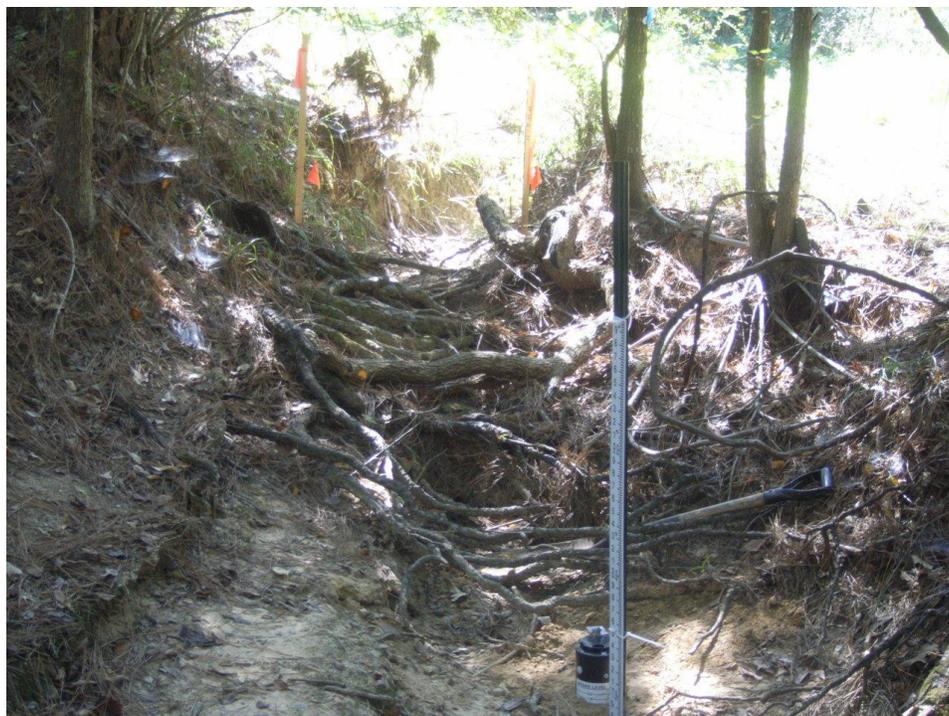
Figure 35. Photograph of site 2, taken on 10/8/10 immediately after deployment of stormwater sampler facing upstream (Source: hand held camera).

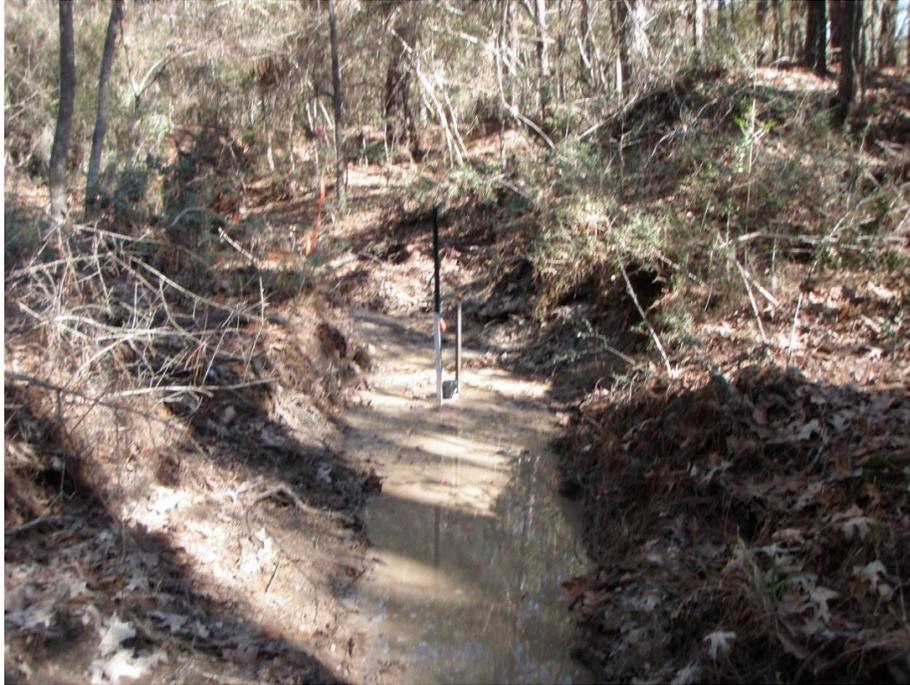
Figure 36. Photograph of site 1, taken during wet weather event 1 on 11/2/10, looking downstream at stormwater sampler and gage. (Source: automated game camera).

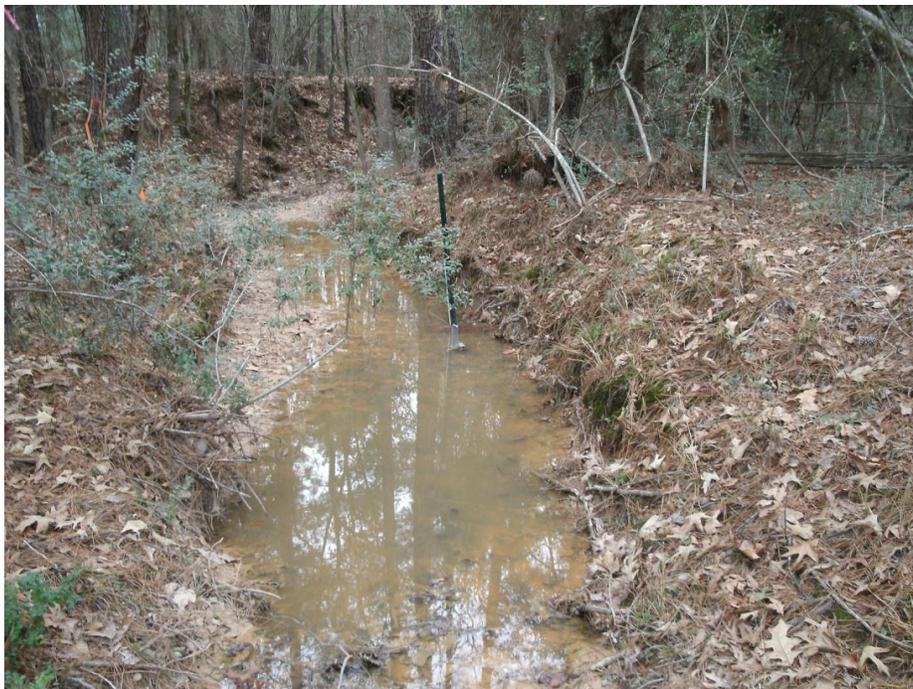
Figure 37. Photograph of site 1, taken during wet weather event 1 on 11/2/10, looking downstream at stormwater sampler and gage. (Source: hand held camera).

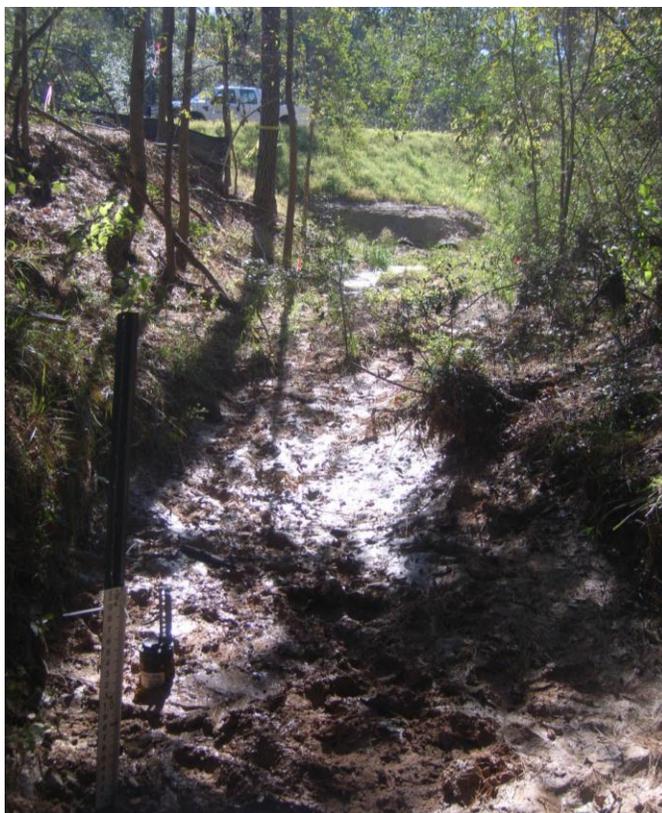
Figure 38. Photograph of site 1, taken during event 1 on 11/2/10, looking upstream from stormwater sampler and gage. (Source: hand held camera).

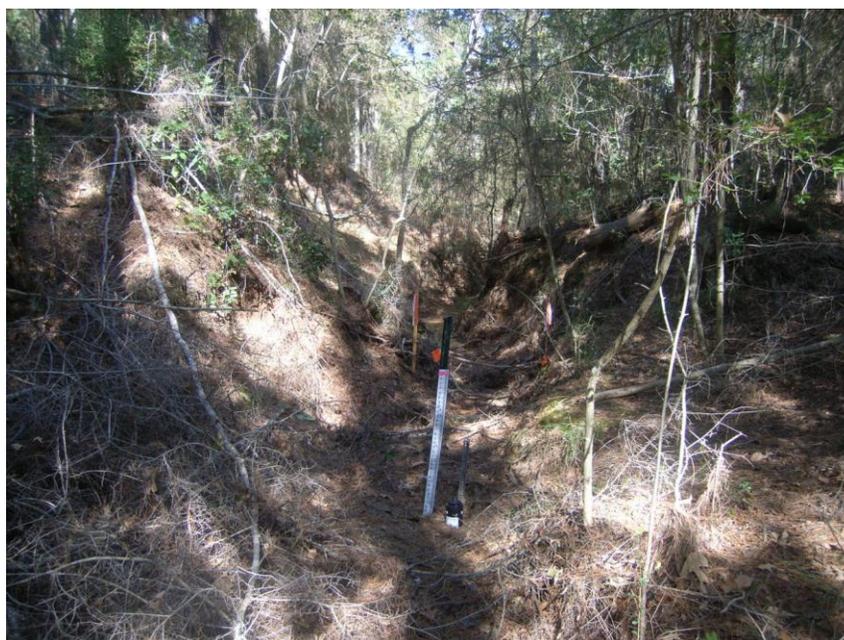
Figure 39. Photograph of site 2, taken during event 2 on 11/2/10, looking downstream from stormwater sampler and gage. (Source: hand held camera).

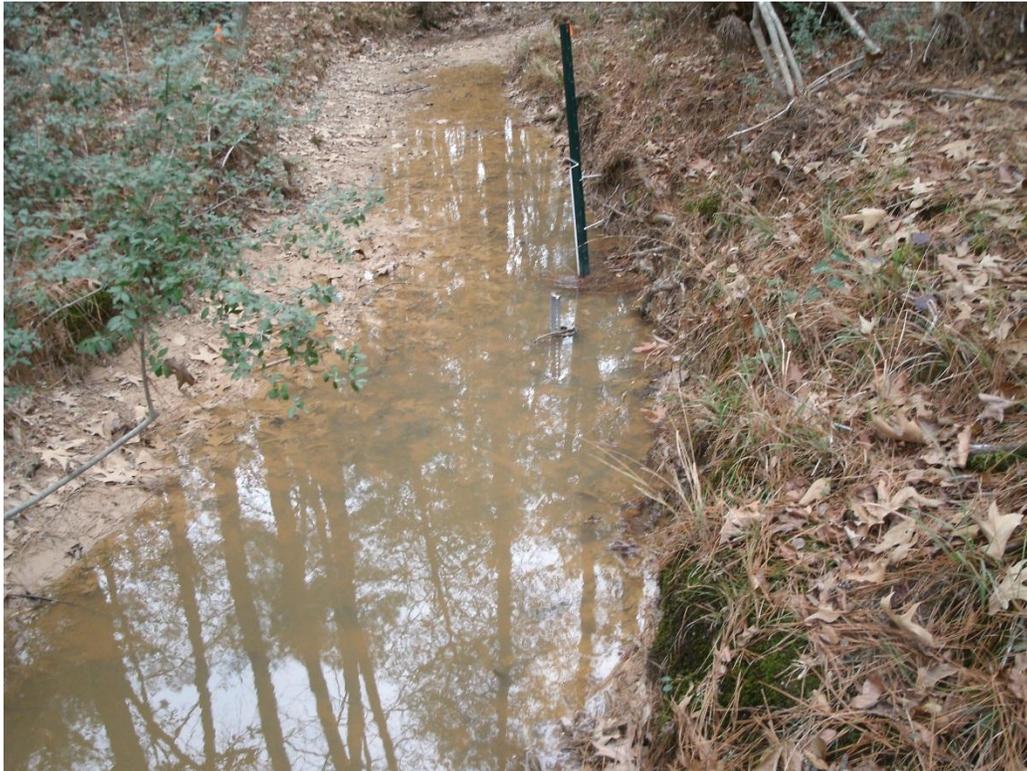
Figure 40. Photograph of site 1, taken during 1/14/11, looking downstream toward flood area containing stormwater sampler and gage 5 days after significant rain (Source: hand held camera).

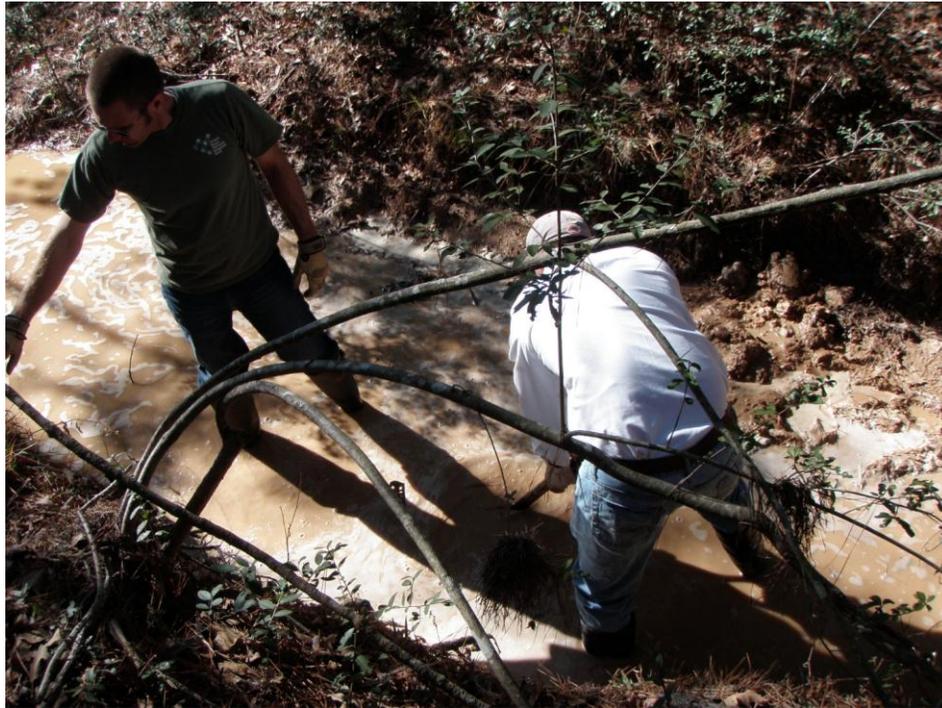
Figure 41. Photograph of site 1, taken on 1/28/11, depicting HCFCD personnel digging up stormwater sampler to move it downstream (Source: hand held camera). Sampler was buried in mud.

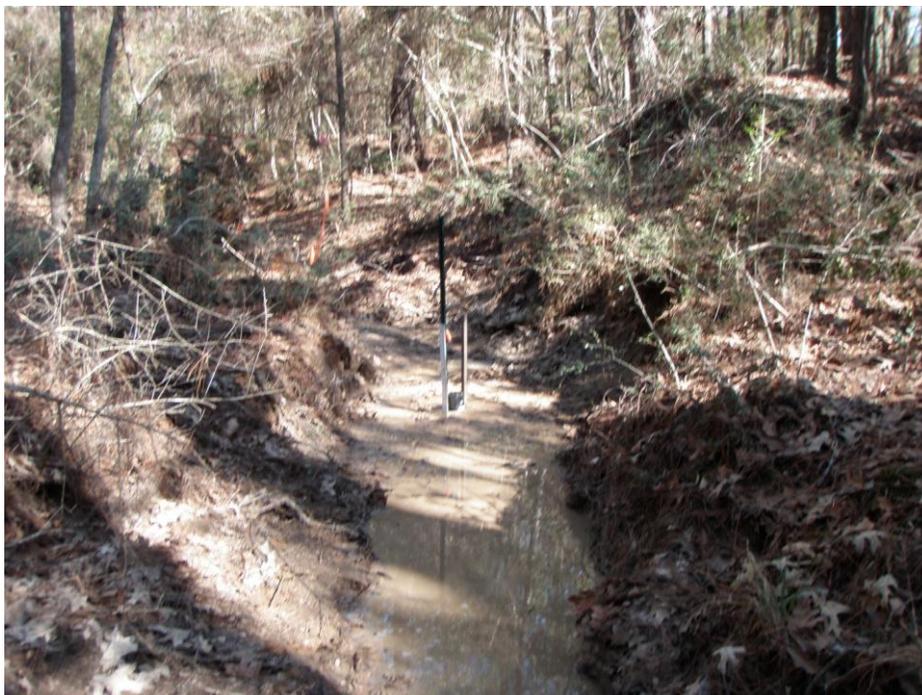
Figure 42. Photograph of site 1, taken on 1/28/11, depicting downstream view of new site location from mid-channel, upstream (Source: hand held camera).

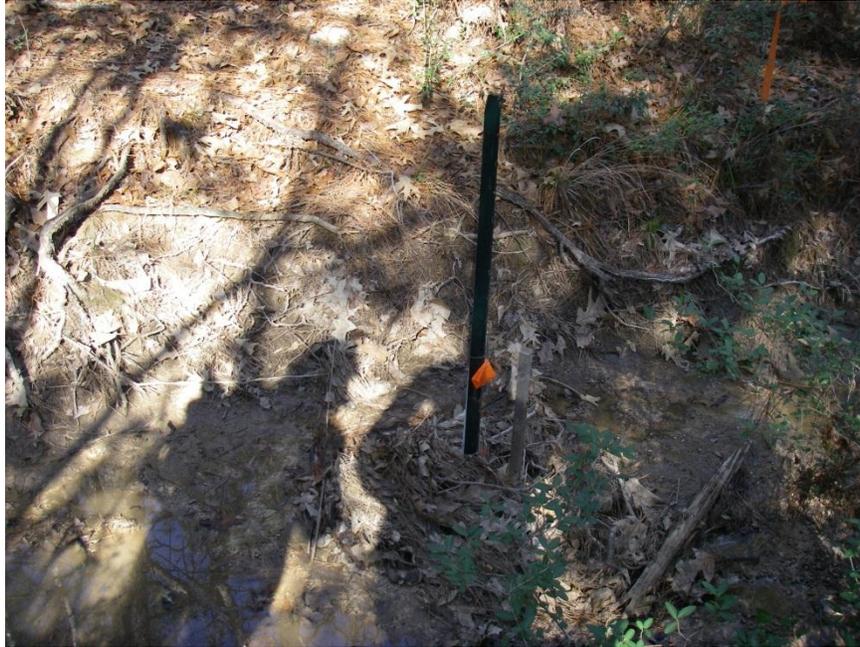
Figure 43. Photograph of site 1, taken on 2/8/11, depicting stormwater sampler and gauge posts from right bank (Source: hand held camera).

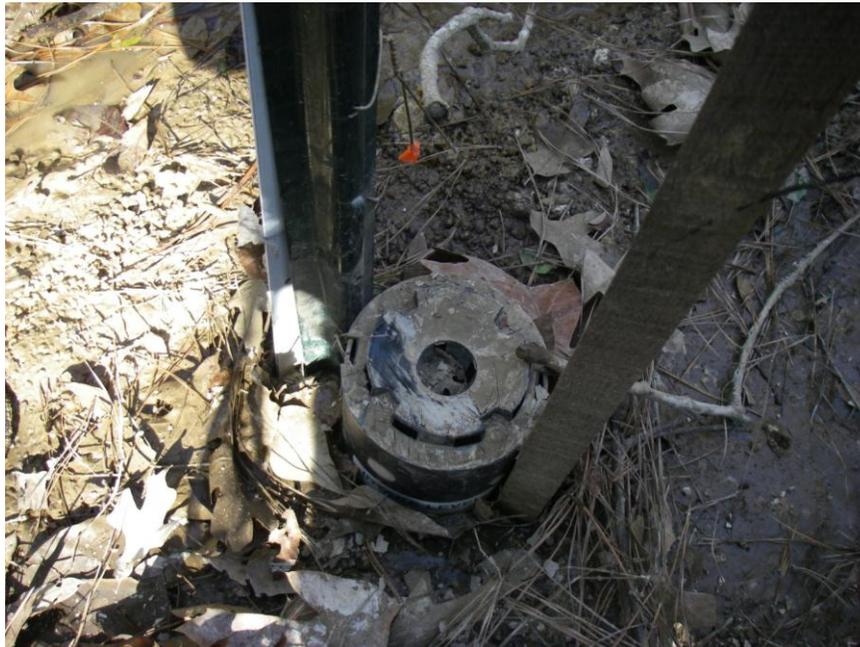
Figure 44. Photograph of site 1, taken on 2/8/11, depicting stormwater sampler with sediment caked on sampler tube top (Source: hand held camera). Sampler checked after non-qualifying rain event.

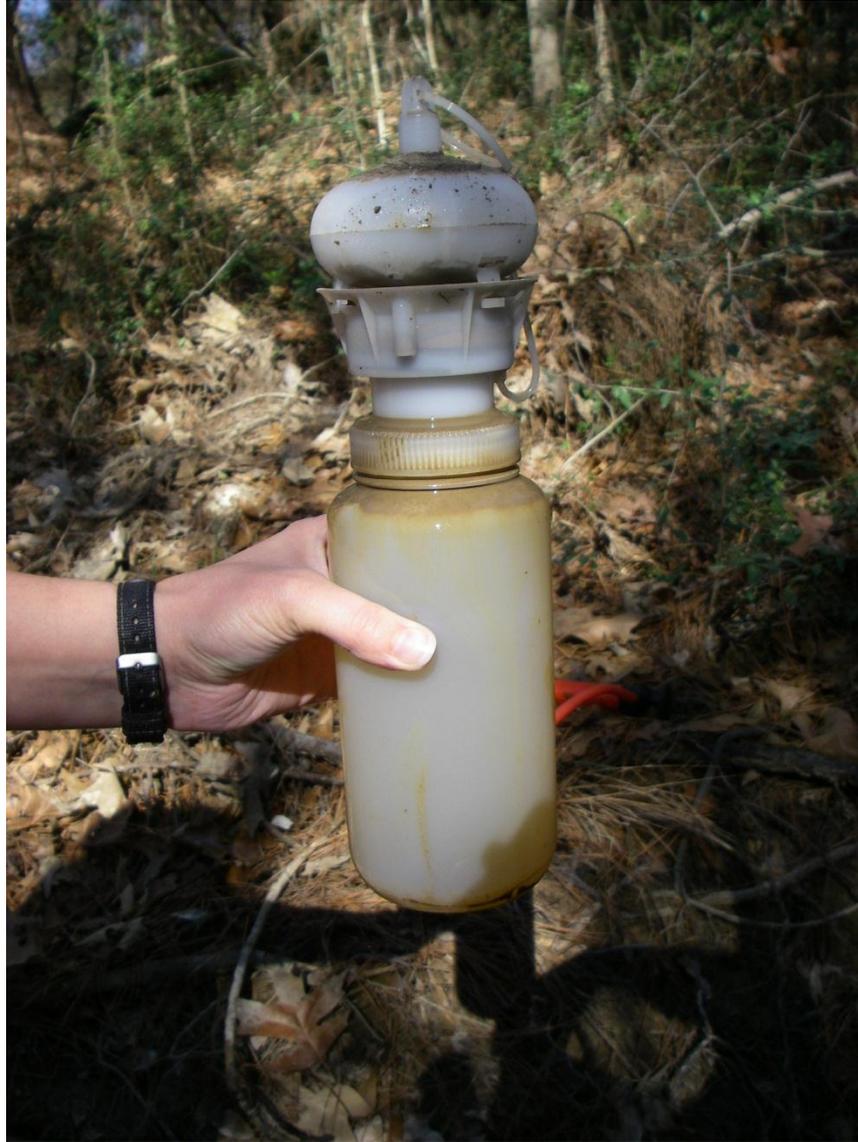
Figure 45. Photograph of site 1, taken on 2/8/11, depicting stormwater sampler bottle completely filled after a non-qualifying rain event (Source: hand held camera).

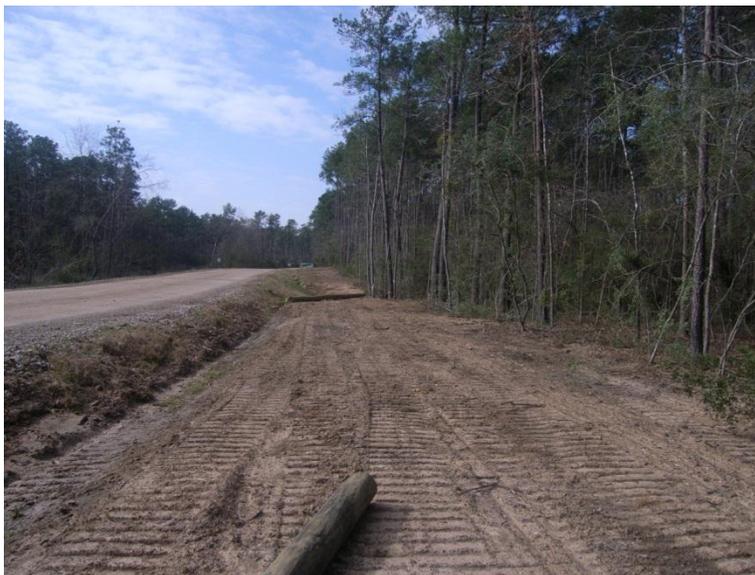
Figure 46. Photograph of new clearly area along road adjacent to site 1, taken on 3/7/11 (Source: hand held camera).

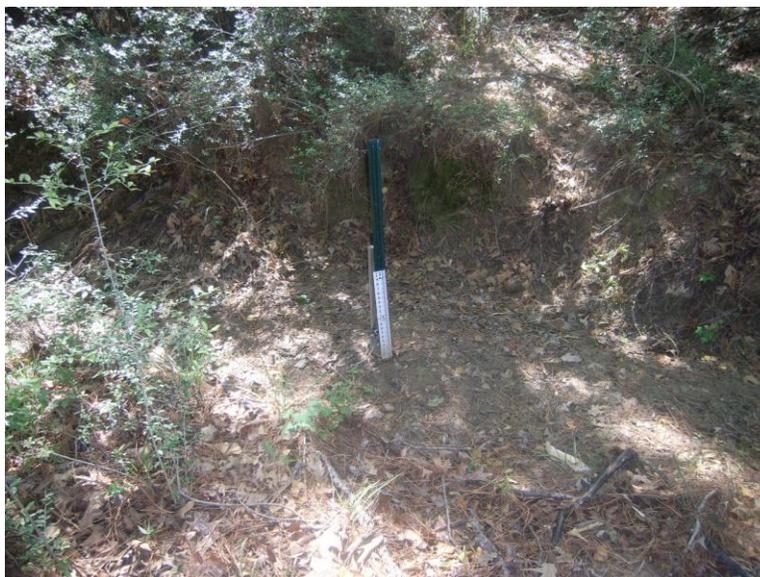
Figure 47. Photograph of site 1 taken during event 2 on May 13, 2011. (Source: hand held camera).

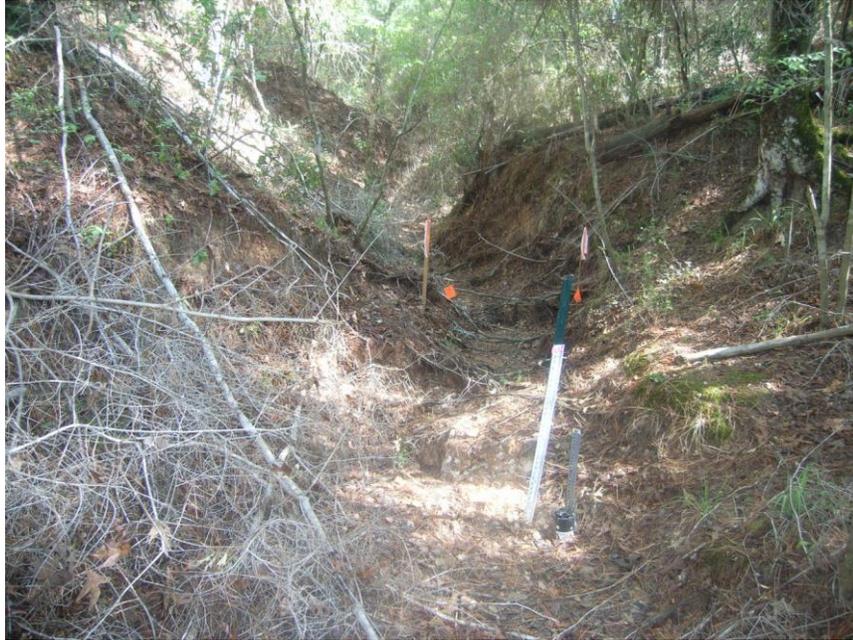
**Figure 48. Photograph of site 2 taken during event 2 on May 13, 2011.
(Source: hand held camera).**

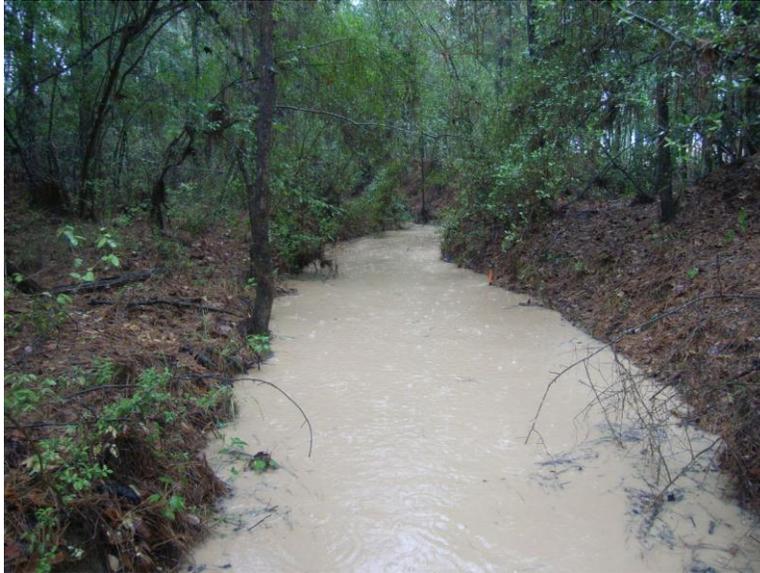
Figure 49. Photograph of site 1 taken during event 3 on June 22, 2011. (Source: hand held camera).

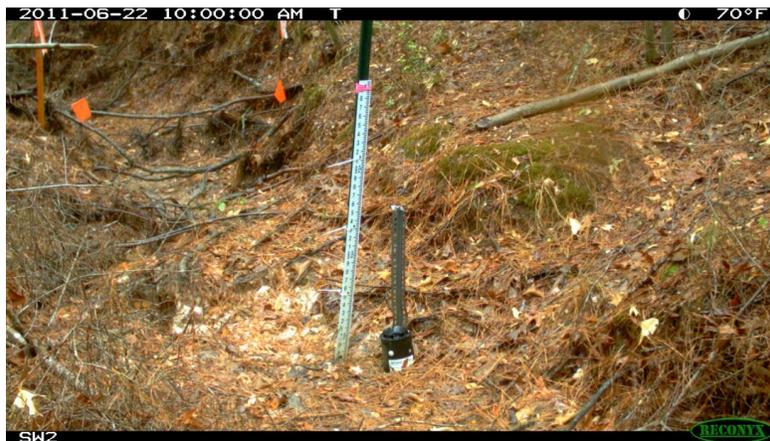
Figure 50. Photograph of site 2 taken during event 3 on June 22, 2011. (Source: game camera).

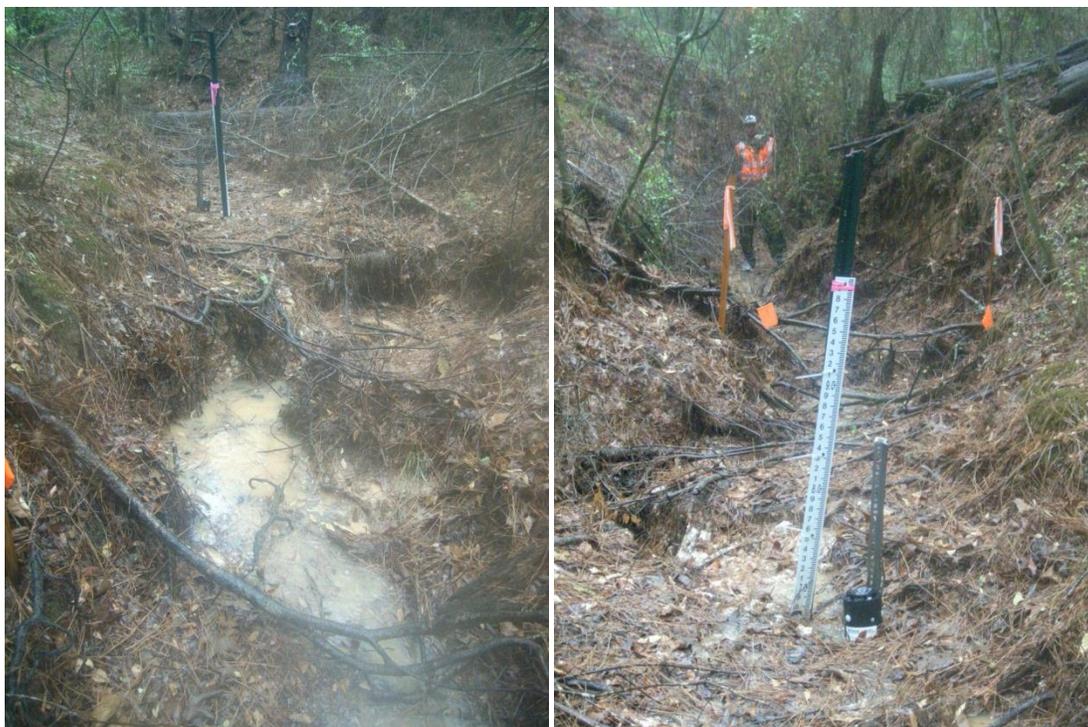
Figure 51. Photograph of site 2 taken during event 3 on June 22, 2011. View is upstream from and downstream toward sampler respectively. (Source: hand held camera).

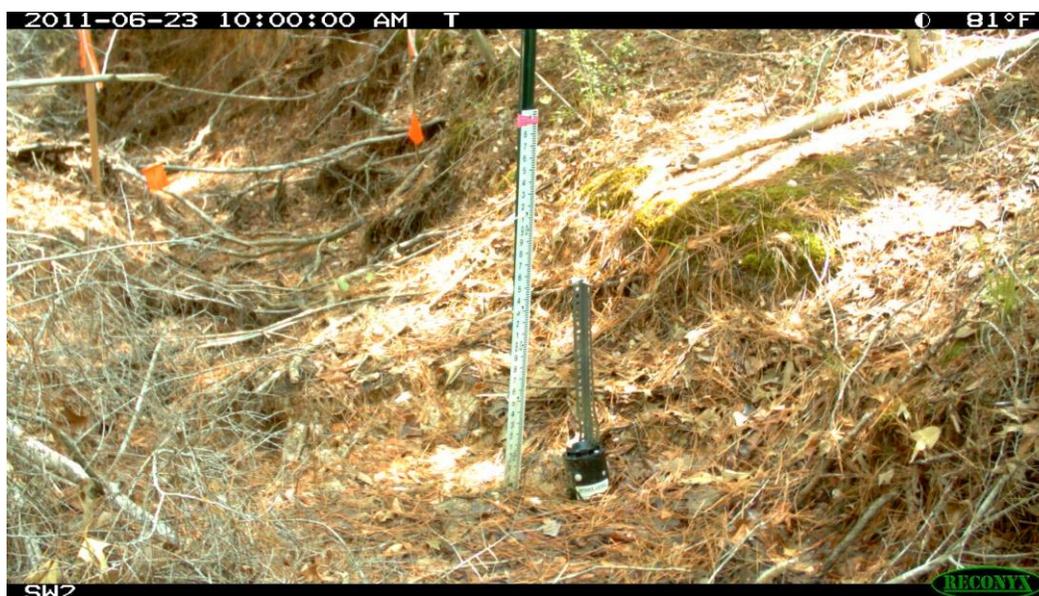
Figure 52. Photograph of site 2 taken during event 4 on June 23, 2011. (Source: game camera).

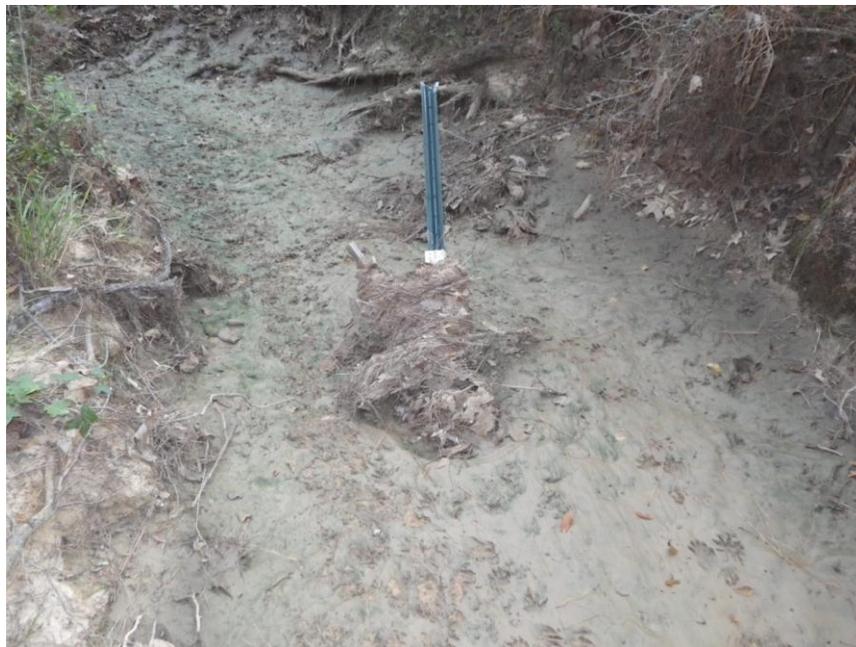
Figure 54. Photograph of site 1 taken on August 18, 2011 showing debris and mud. (Source: hand held camera).

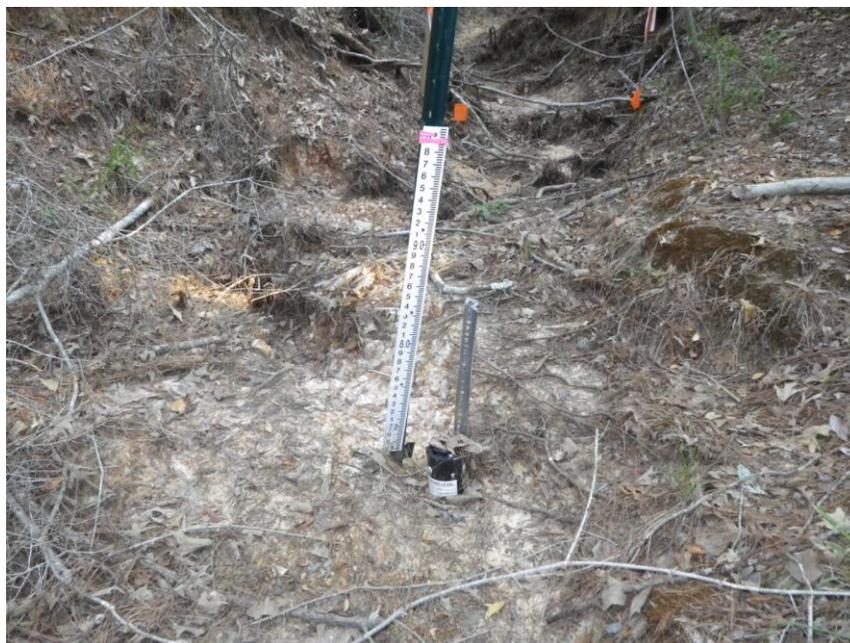
Figure 55. Photograph of site 2 taken on August 18, 2011 showing stormwater sampler and gage in dry creek (Source: hand held camera).

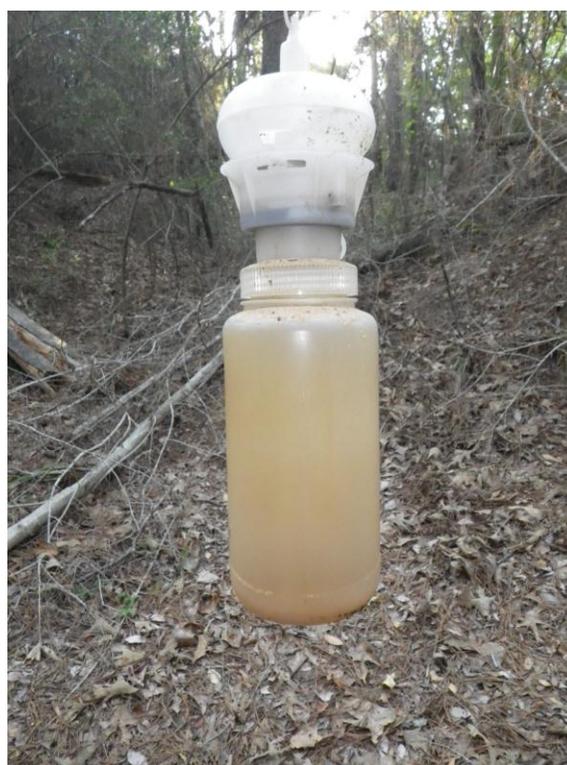
Figure 56. Photograph of site 2 taken on August 18, 2011 showing stormwater sampler bottle completely full from non-qualifying wet weather event (Source: hand held camera).

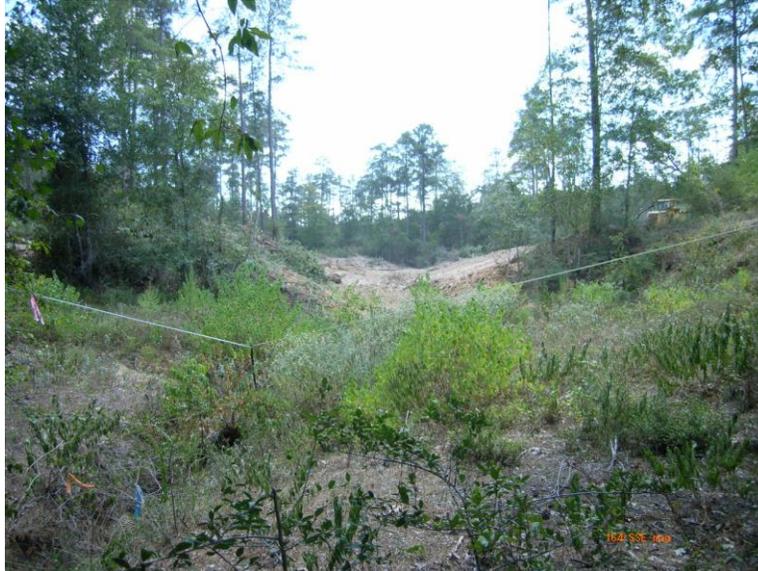
Figure 57. Photograph of site 2 taken on September 1, 2011 showing construction activity upstream of sampler (Source: hand held camera).

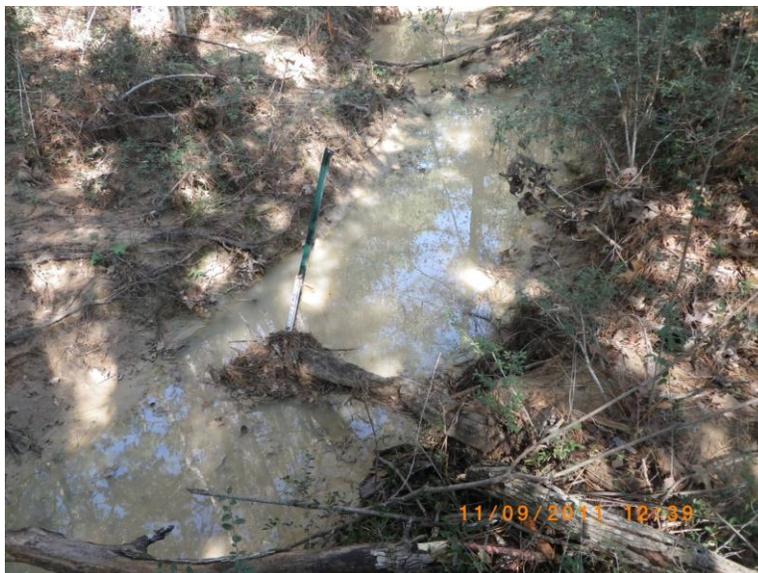
Figure 58. Photograph of site 1 taken on November 9, 2011 showing stormwater sampler and staff gage with accumulated debris (Source: hand held camera). No sample bottles deployed prior to this rain event.

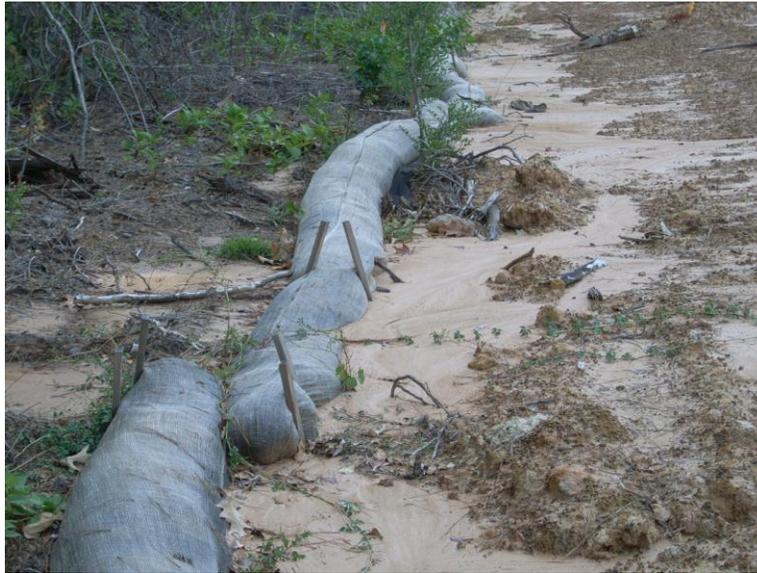
Figure 59. Photograph of site 1 taken on stormwater sampling event 5, September 19, 2011 showing construction activity upstream of sampler (Source: hand held camera).

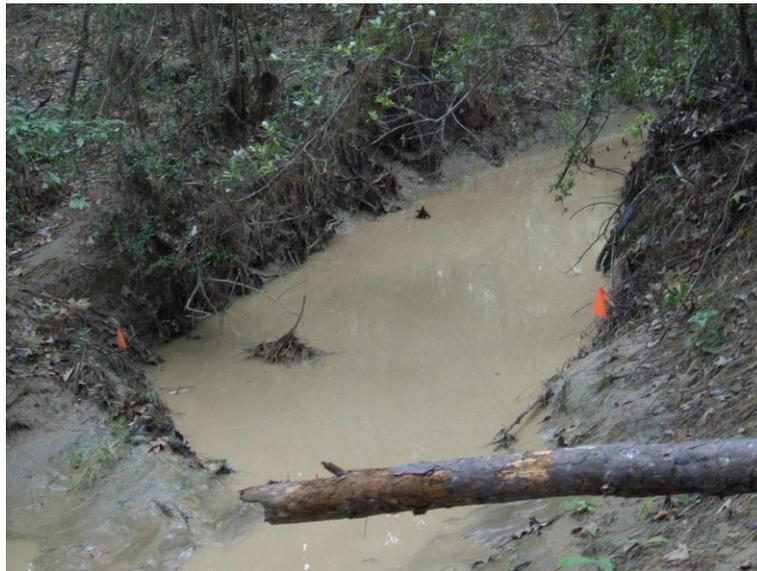
Figure 60. Photograph of site 1 taken during stormwater sampling event 5 on September 19, 2011 depicting ditch upstream of sampler full of muddy runoff from construction activity (Source: hand held camera).

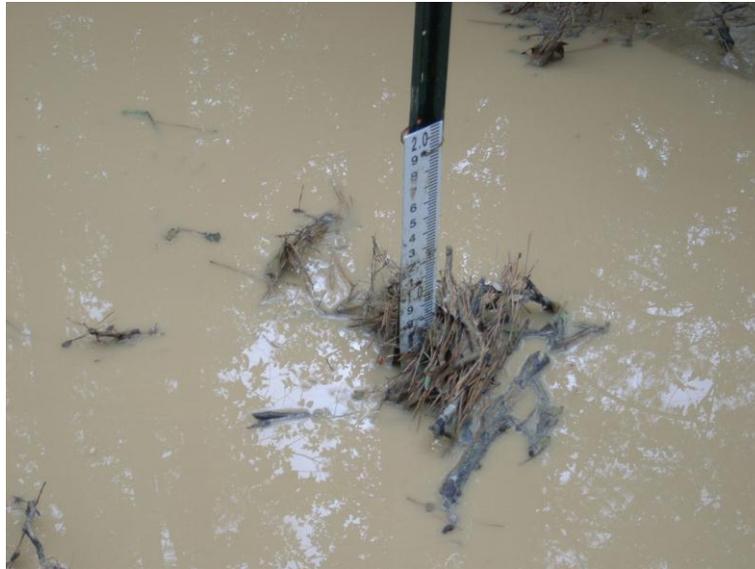
Figure 61. Photograph of site 1 taken during stormwater sampling event 5 on September 19, 2011 showing stormwater sampler obstructed with debris (Source: hand held camera).

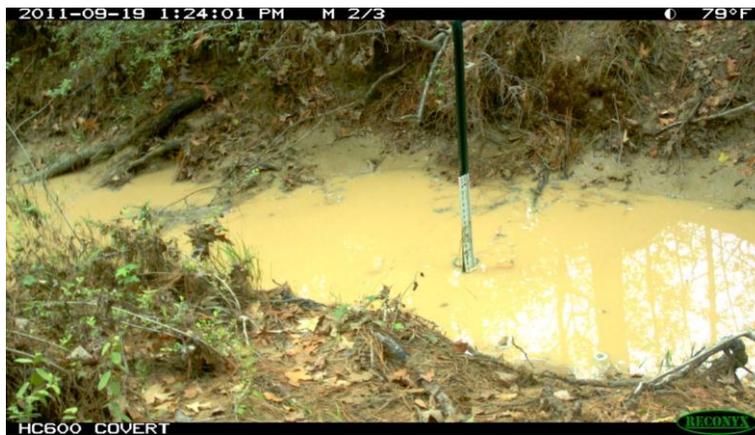
Figure 62. Photograph of site 1 taken during event 5 on September 19, 2011. (Source: game camera).

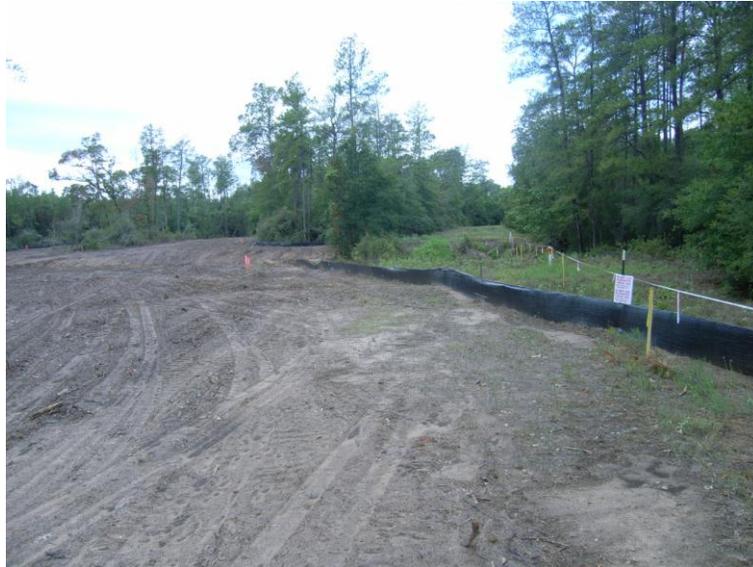
Figure 63. Photograph of site 2 taken on stormwater sampling event 5, September 19, 2011 showing construction activity upstream of sampler (Source: hand held camera).

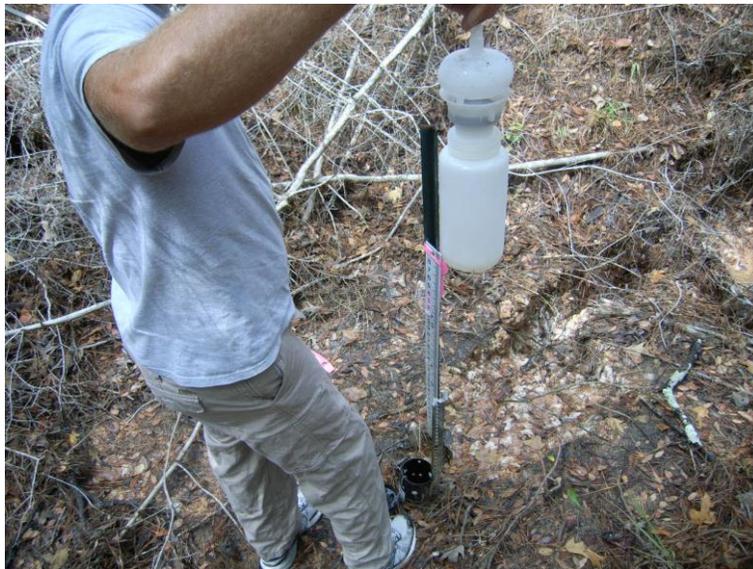
Figure 64. Photograph of site 2 taken on stormwater sampling event 5, September 19, 2011 showing minimal water in ditch and minimal amount of water in sampler (Source: hand held camera). Insufficient water collected for most analyses.

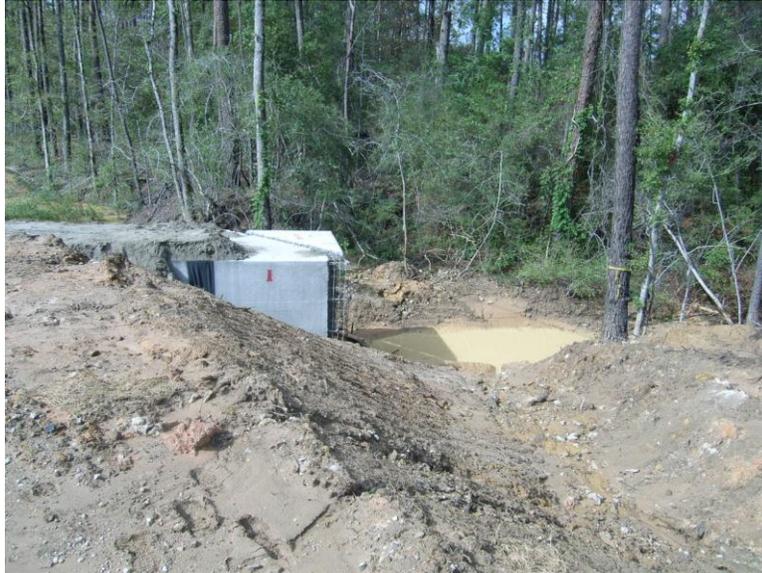
Figure 65. Photograph of side view of new culvert installed near upstream of site 1 taken during event 6 on October 10, 2011. (Source: hand held camera).

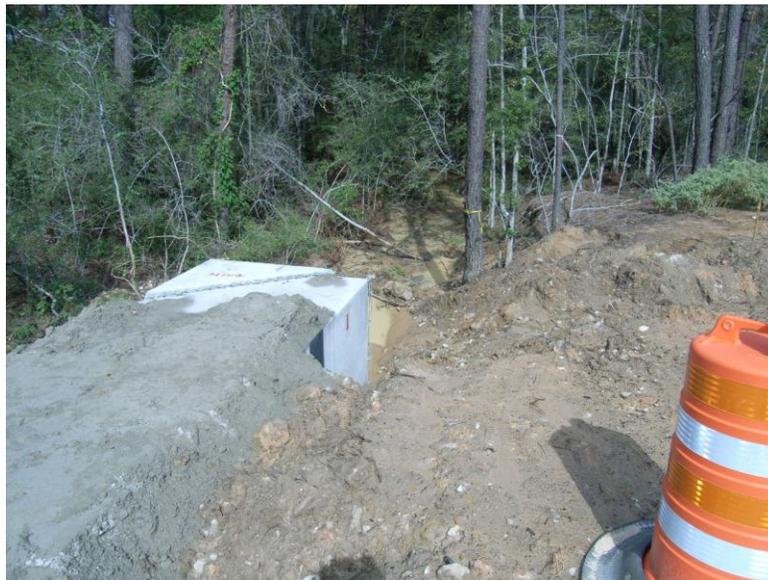
Figure 66. Photograph of top view of new culvert installed near upstream of site 1 taken during stormwater sampling event 6 on October 10, 2011. (Source: hand held camera).

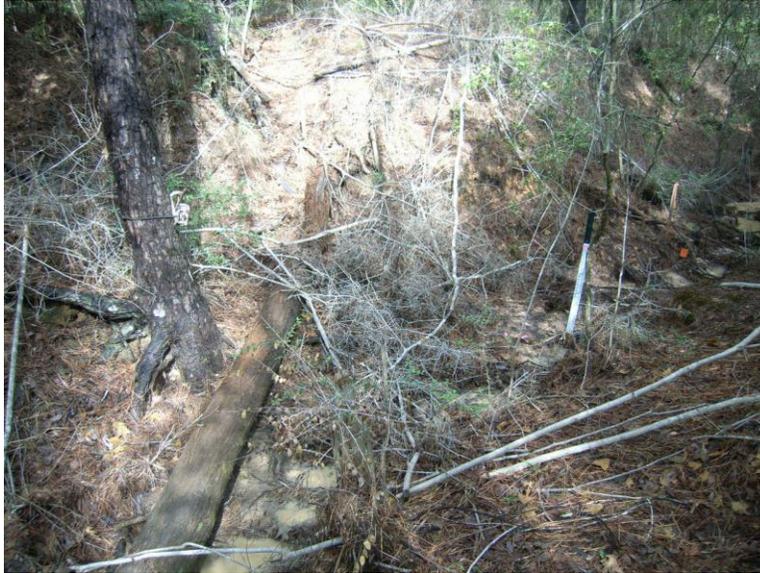
Figure 67. Photograph of site 2 taken during event 6 on October 10, 2011. View of pools of rain water in the creek; photo taken from right bank looking downstream (Source: hand held camera).

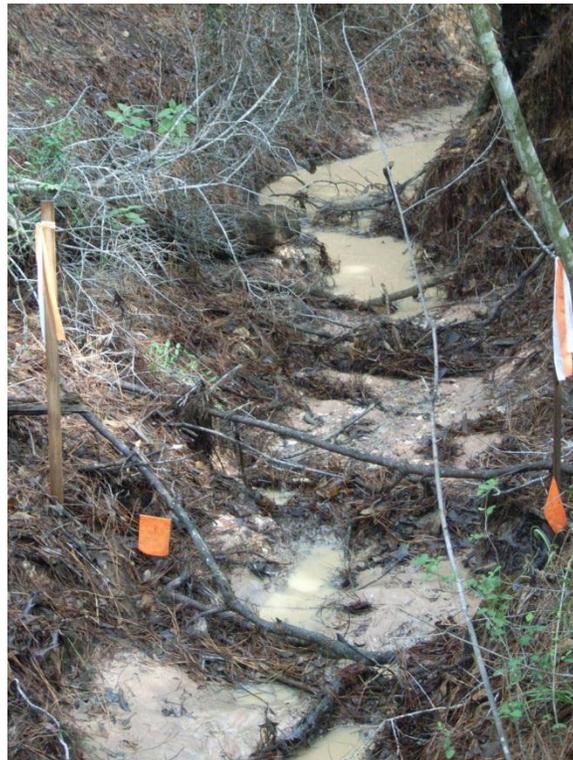
Figure 68. Photograph of site 2 taken during event 6 on October 10, 2011. View of the pools of rain water downstream of the sampler. (Source: hand held camera).

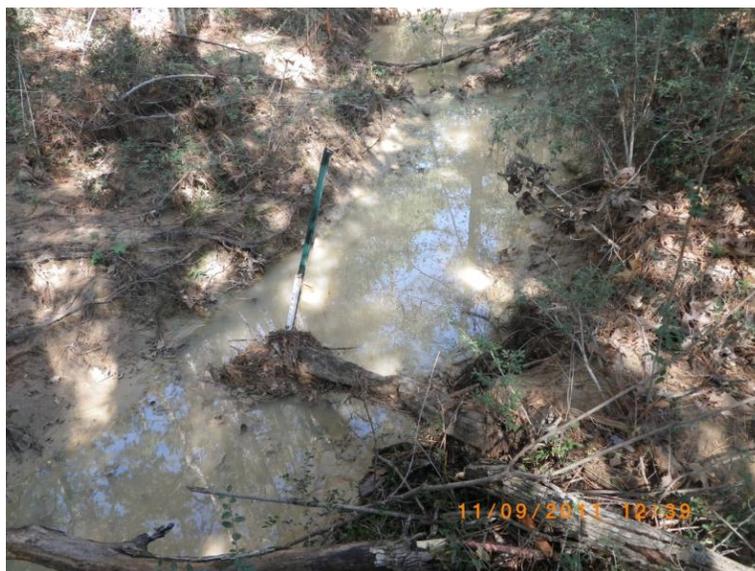
Figure 69. Photograph of site 1 staff gage taken on November 9, 2011, a day after rainfall. No stormwater sampler was deployed on this date. (Source: hand held camera).

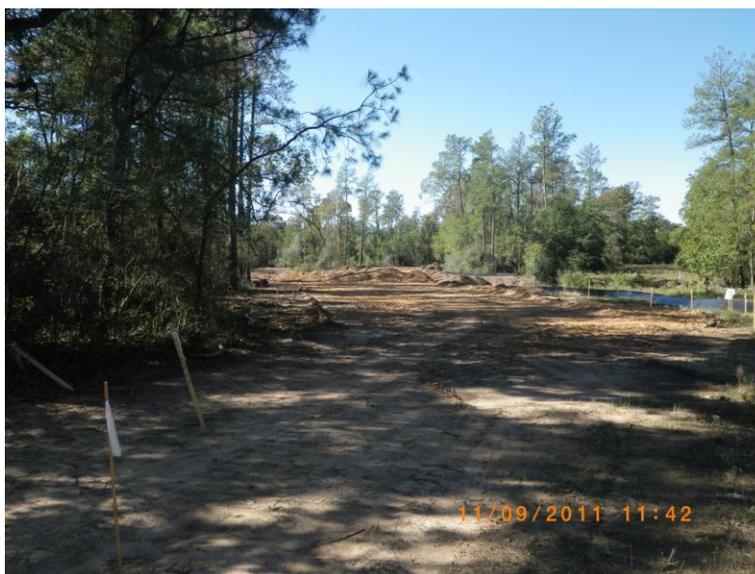
Figure 70. Photograph of construction area immediately upstream of site 2 on November 9, 2011, a day after significant rainfall. (Source: hand held camera).

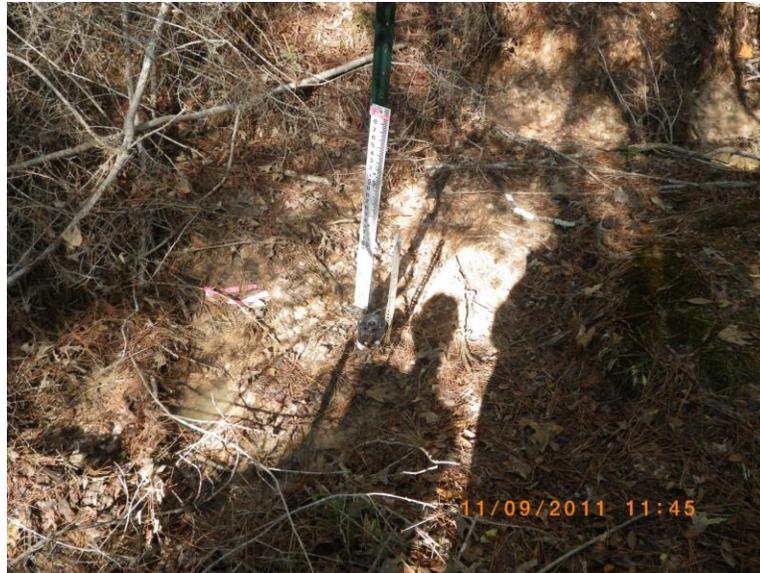
Figure 71. Photograph of site 2 on November 9, 2011, a day after rainfall. (Source: hand held camera).

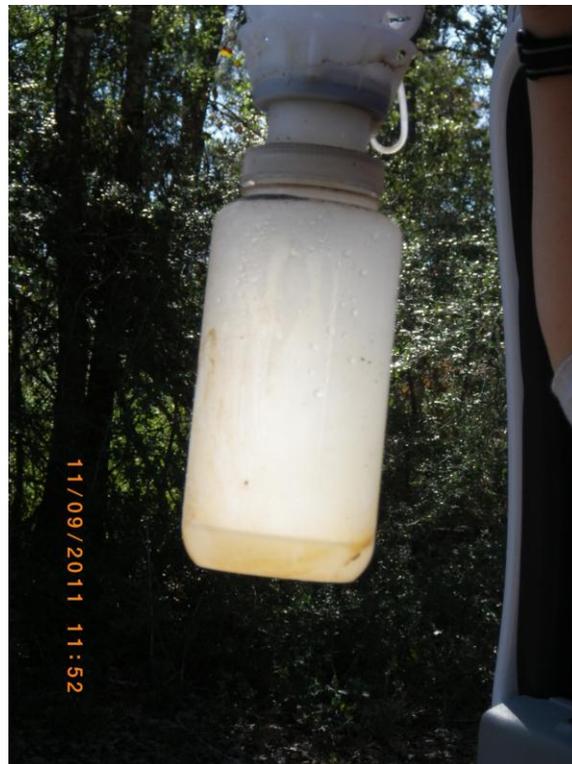
Figure 72. Photograph of collection bottle from stormwater sampler bottle at site 2 on November 9, 2011, a day after rainfall. (Source: hand held camera). Note minimal sample volume collected which was not used for analyses.

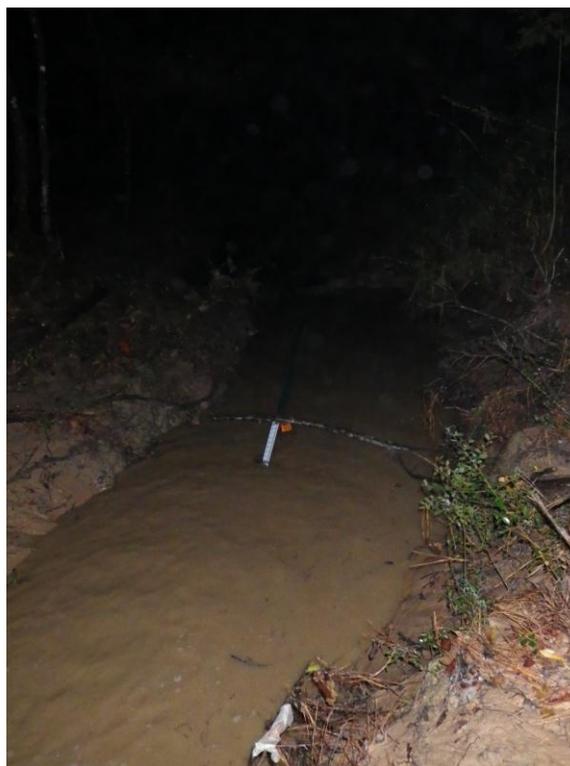
Figure 73. Photograph of stormwater sampler at site 1 during sampling event 7 on November 15, 2011.

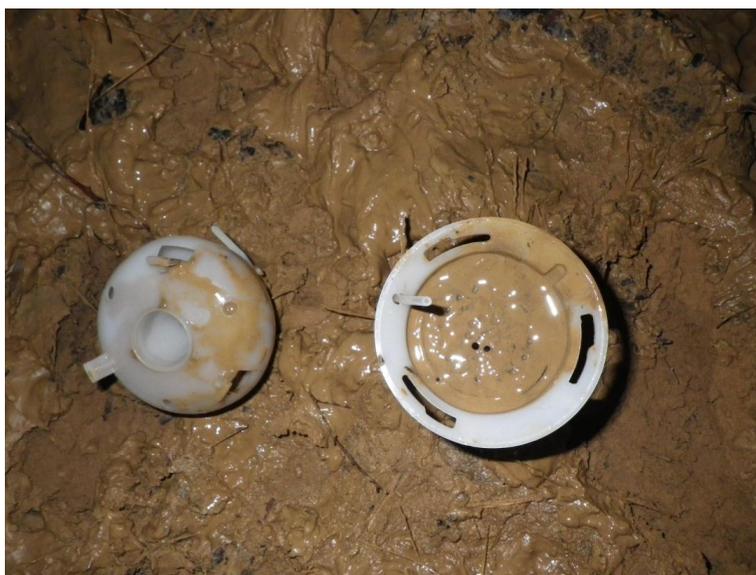
Figure 74. Photograph of stormwater sampler at site 1 during sampling event 7 on November 15, 2011. (Source hand held camera). Note sampler cap is full of mud.

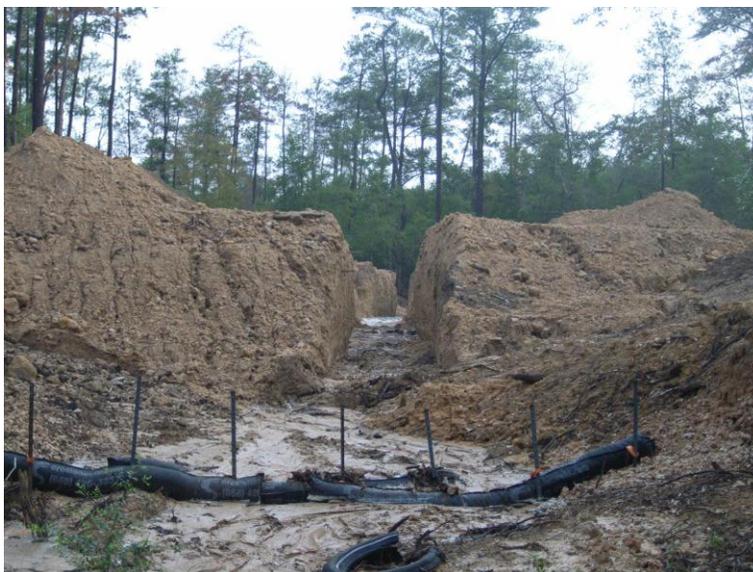
Figure 75. Photograph of construction site upstream of site 2 on November 15, 2011 during event 7. (Source: hand held camera).

During the early phases of the project, measured runoff flows and suspended solids were generally lower, but gradually increased through time as new development occurred at both sites (Figure 22 and Figure 23, and Figure 53 to Figure 82). This trend was first observed at site 1 and subsequently after June, 2011 at site 2 as well. The ultimate cause of increased sediments and turbidity appears to be increased road construction near each site. The background levels of each monitored pollutant were likely only present near the beginning of the project before road construction activity had begun at each site. In the case of site 1, it appears that construction activity had already affected water quality at the site before sampling started. At site 2, observed turbidity in the field, and associated turbidity measurements increased near the end of the project and were likely associated with the increased road construction that were observed on 11/15/12 (Figure 22 and Figure 23; Figure 76 to Figure 78). The general appearance of the turbid water at both sites was a yellowish clay color.
