Springwoods Subdivision Study Final Report

Prepared in cooperation with the Harris County Flood Control District
Project ID: Z100-00-00-Y053

EIH Technical Report # 12-003a

Environmental Institute of Houston
University of Houston-Clear Lake

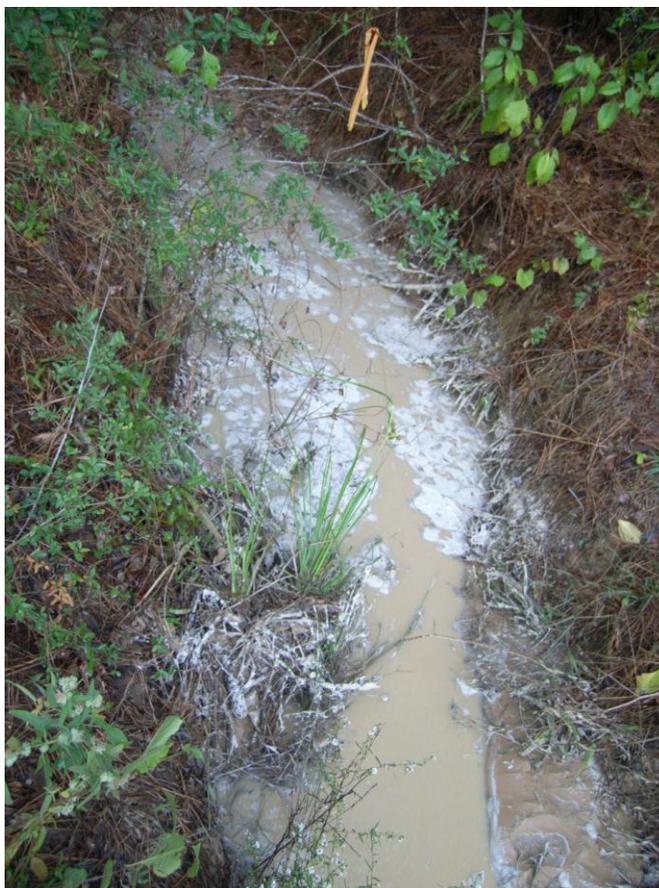
Figure 76. Photograph of ditch upstream of site 2 on November 15, 2012 during sampling event 7. Note foam in water. (Source hand held camera).

During the early phases of the project, measured runoff flows and suspended solids were generally lower, but gradually increased through time as new development occurred at both sites (Figure 22 and Figure 23, and Figure 53 to Figure 82). This trend was first observed at site 1 and subsequently after June, 2011 at site 2 as well. The ultimate cause of increased sediments and turbidity appears to be increased road construction near each site. The background levels of each monitored pollutant were likely only present near the beginning of the project before road construction activity had begun at each site. In the case of site 1, it appears that construction activity had already affected water quality at the site before sampling started. At site 2, observed turbidity in the field, and associated turbidity measurements increased near the end of the project and were likely associated with the increased road construction that were observed on 11/15/12 (Figure 22 and Figure 23; Figure 76 to Figure 78). The general appearance of the turbid water at both sites was a yellowish clay color.

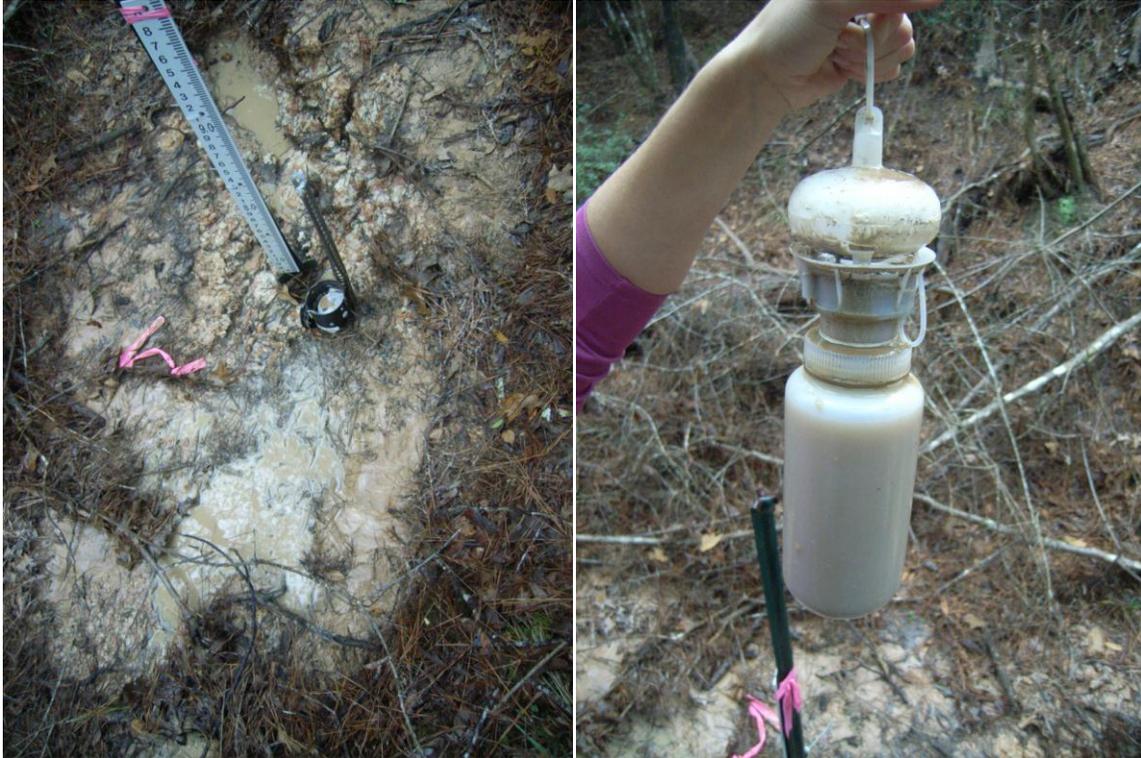
Figure 77. Photograph of the staff gage and sampler at site 2 on November 15, 2012, with sampler cap removed; more sediment deposited in the creek from the construction. Note rain water filled the sampler (Source: hand held camera).

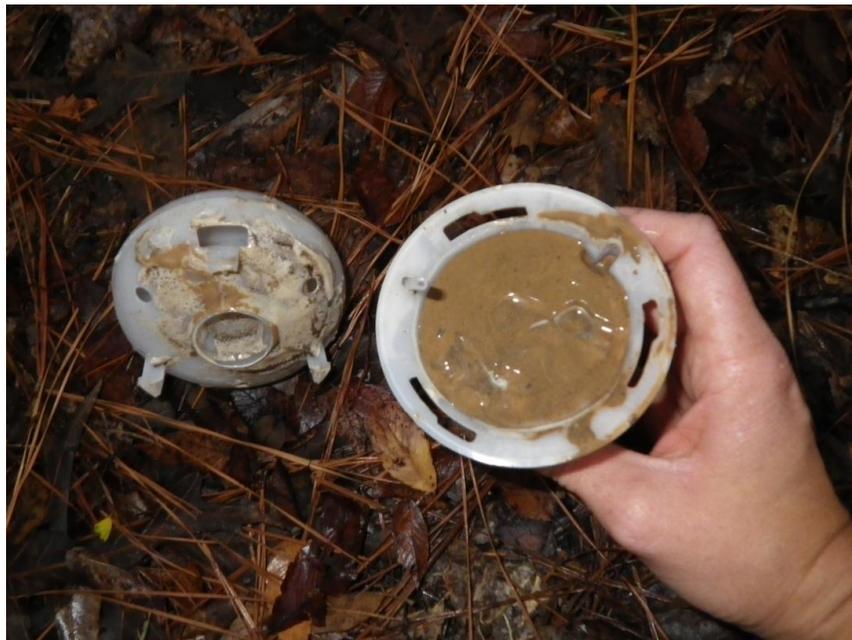
Figure 78. Photograph of sediment deposited on the stormwater sampler collector at site 2 during event 7 on November 15, 2012. Note cap lying on the ground had a frothy film on it. (Source: hand held camera).

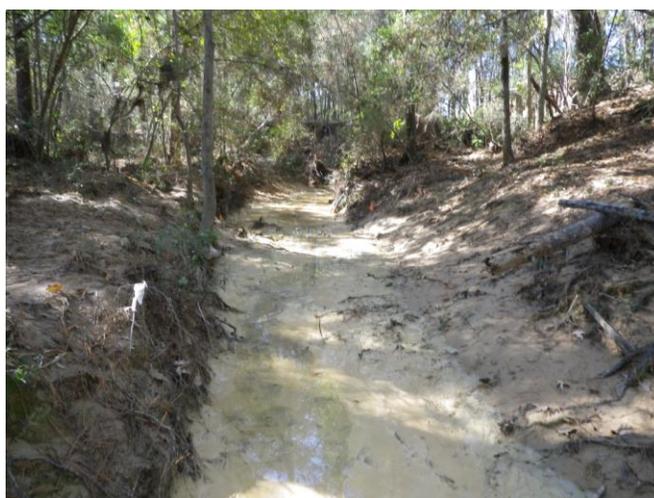
Figure 80. Photograph of area upstream of site 1 stormwater sampler on November 29, 2011. (Source: hand held camera).

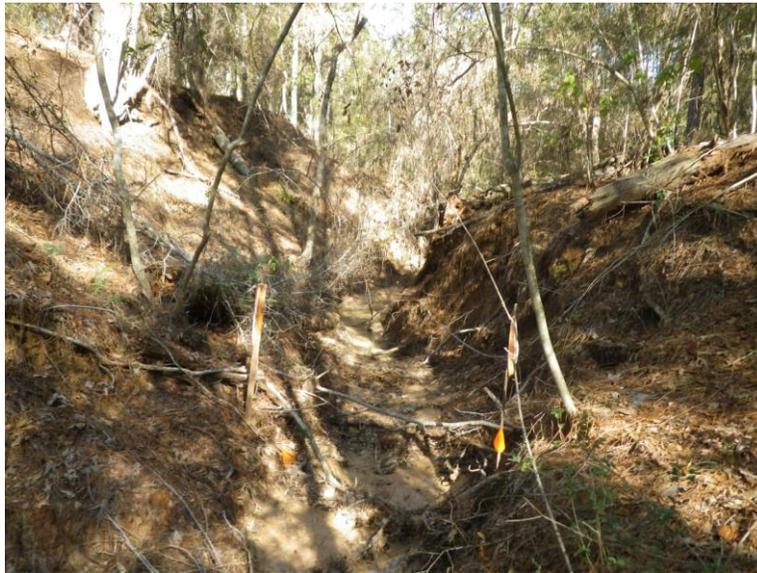
Figure 81. Photograph of site 2 on November 29, 2011 on last day of study prior to stormwater sampler removal. (Source: hand held camera).

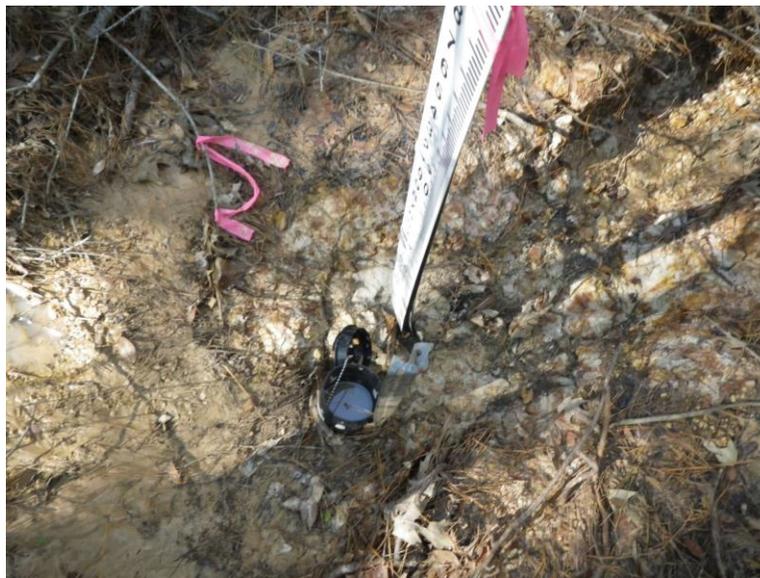
Figure 82. Photograph of stormwater sampler at site 2 on November 29, 2011 prior to stormwater sampler removal on last day of study. (Source: hand held camera). No stormwater sample bottle had been deployed prior to this event.
