Lake Madeline Bacteria Study Final Summary Report

November 16, 2010

Dr. George Guillen University of Houston Clear Lake – Environmental Institute of Houston

Environmental Institute of Houston
EIH Technical Report 2-10A

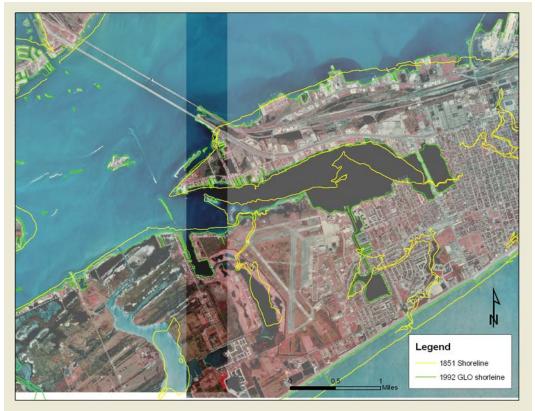
Figure 2. Past shorelines in the vicinity of Lake Madeline illustrating the extensive modification of the shoreline.

Water quality has been monitored in Lake Madeline by various agencies including Galveston County Health District (GCHD), Texas Commission on Environmental Quality (TCEQ), Texas Parks and Wildlife Department (TPWD), and the Clean Rivers Program (CRP). Routine monitoring has been limited to a few locations within the watershed. Sampling usually occurs on a monthly or less frequent basis. Local citizens have observed and complained for many years about periodic fish kills, floating debris of sanitary sewer origin, and foul odors within the lake. Fish kills and poor water quality have also been documented within Lake Madeline by various agencies (R. Schultz – GCHD, Winston Denton – TPWD). During 2005 and 2006 the GCHD documented elevated Enterococcus bacteria levels in the Lake due to various potential sources including malfunctioning sanitary sewer outfalls and wastewater treatment facilities (R. Schultz pers. comm.). Offatts Bayou has exhibited impaired water quality and historical fish kills since the early 1930's due to poor circulation caused by the deep dredging and subsequent silting of the mouth (Gunter 1942, Cooper and Morse 1996) (Figure 2).

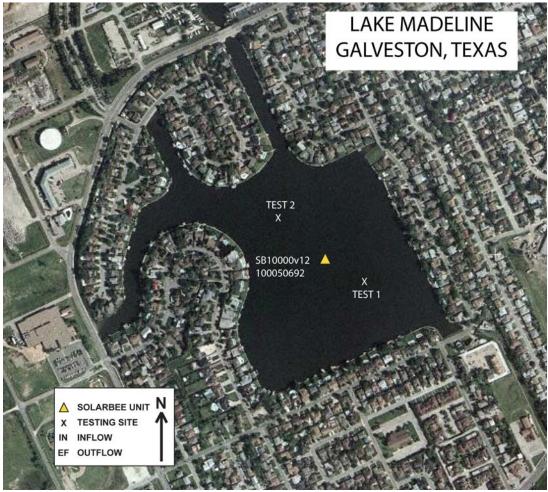
Figure 3. Location of subsurface aerator for Lake Madeline. Installed June 25, 2007.

The local residents and/or COG installed a solar powered aeration system (i.e. Solar Bee) in Lake Madeline to increase vertical circulation and potentially reareation (Figures 3 and 4). The solar pump was installed on June 25, 2007. The unit was installed at 21' depth to reduce potential odors. To our knowledge the unit has been continuously in operation.

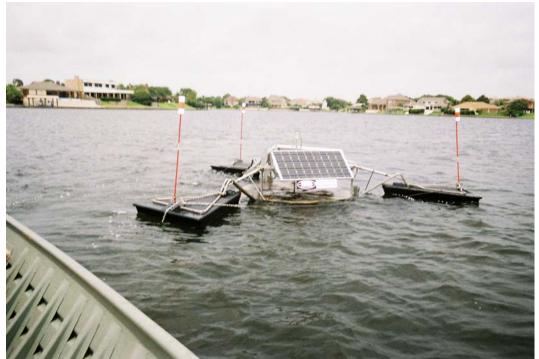
Figure 4. Solar powered aerator assembly floating in middle of Lake Madeline.
