Executive Summary

Introduction

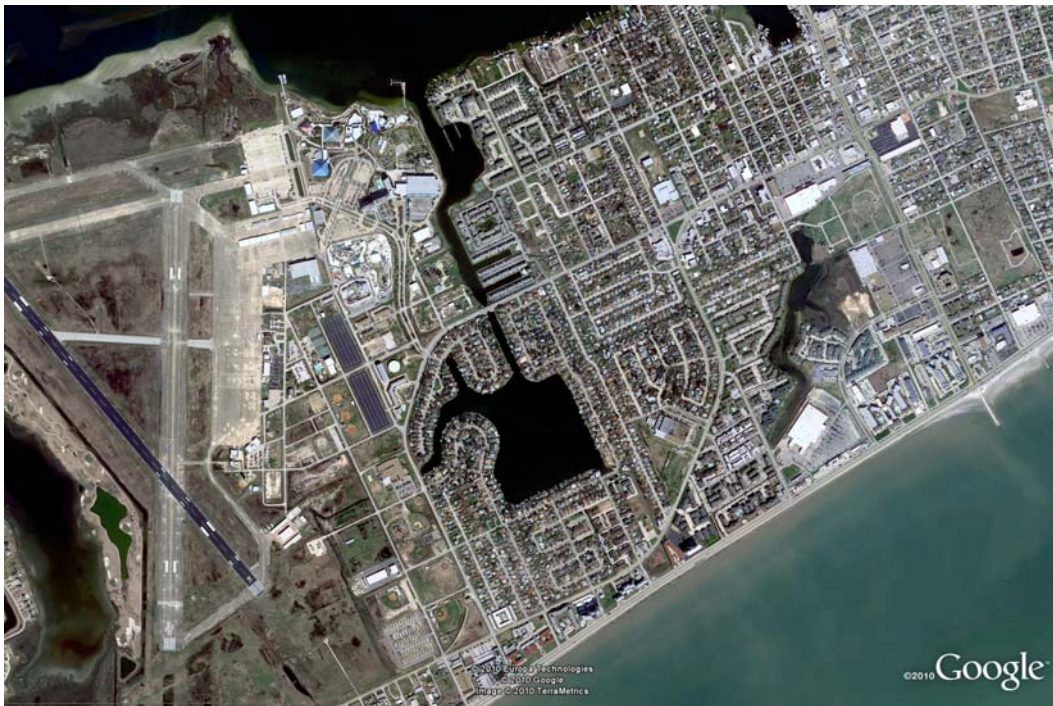
Figure 1. Location of Lake Madeline on Galveston Island, Texas.

Lake Madeline is a man-made lake located on the western end of Galveston Island, Texas (Figure 1). The lake is irregular in shape and measures 1,506 feet wide at its longest axis. The calculated area is approximately 47.7 acres. There are two finger canals that extend from the lake along the northwestern and western end of the lake. Water depths near the middle of the lake extend to 25 feet in its deeper portions. Lake Madeline is connected to Offatts Bayou via a 3,925 ft long canal. The 26.21 acre canal is on average 30 ft wide and has an average depth of 13 feet. The total estimated drainage area into the lake is 953 acres (E. Wilson, City of Galveston, pers. comm.). Based on the observed tidal amplitude and the surface area of the lake, we estimated that the volume of water displaced within the lake during a tidal cycle is approximately 24.85 million gallons. An additional 13.66 million gallons is displaced in the connecting canal. The surrounding watershed including Offatts Bayou was highly modified prior to World War II by dredging to provide fill material for maintenance of the Galveston seawall (Gunter 1942). Since then the area has had numerous water quality problems including fish kills associated with resulting water stratification and poor circulation.

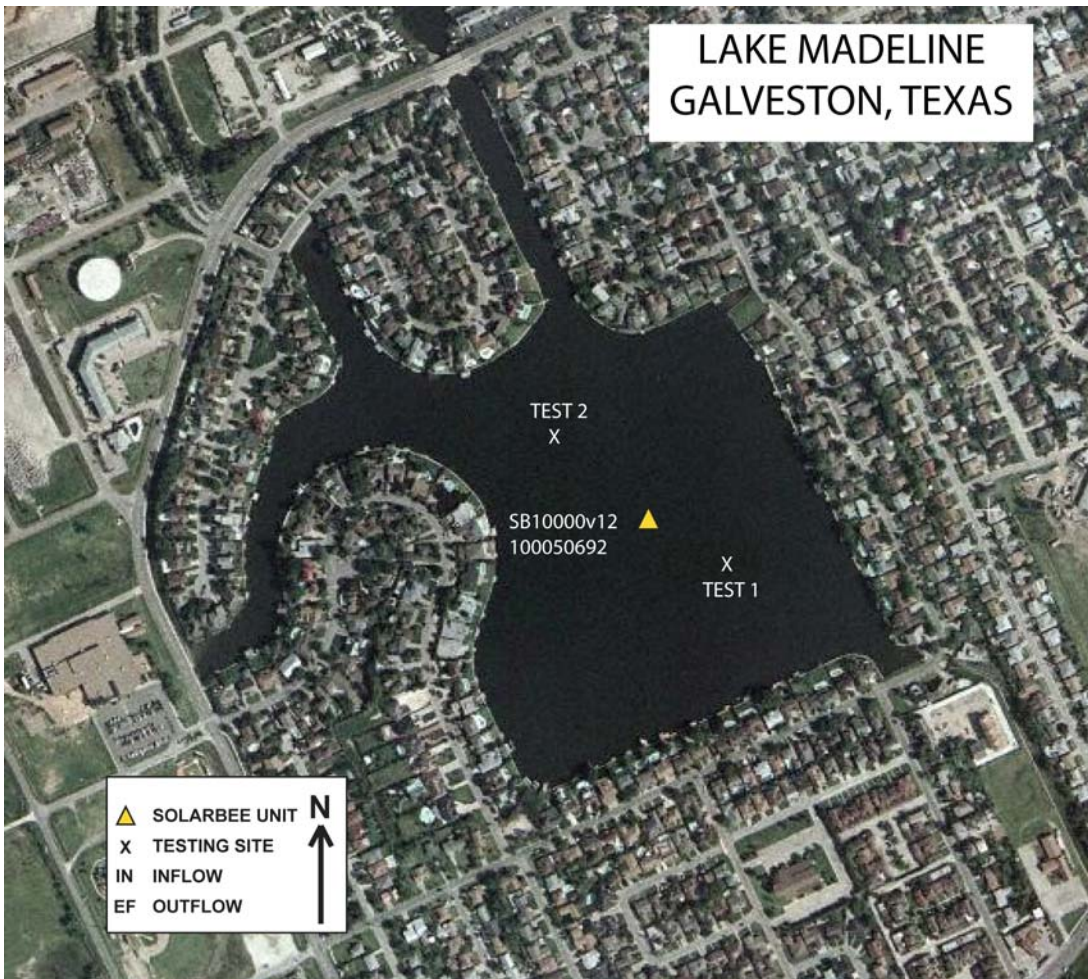
Figure 3. Location of subsurface aerator for Lake Madeline. Installed June 25, 2007.

The local residents and/or COG installed a solar powered aeration system (i.e. Solar Bee) in Lake Madeline to increase vertical circulation and potentially reareation (Figures 3 and 4) . The solar pump was installed on June 25, 2007. The unit was installed at 21’ depth to reduce potential odors. To our knowledge the unit has been continuously in operation.

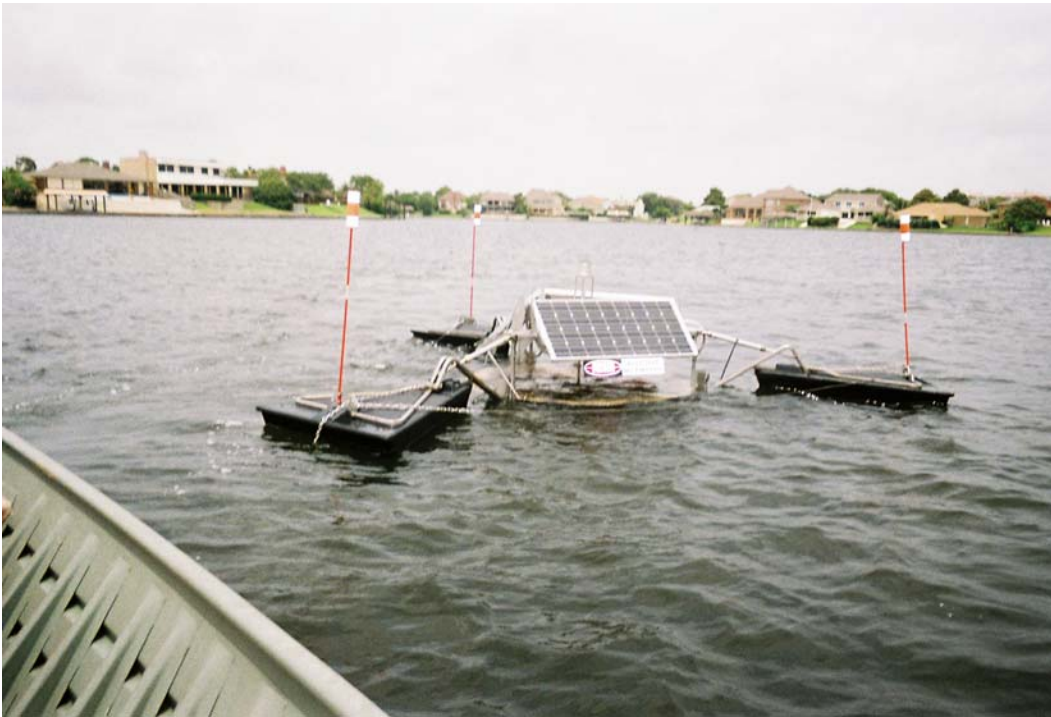
Figure 4. Solar powered aerator assembly floating in middle of Lake Madeline.

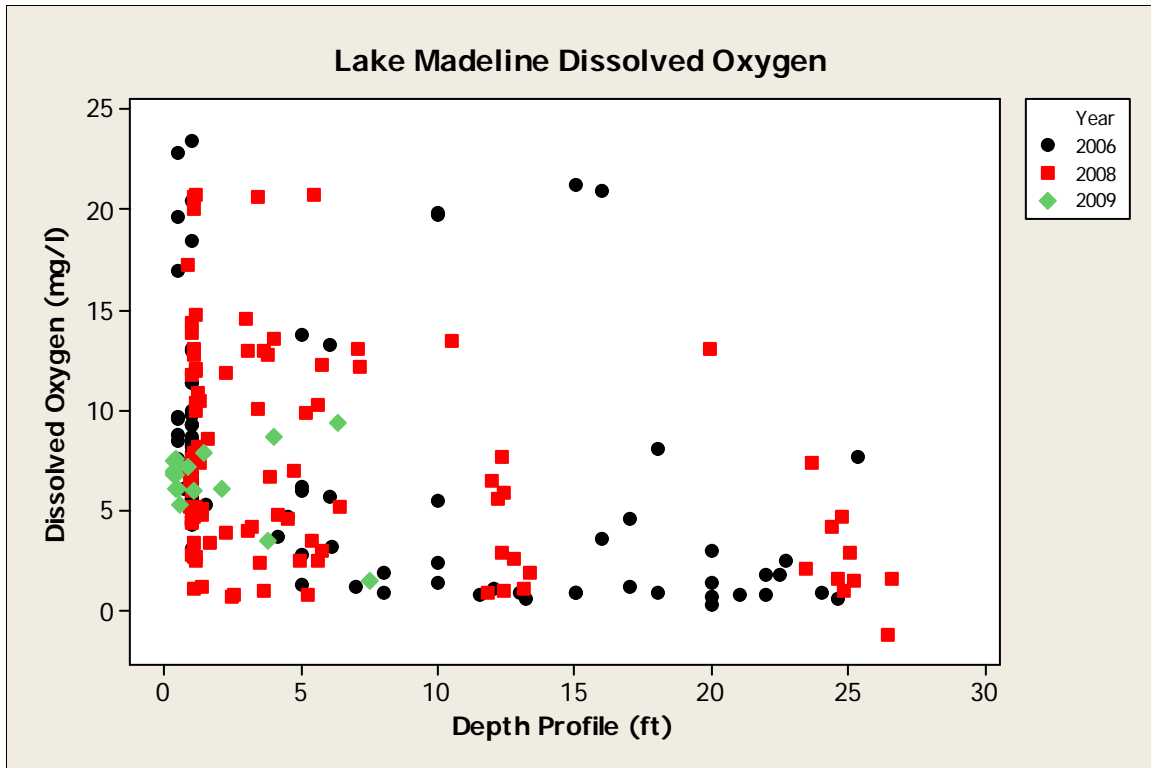
Figure 14. Dissolved oxygen profile composed from various sites during 2006, 2008-2009.
